The Valley Lo Towers I Condominium Association

RESERVE STUDY
For
Valley Lo Towers I

Glenview, IL
Date of Inspection
January 10, 2014

BUILDING RESERVES, INC.

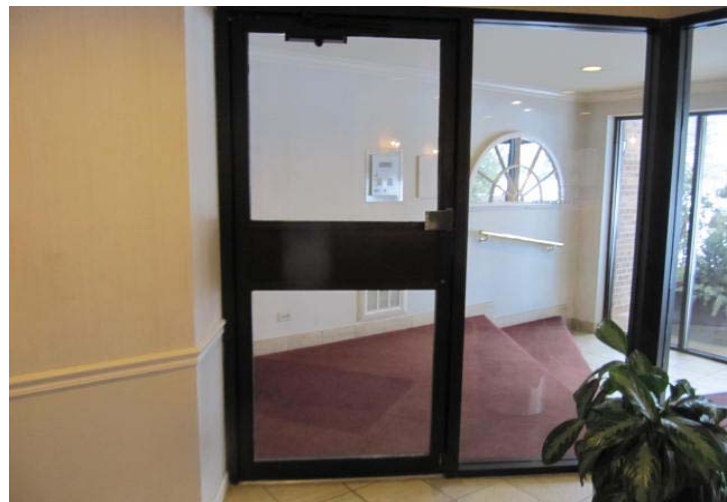
Swing style entry door with adjacent glazing.

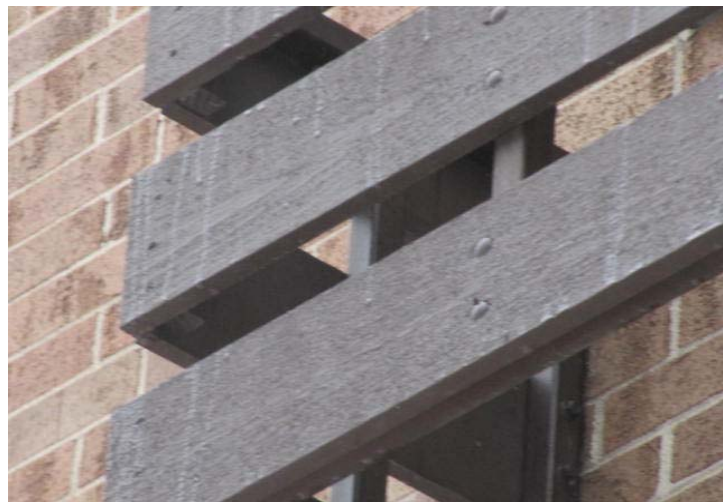
Railings at private stairwell door.

Wood rails and finishes are in very good condition.

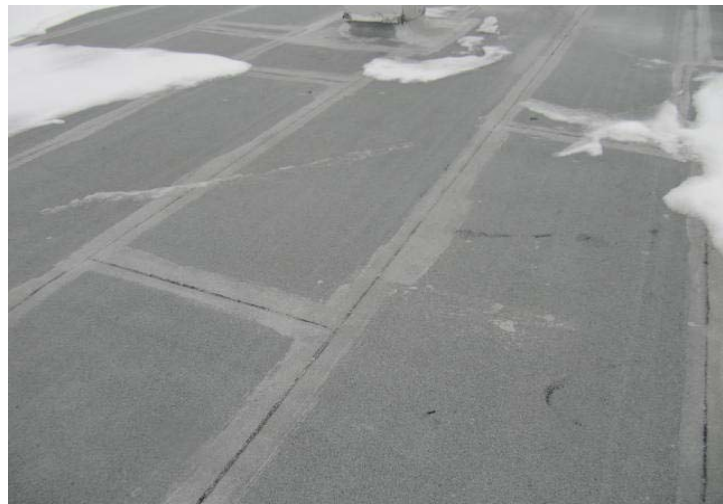
Modified bitumen roof, in good overall condition.

Building roof, replaced in 2006.

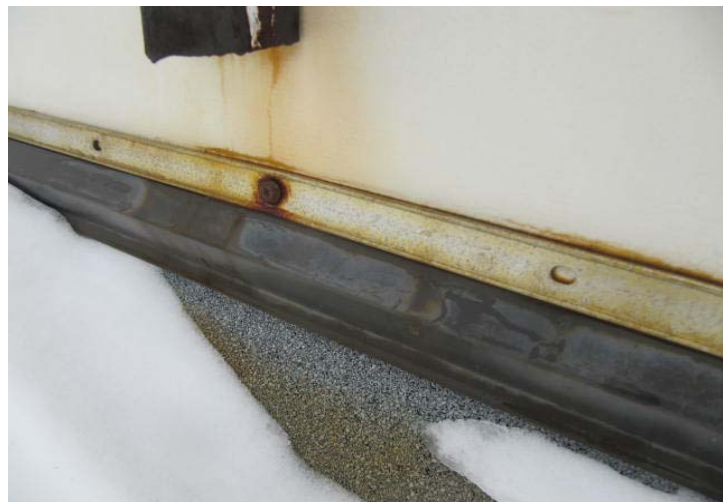
TPO membrane at vertical parapet wall surface.

Transition / flashing between flat roof and parapet wall.

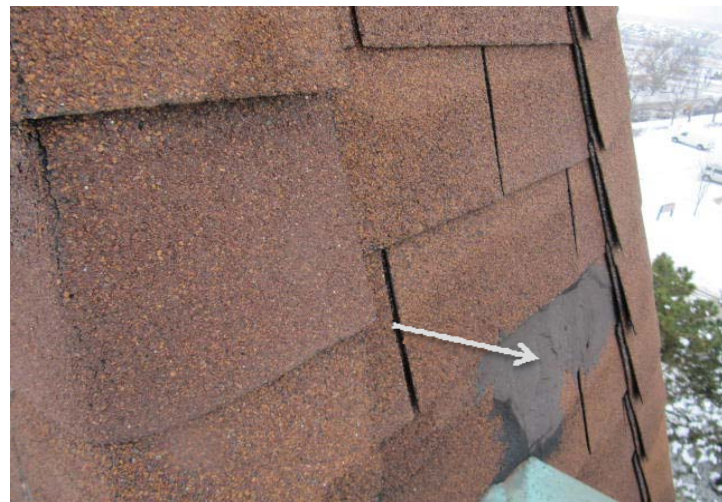
Asphalt shingles, in fair condition.

Evidence of past repairs / patching at roof.

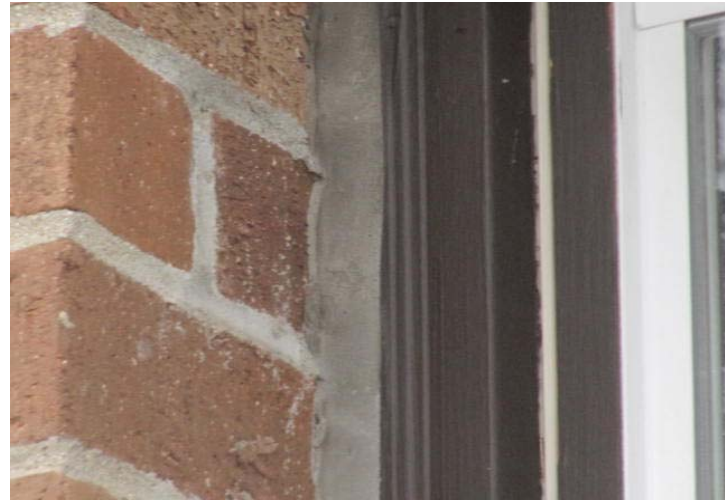
Sealant at perimeter of unit window.

Sealant at unit window, in good overall condition.

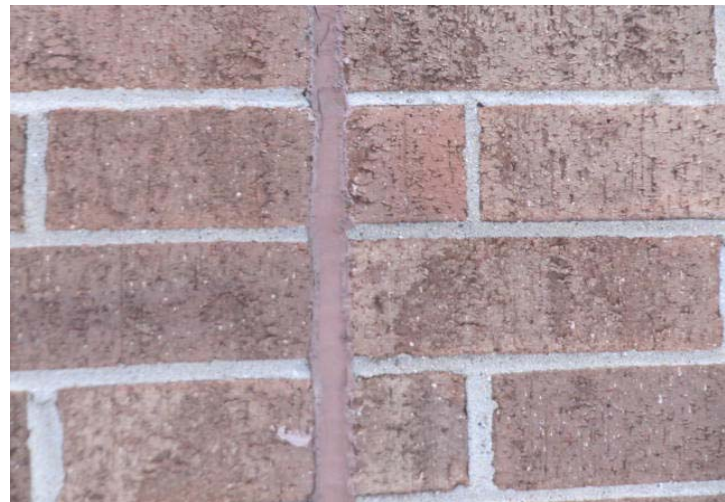
Sealant between masonry façade and wood siding.

Sealant at building masonry control joint.

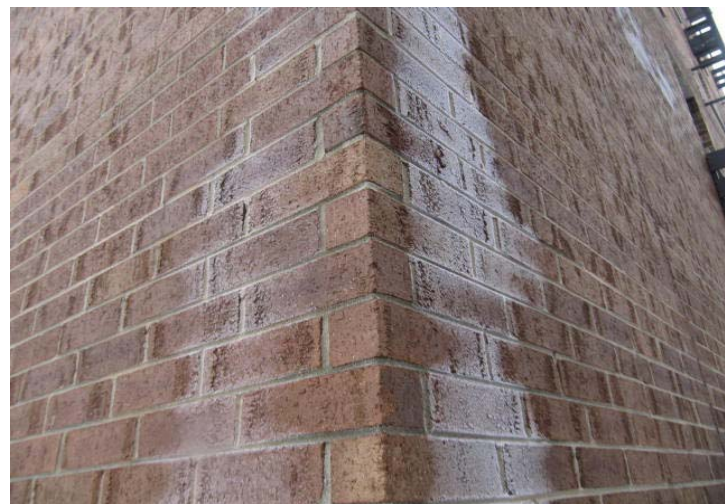
Evidence of past repointing at masonry mortar joints.

Efflorescence at exterior masonry façade (noted at multiple locations).

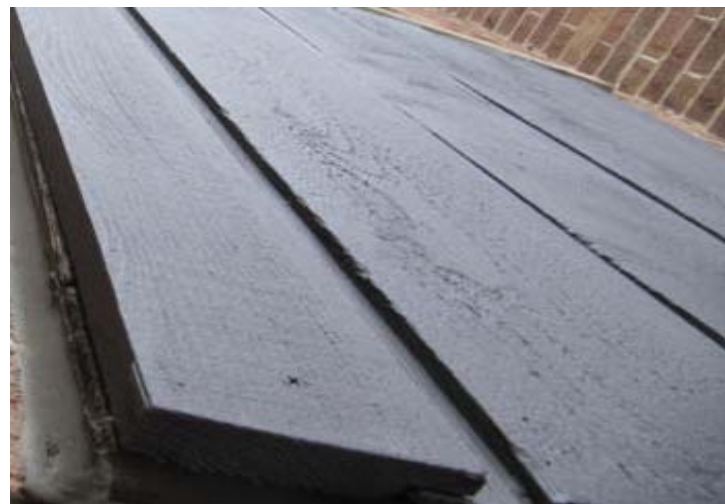
Wood siding with paint finishes.

Wood siding panels are in good overall condition.

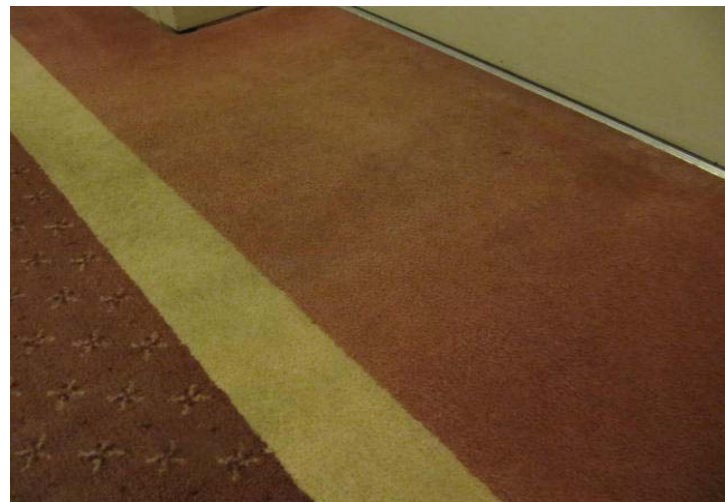
Matted carpet texture.

Stained carpet near elevator entrance.

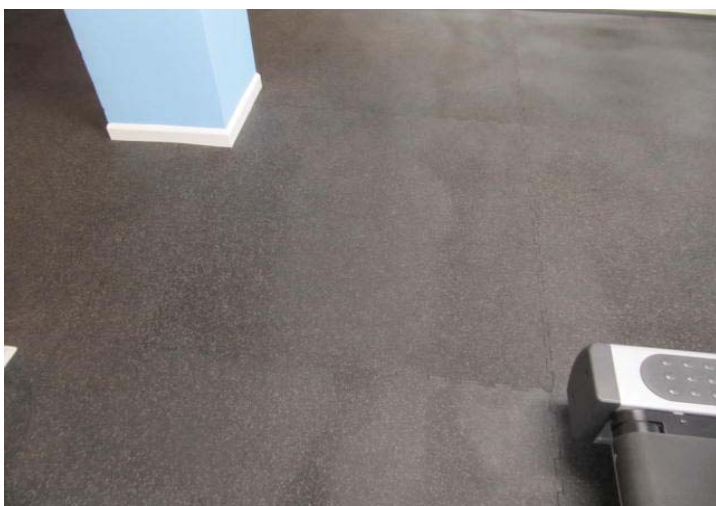
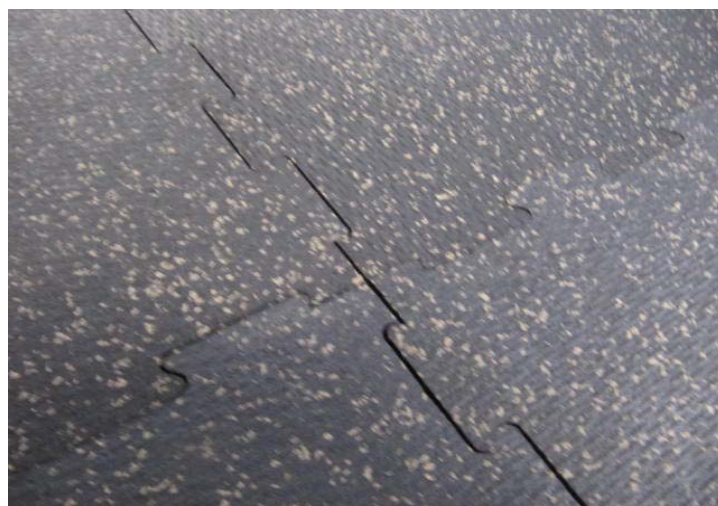
Rubber sports flooring, in very good condition.

Interlocking floor tiles, in very good condition.

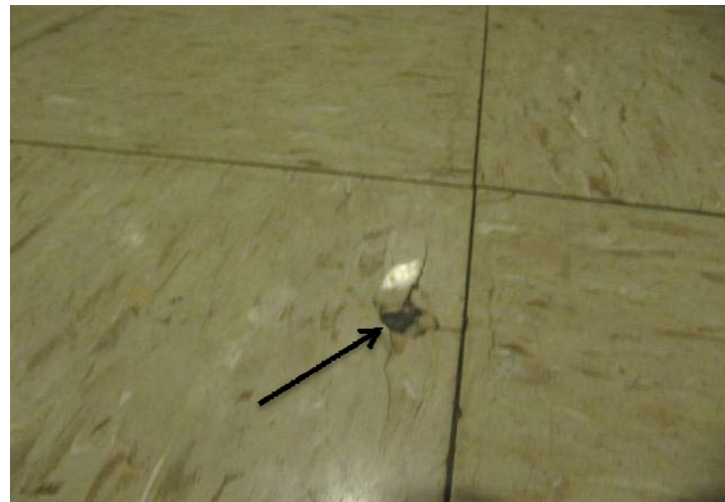
Hairline cracks at vinyl tile at lower level elevator lobby.

Cracked, damaged vinyl tile at lower level elevator lobby.

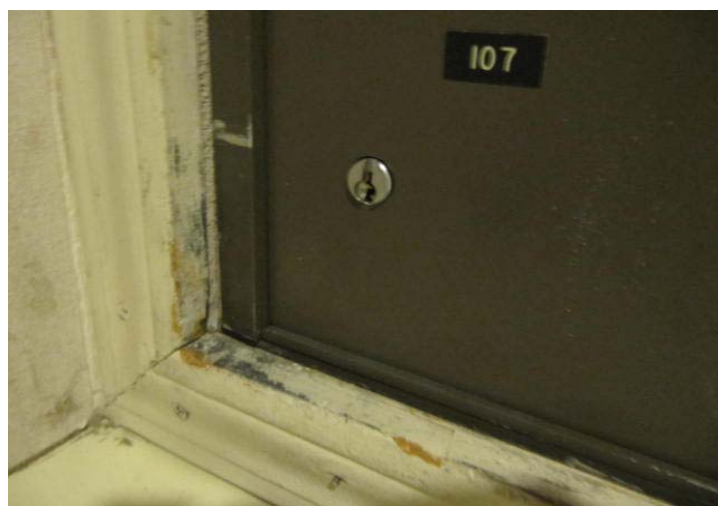
Worn finishes at aluminum mailboxes.

Wood trim at mailbox surround is in poor condition.

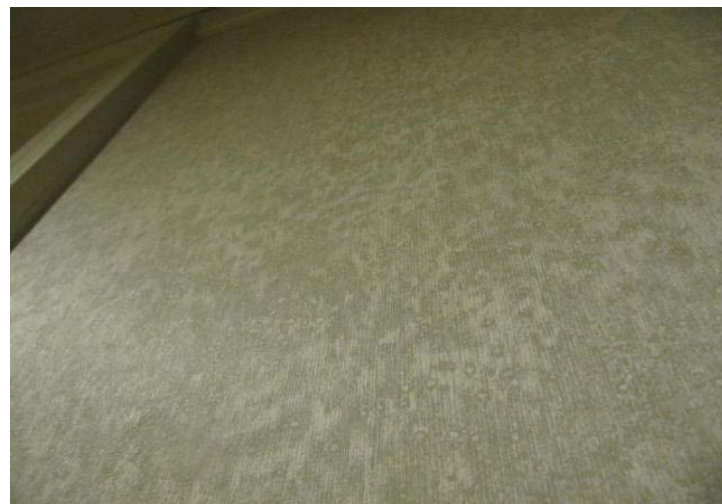
Markings at wall coverings.

Typical surface condition at wall coverings at lobby.

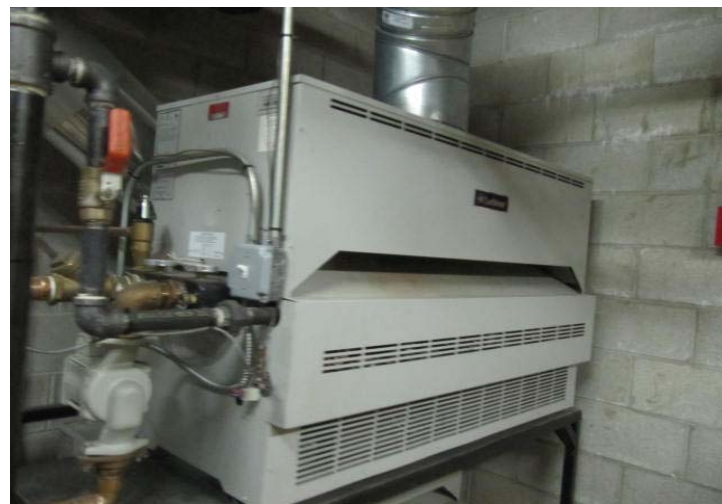
Lochinvar boilers at garage-level mechanical room.

Boilers are in good operational condition.

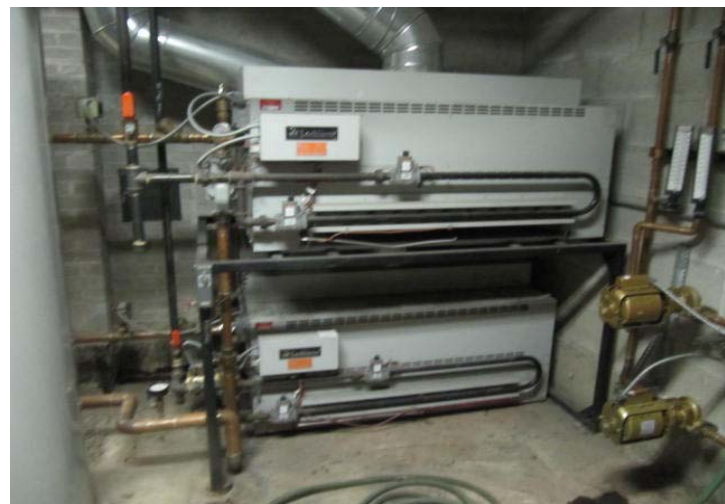
Lochinvar boilers at garage-level mechanical room.

Boilers are in good operational condition.

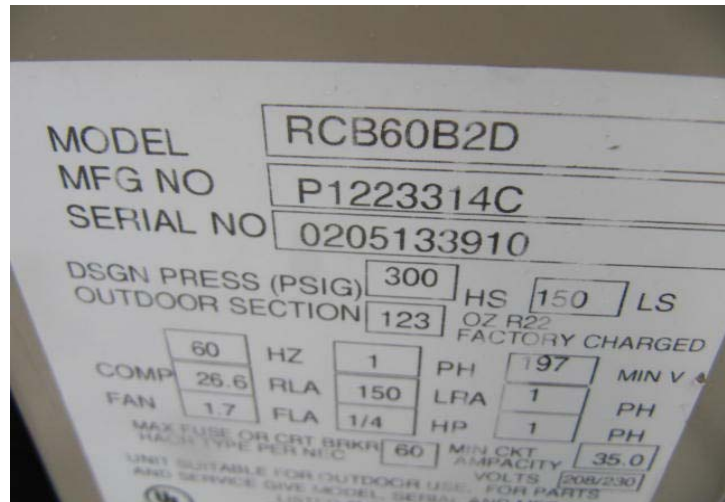
Condensing unit at building rooftop.

Condensing unit at unknown age.

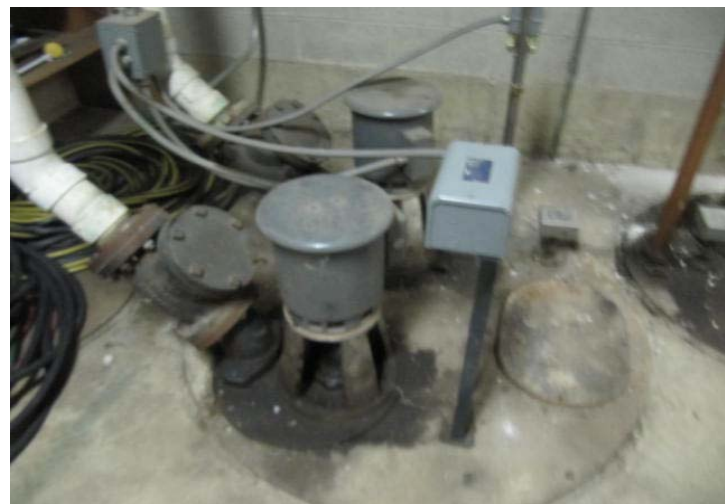
Sump pumps vary in age and condition.

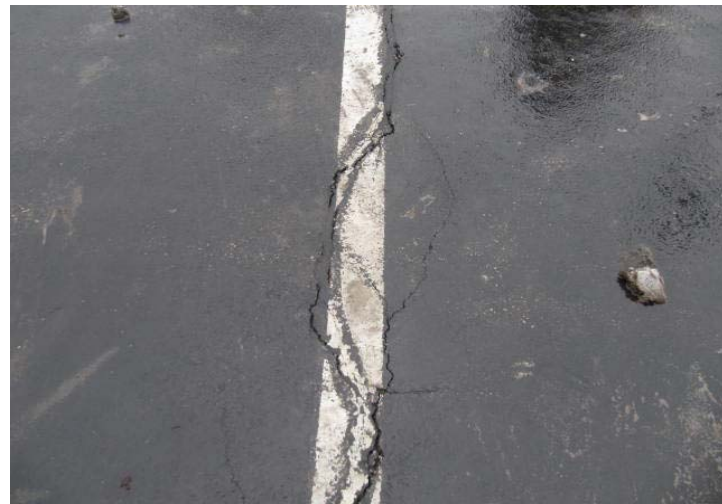
Clear marking at handicap parking stall.

Cracks at asphalt pavement.

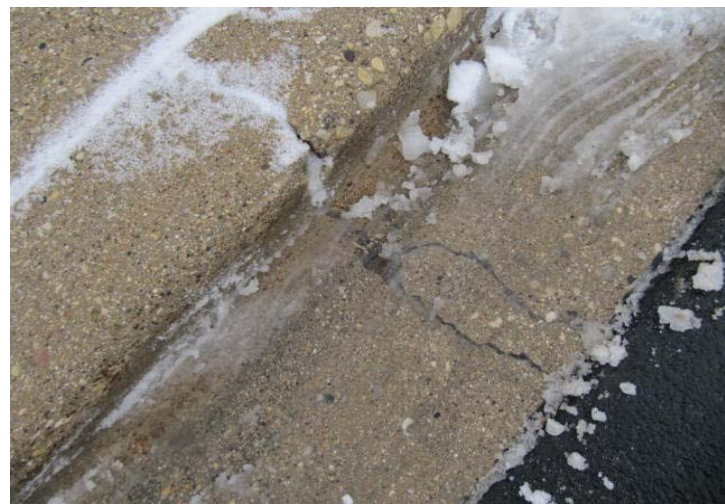
Raised concrete curb and gutter at parking lot.

Cracked concrete curb and gutter at parking lot.

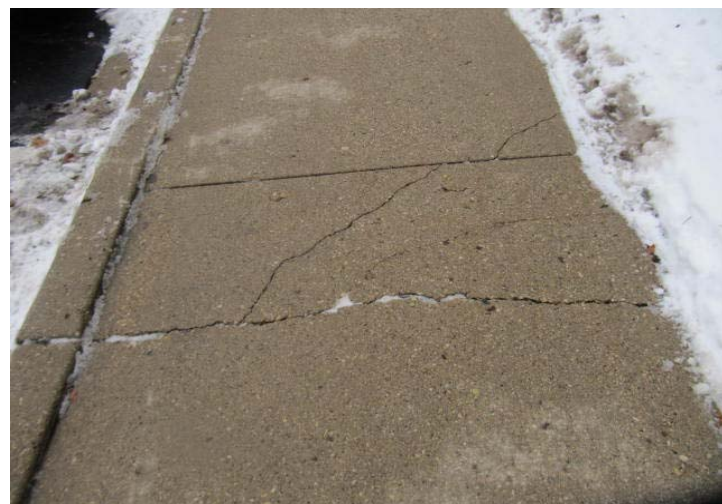
Area of sidewalk in good overall condition.

Cracked concrete flatwork at sidewalk.

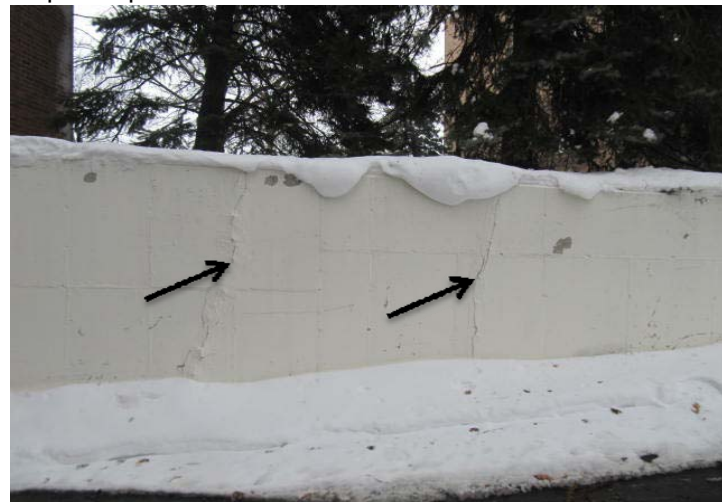
Crack at concrete retaining walls.

Various cracks at concrete retaining walls.

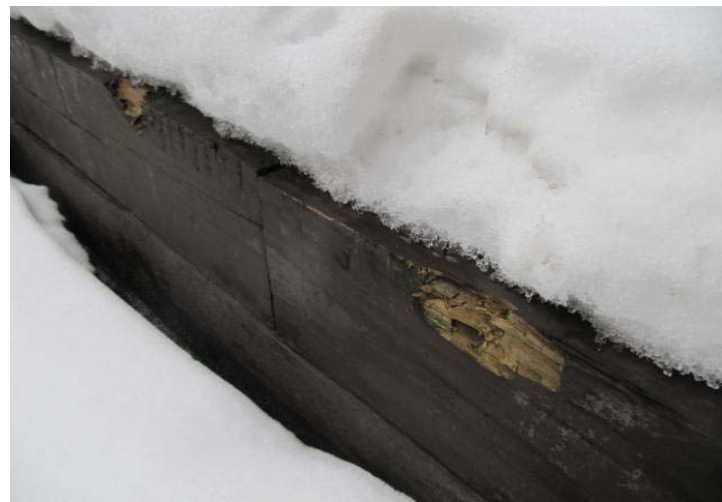
Typical timber retaining wall, with paint finishes.

Chipped timber member, with exposed wood.

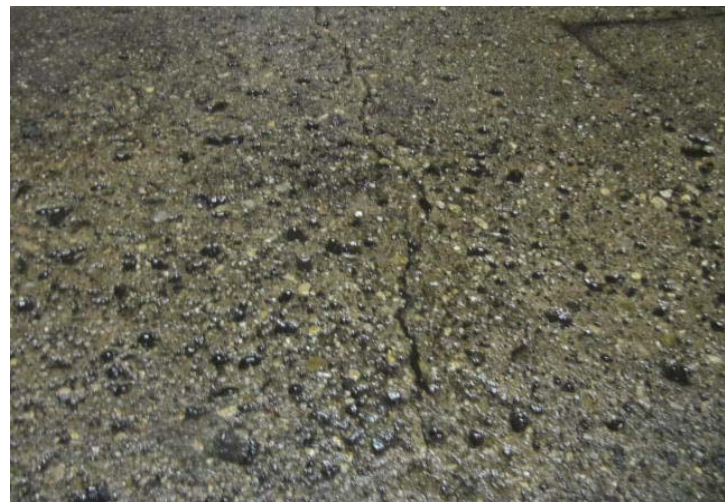
Hairline cracks at concrete garage floor.

Pitted concrete near garage entrance.

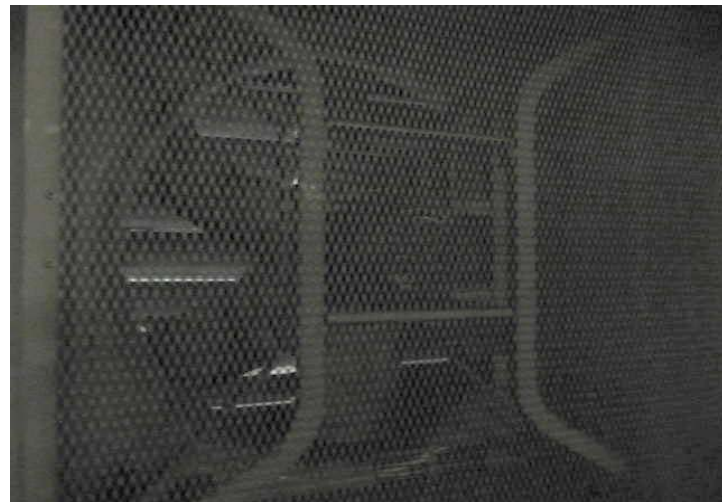
Original exhaust fan, at 30 years of age.

Interior of exhaust fan, with axial blades and motor.

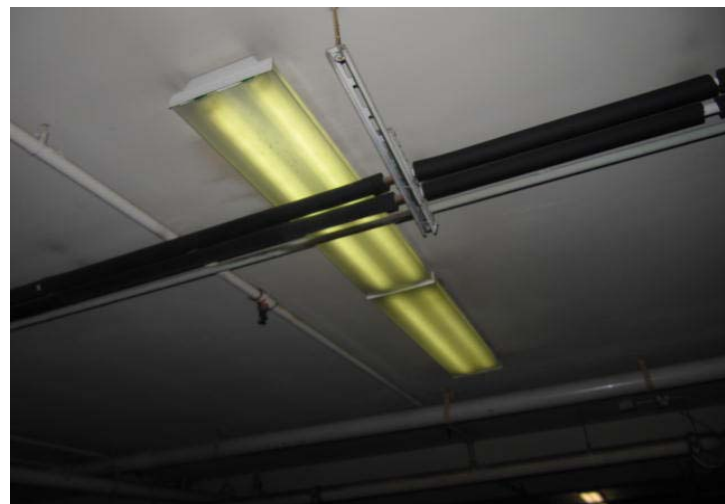
(2) light fixtures back-to-back

Garage light fixtures are in good overall condition.

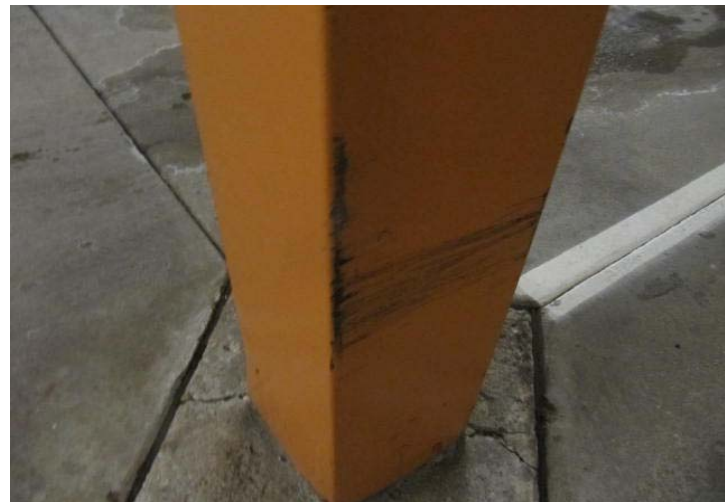
Painted ceiling surfaces at parking garage.

Markings at structural concrete column.

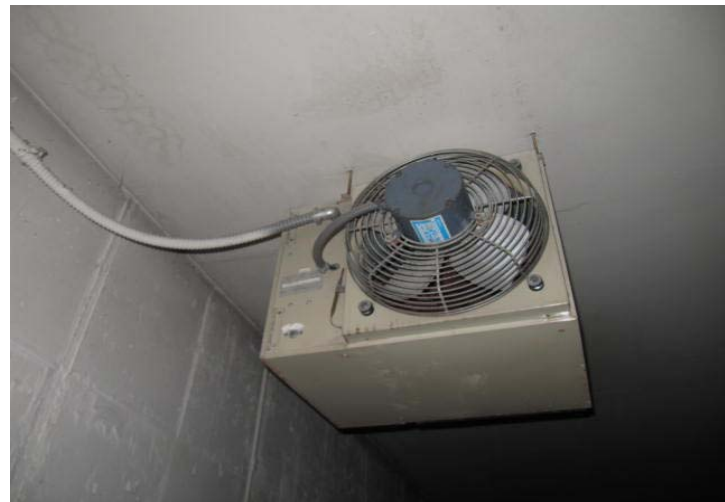
Electric unit heater at parking garage.

Original unit heater, at 30 years of age.
