# RESERVE STUDY

## Valley Lo Towers I Condominium Association

**Glenview, Illinois**

**June 12, 2019**

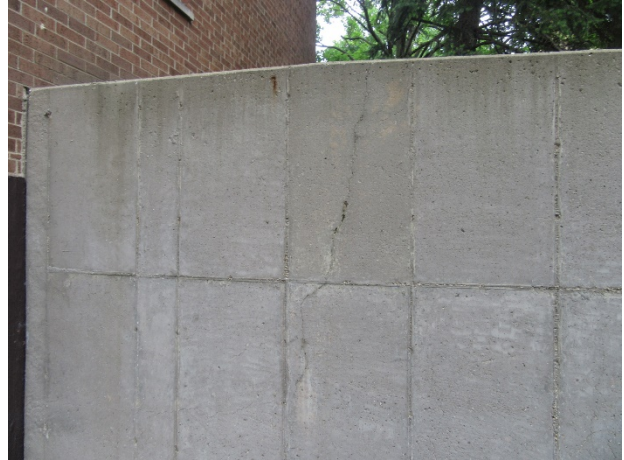
**Wall cracks**

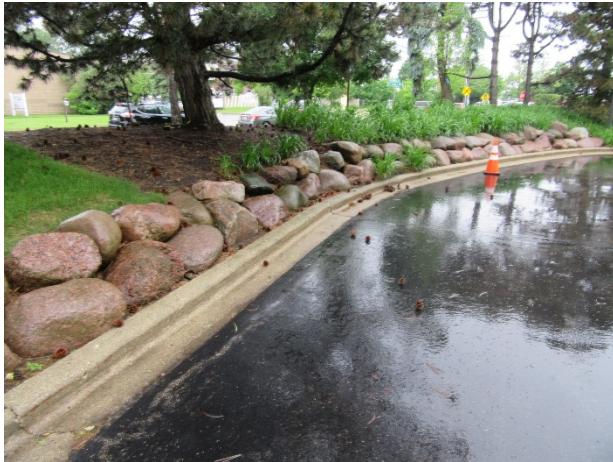
**Stone retaining wall**

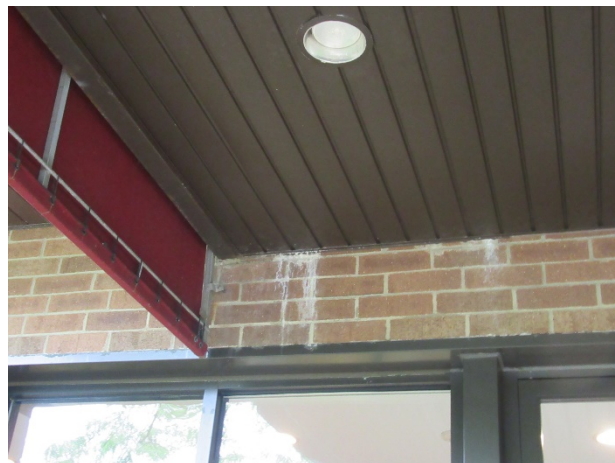
Evidence of water infiltration between canopy and building

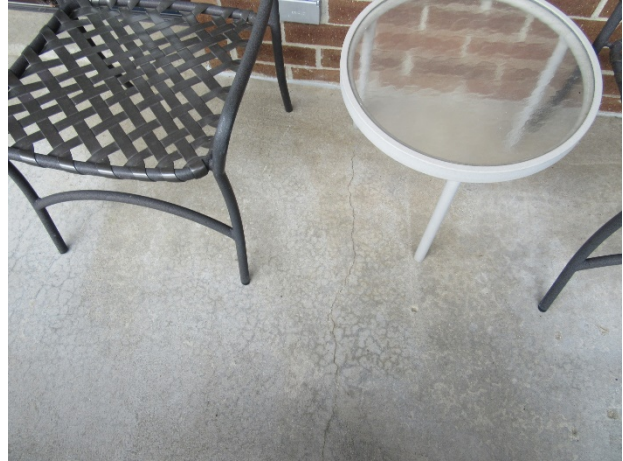
**Balcony crack**

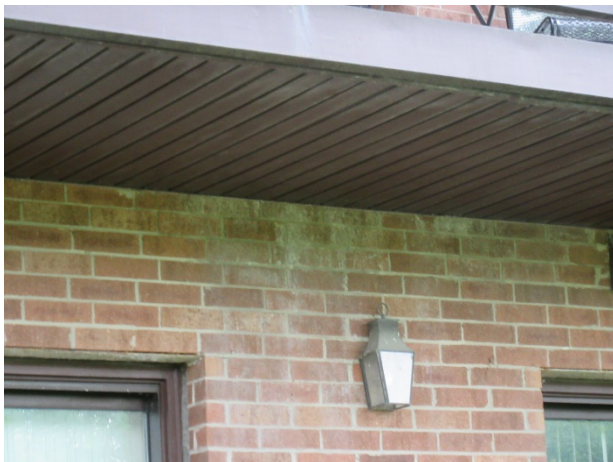
**Evidence of water infiltration between balcony and wall**

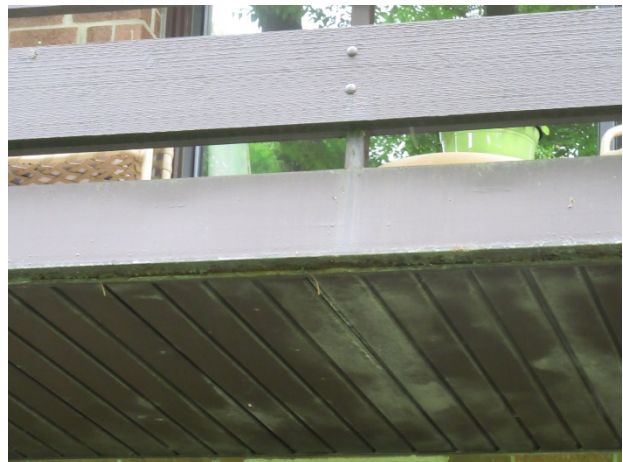
**Evidence of water infiltration**

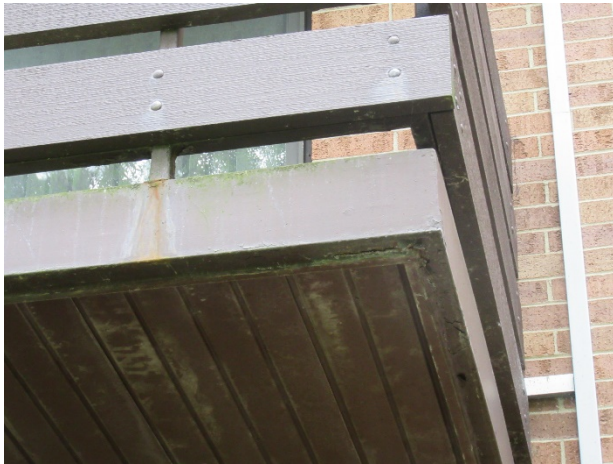
**Rust and evidence of water infiltration**

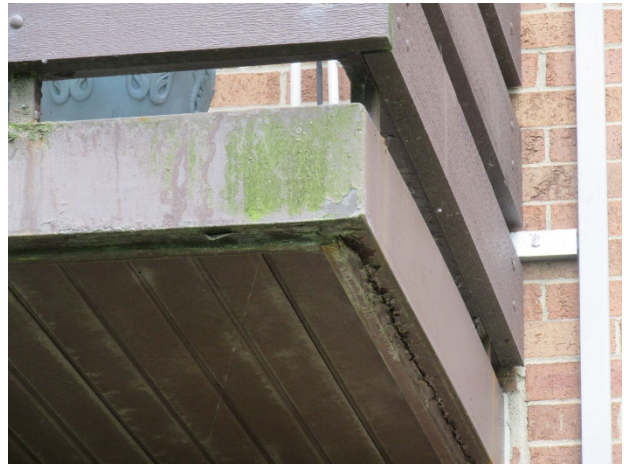
**Rust and evidence of water infiltration**

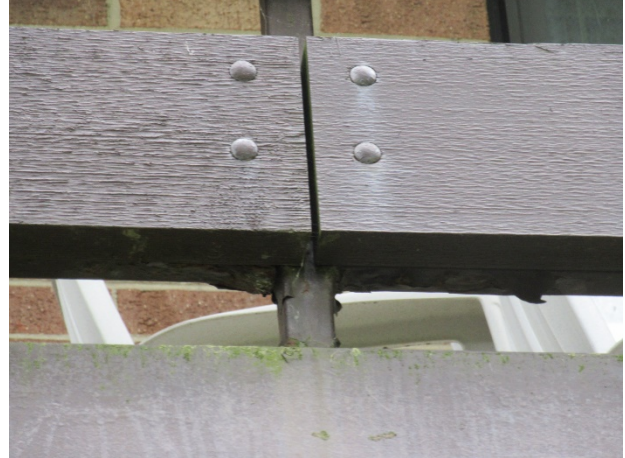
**Finish deterioration at metal support**

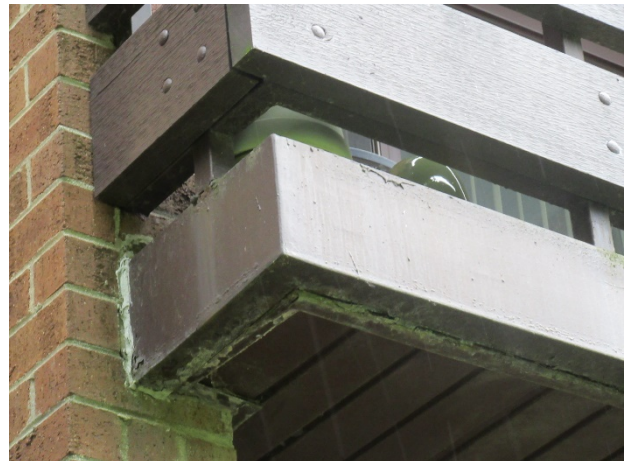
**Rust and evidence of water infiltration**

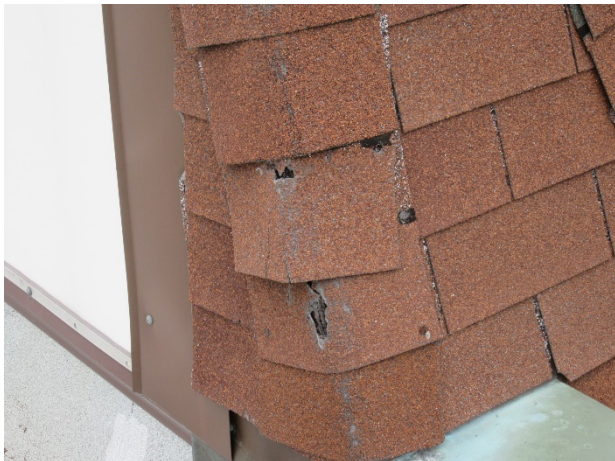
**Shingle damage**

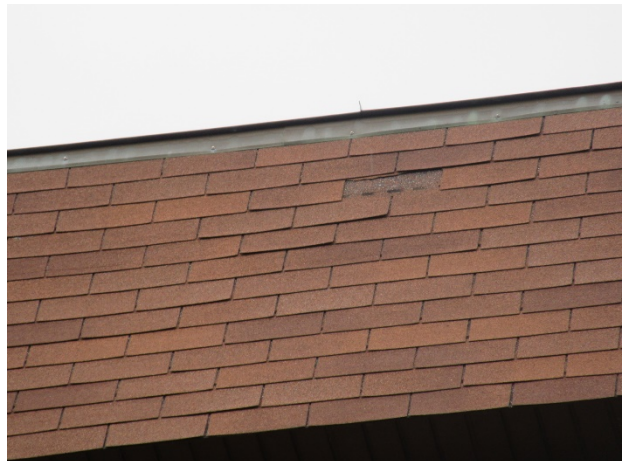
**Missing and loose shingles**

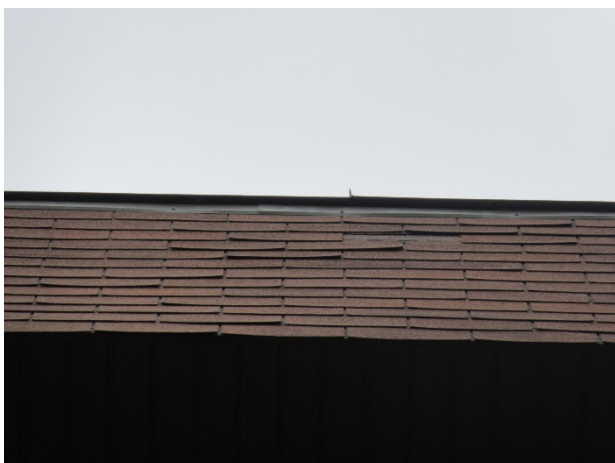
**Missing and loose shingles**

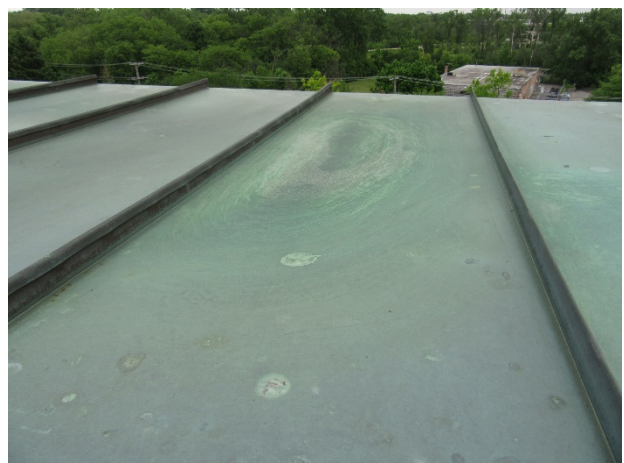
**Evidence of water accumulation at metal coping**

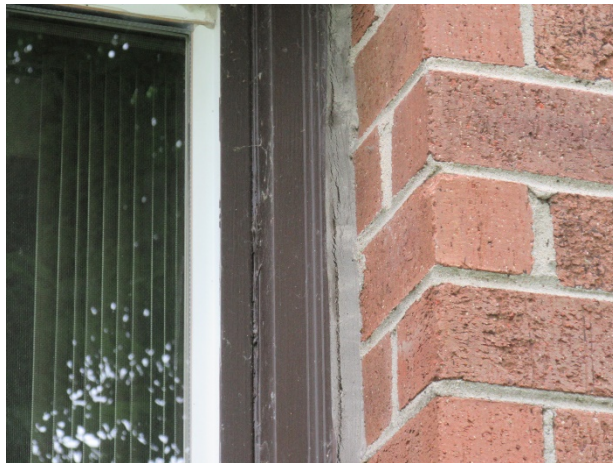
**Cohesive failure**

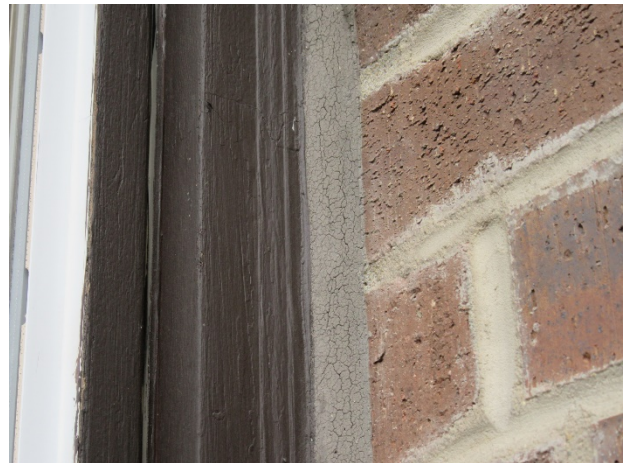
**Sealant deterioration**

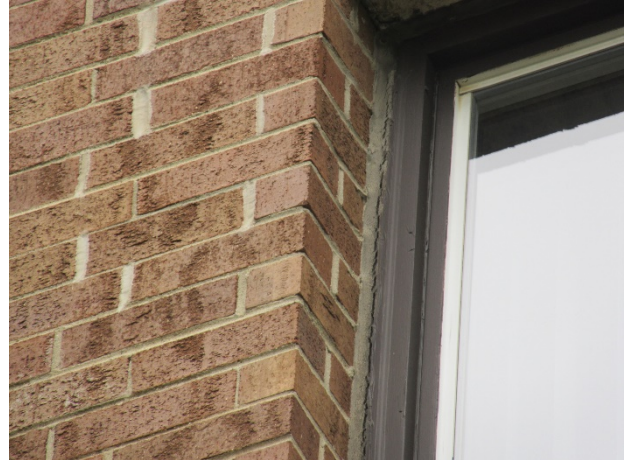
**Adhesion failure**

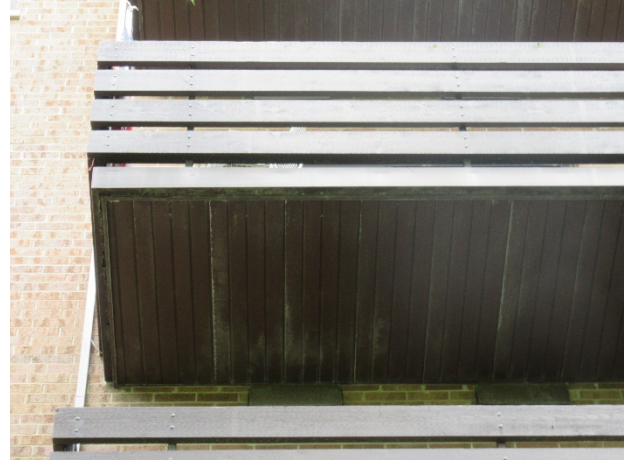
**Evidence of water infiltration**

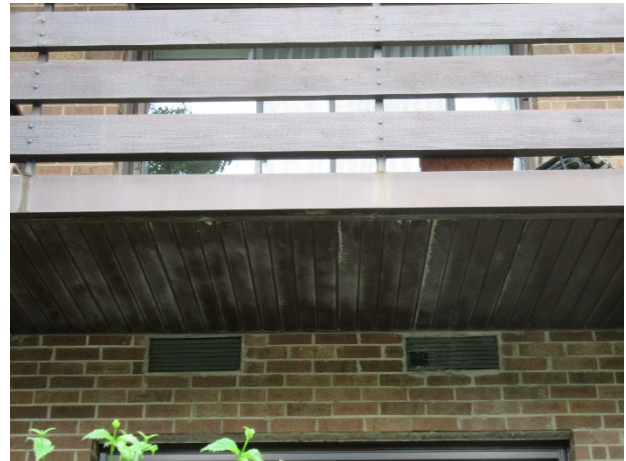
**Evidence of water infiltration**

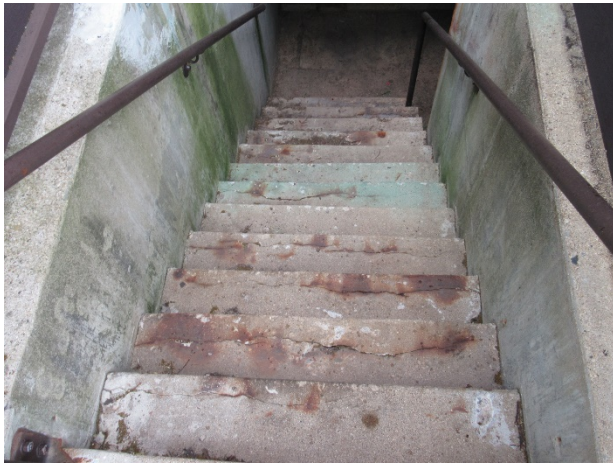
**Cracks and rust from reinforcement bars**

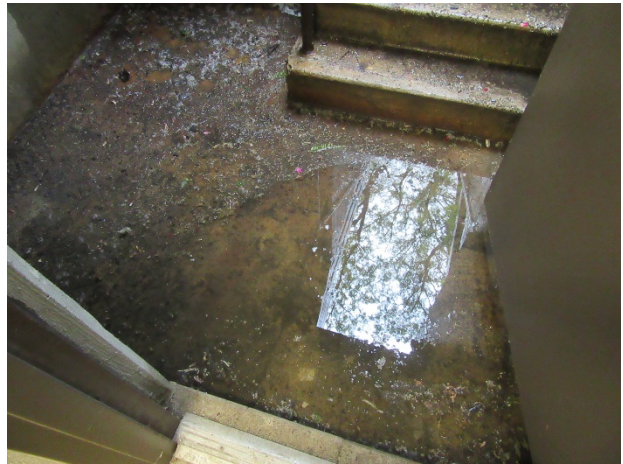
**Water accumulation**

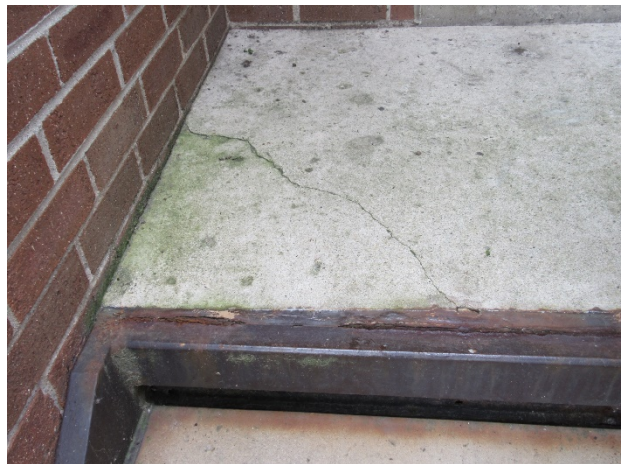
**Concrete crack**

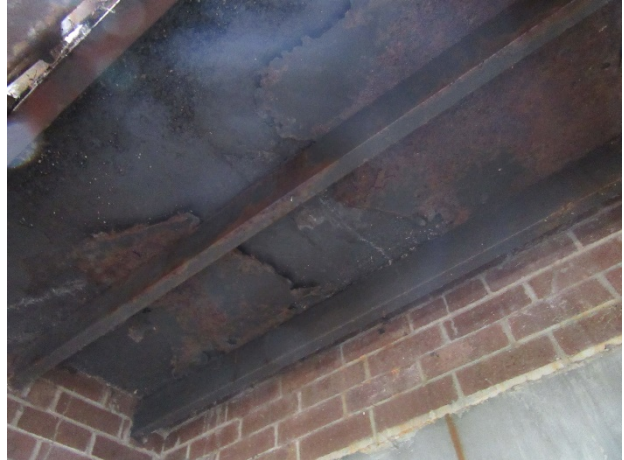
**Finish deterioration and rust**

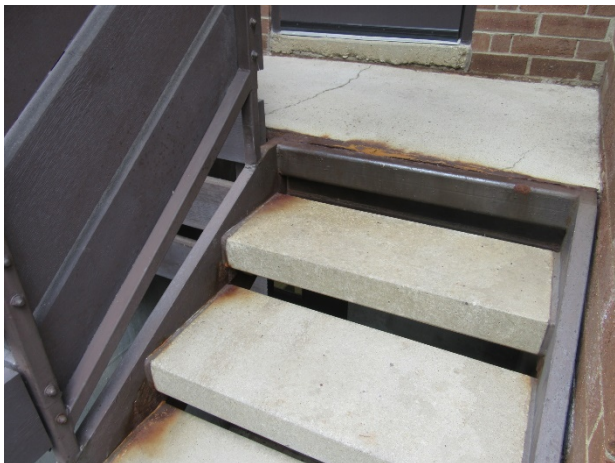
**Concrete cracks and rust**

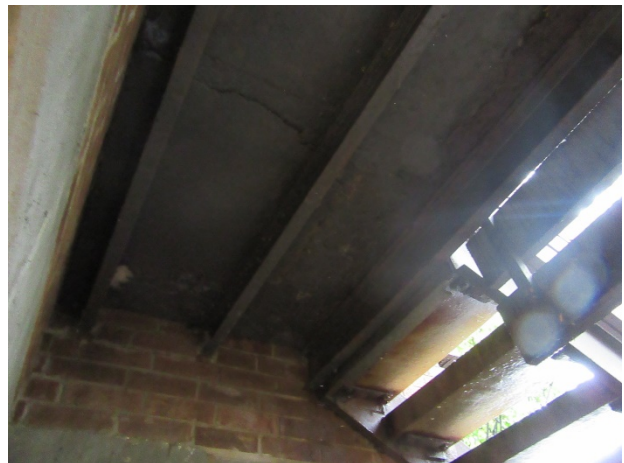
**Finish deterioration and rust**

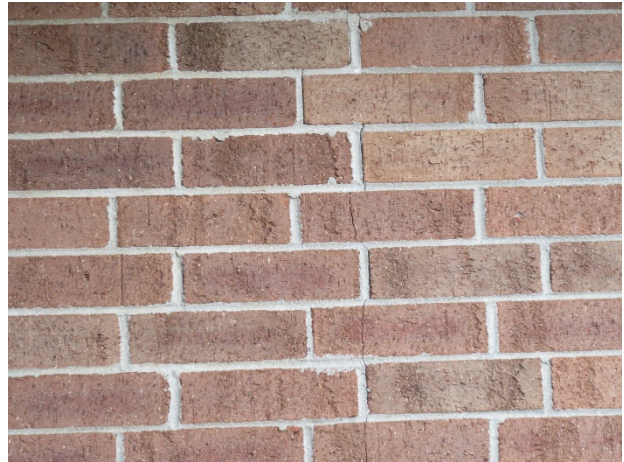
**Masonry crack**

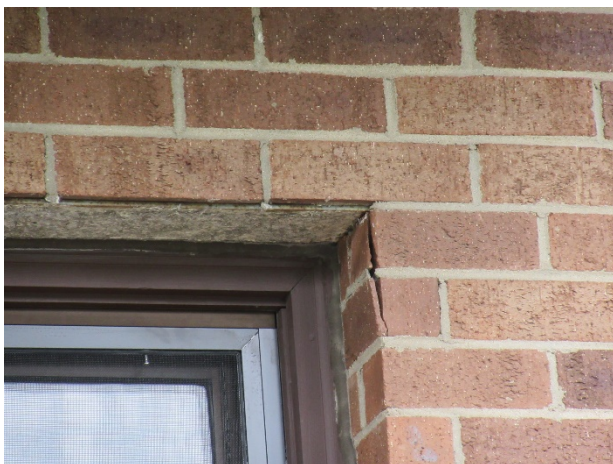
**Delamination**

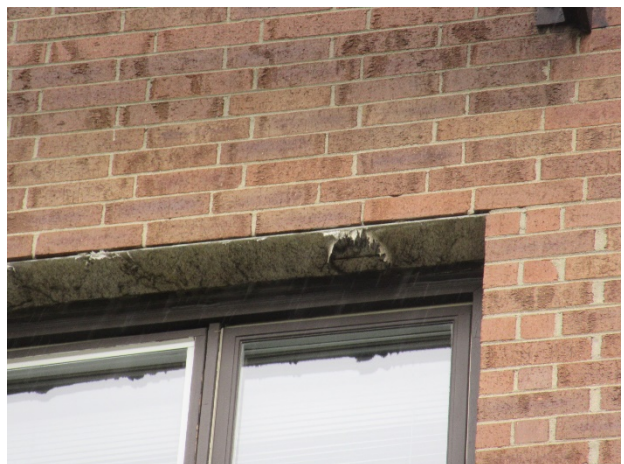
**Finish deterioration at lintel**

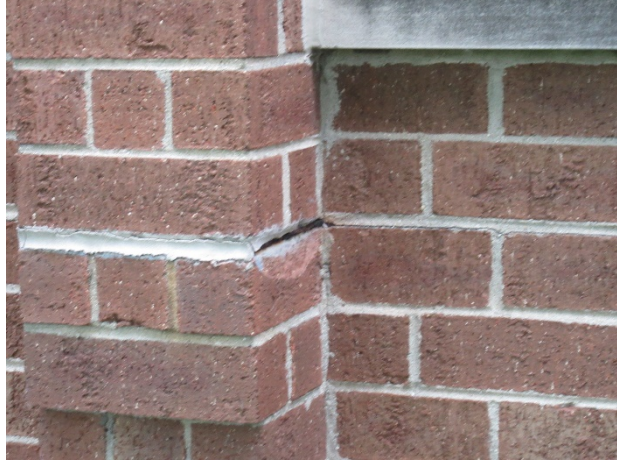
**Exposed shelf angle**

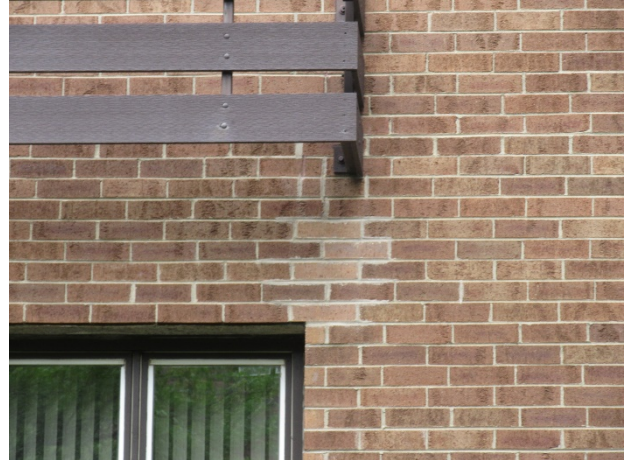
**Evidence of prior repairs**

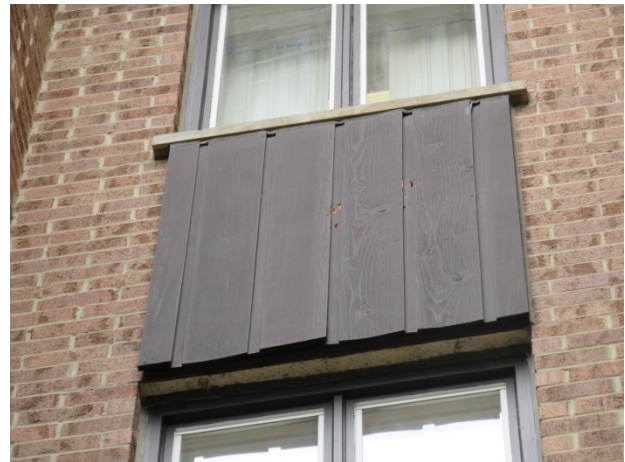
**Deflection and damage**

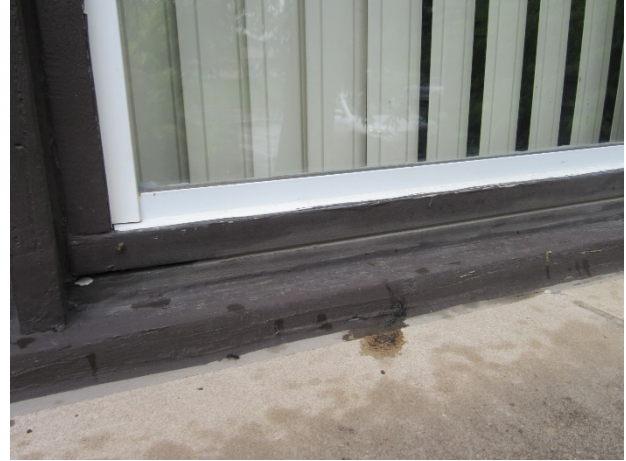
**Frame deterioration**

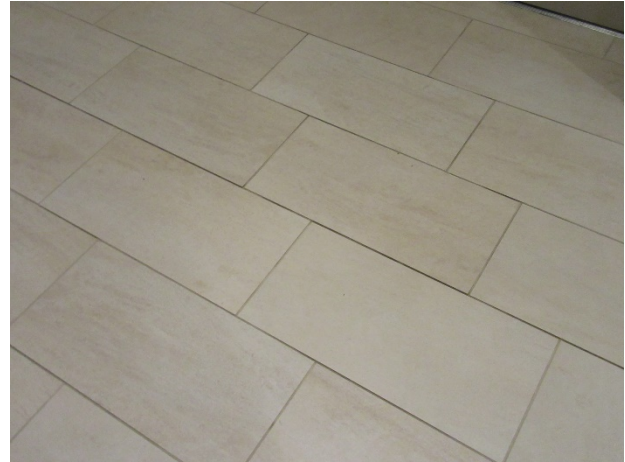
**Grout discoloration**

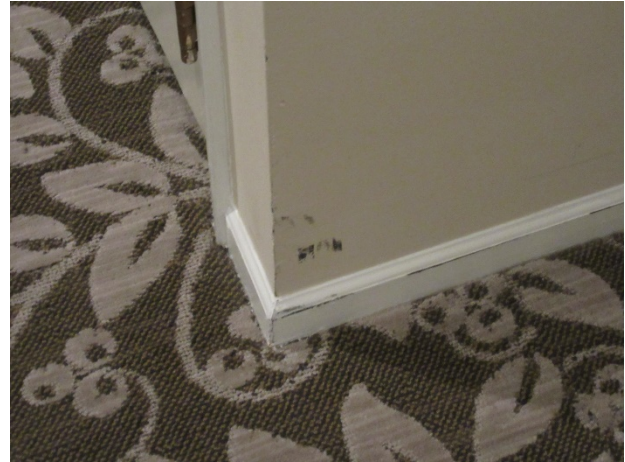
**Corner scuffs**

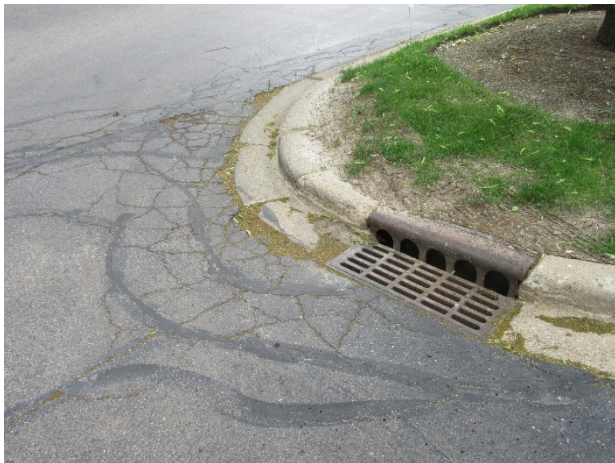
**Alligator cracks near catch basin**

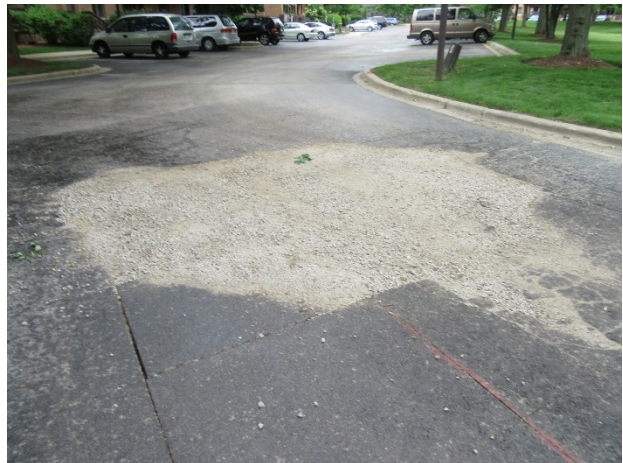
**Pavement deterioration near the east garage of the 2000 building**

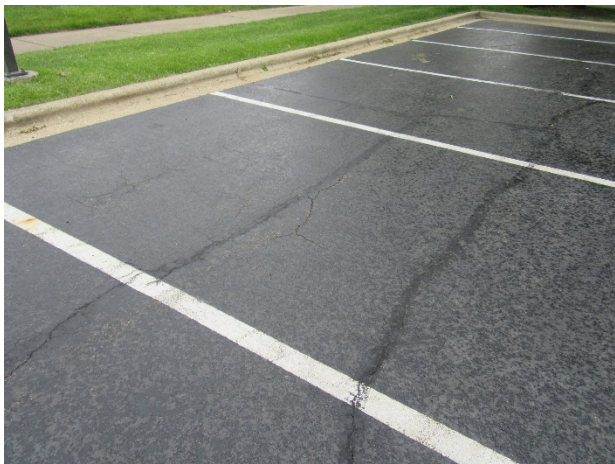
**Longitudinal cracks**

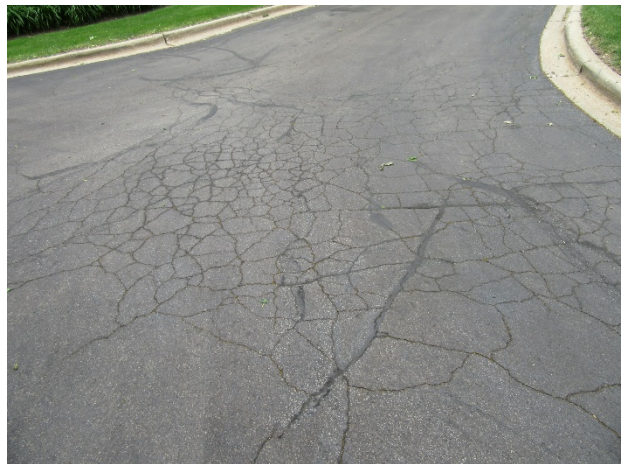
**Alligator cracks**

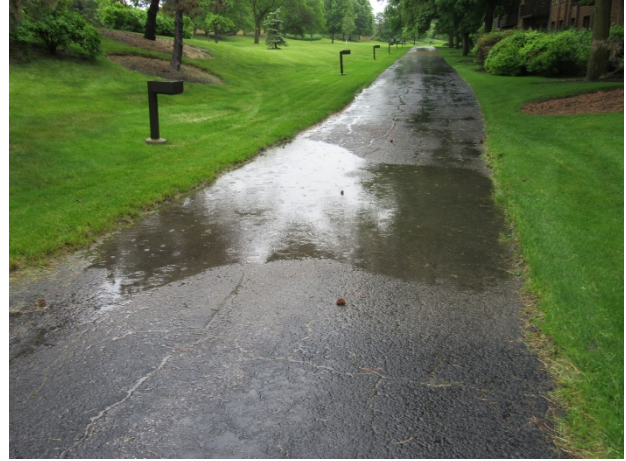
**Water accumulation at west end of fire lane**

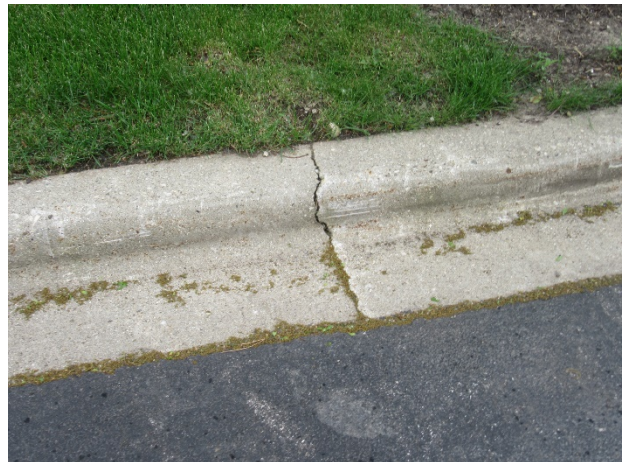
**Curb crack**

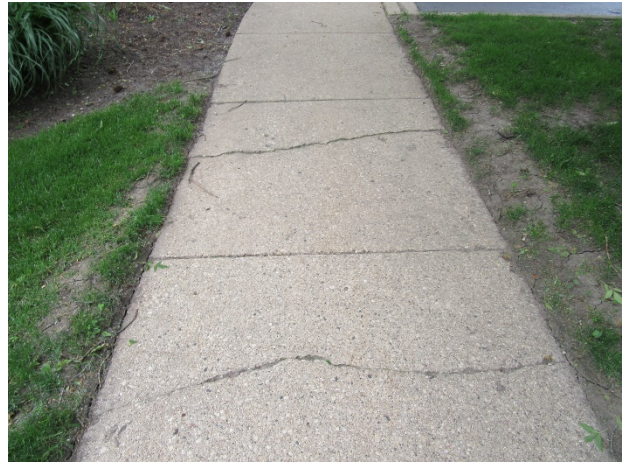
**Sidewalk cracks**

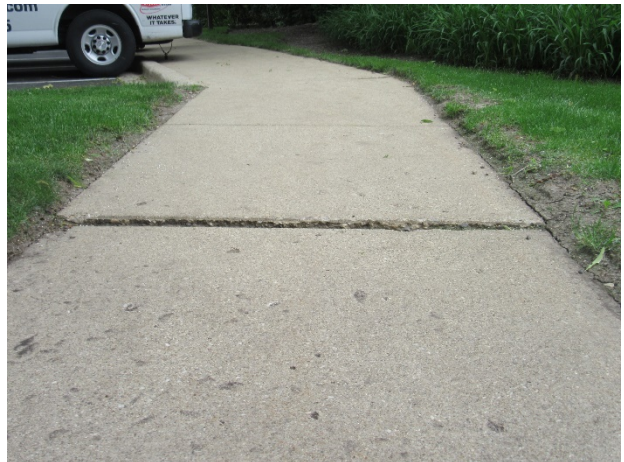
**Trip hazard**

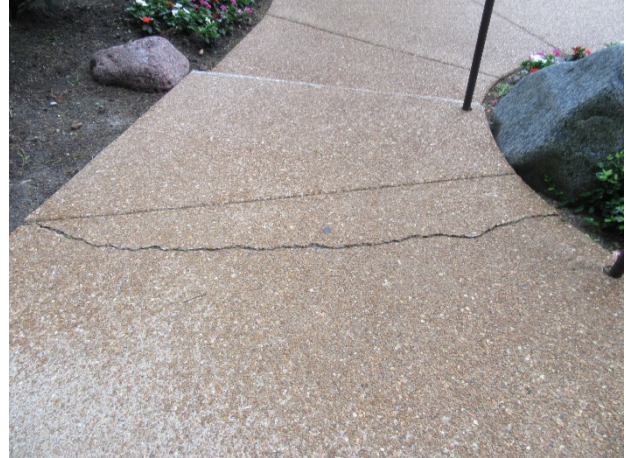
**Crack at exposed aggregate sidewalk**

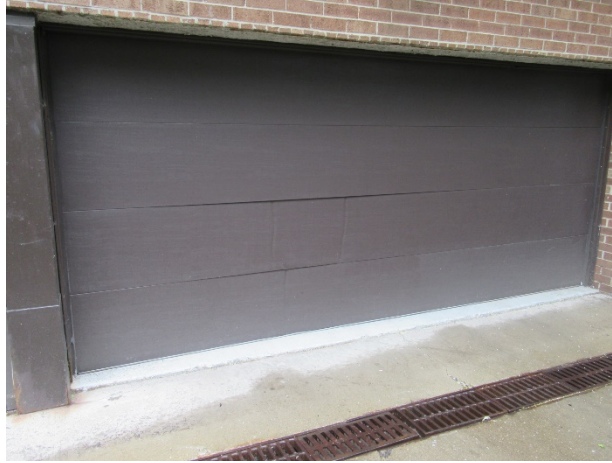
**Panel deflection**

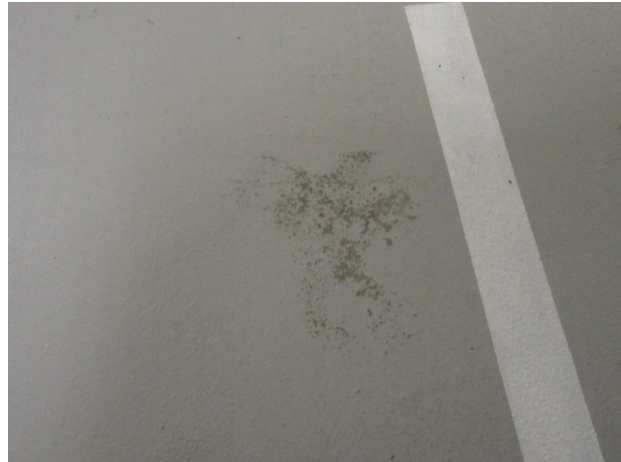
**Finish deterioration**

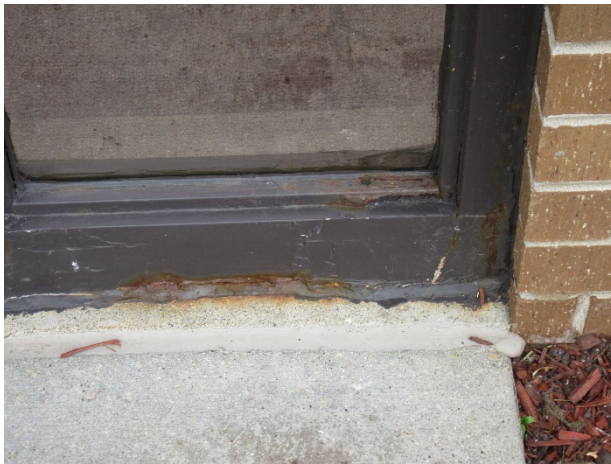
**Frame deterioration**

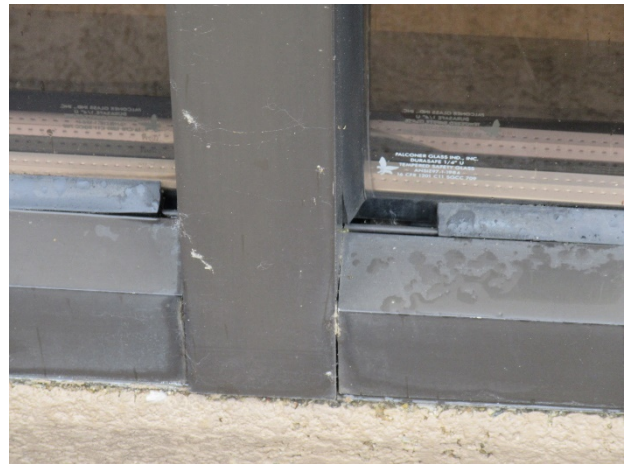
**Missing sealant at atrium windows**

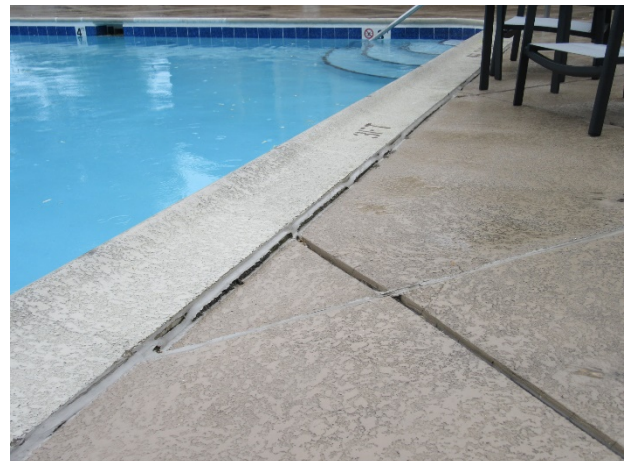
Settlement, sealant adhesion failure and potential trip hazard

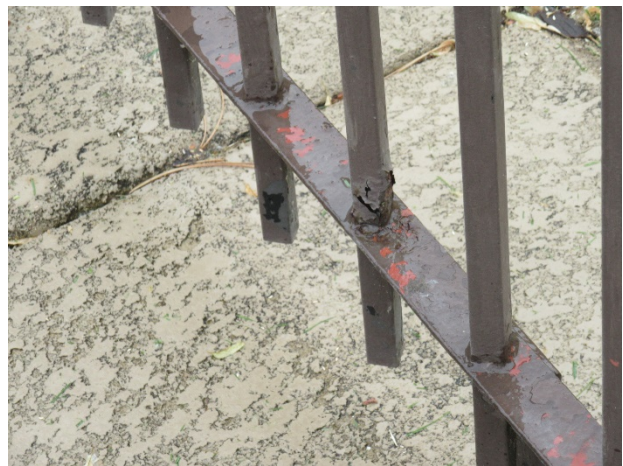
**Finish deterioration and rust**
