The Valley Lo Towers I Condominium Association

RESERVE STUDY
For
Valley Lo Towers I

Glenview, IL
Date of Inspection
January 10, 2014

BUILDING RESERVES, INC.

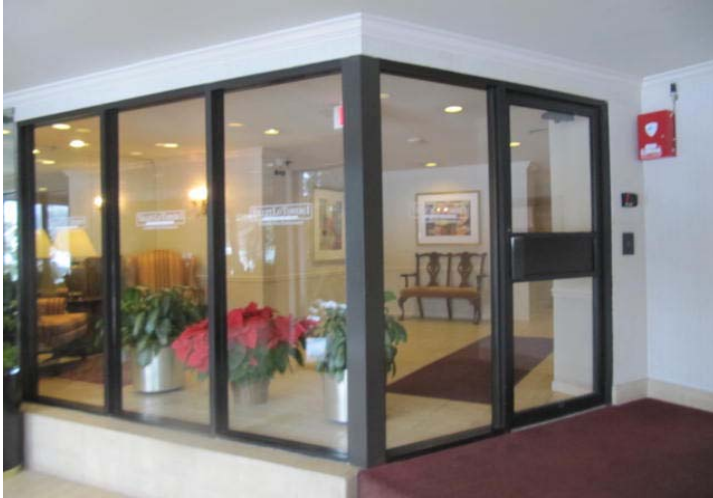
Commercial store-front style glazing with entry door.

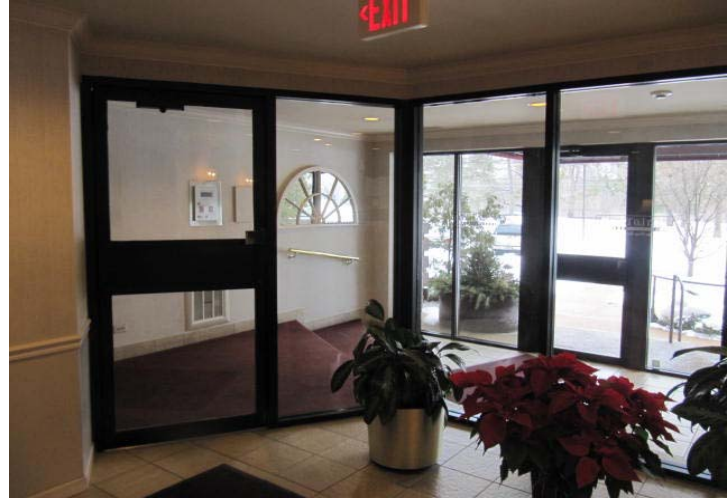
Interior view of glazing and entry doors.

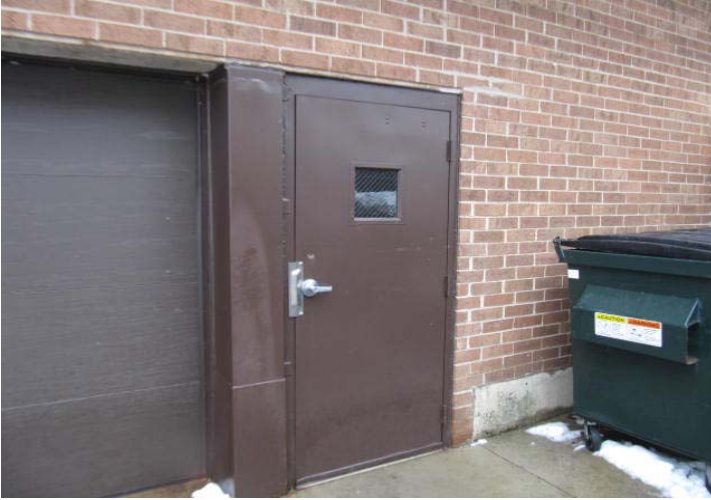
Pedestrian door near garage door.

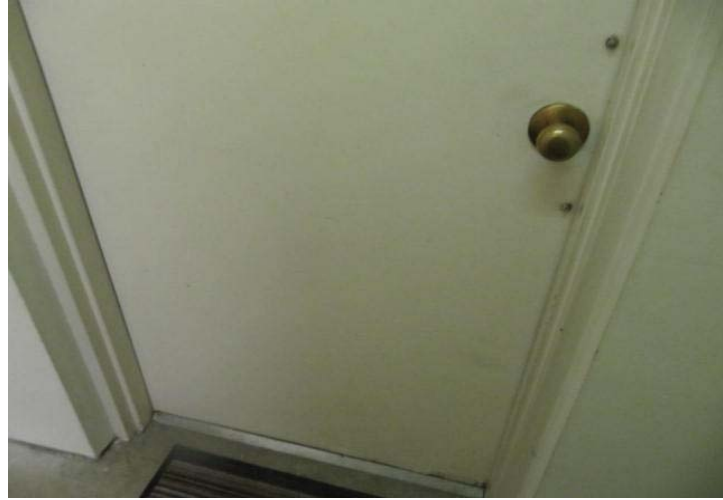
Interior view of door at private stairwell.

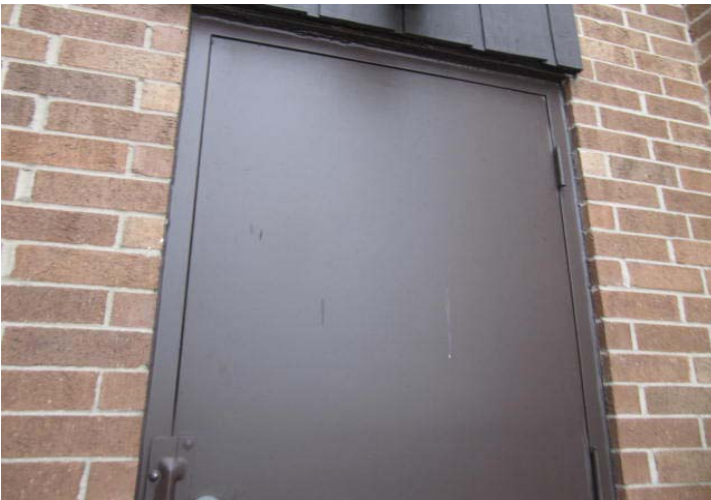
Paint finishes at exterior face of door.

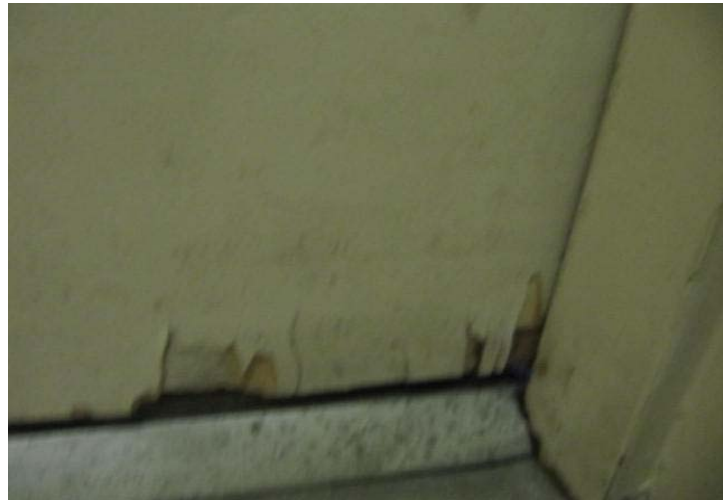
Deteriorating wood door leaf, near grade.

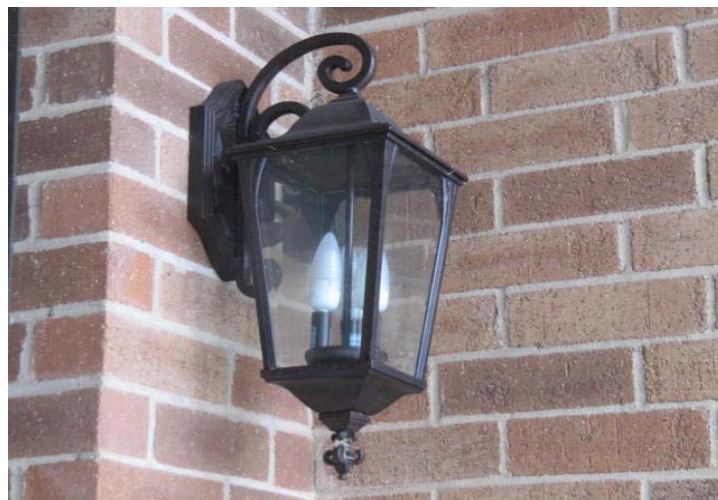
Wall sconce near building front entry.

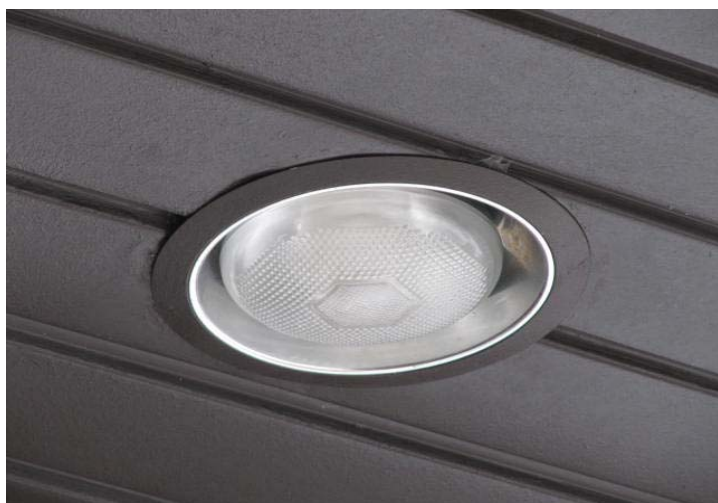
Recessed can fixture at entry soffit.

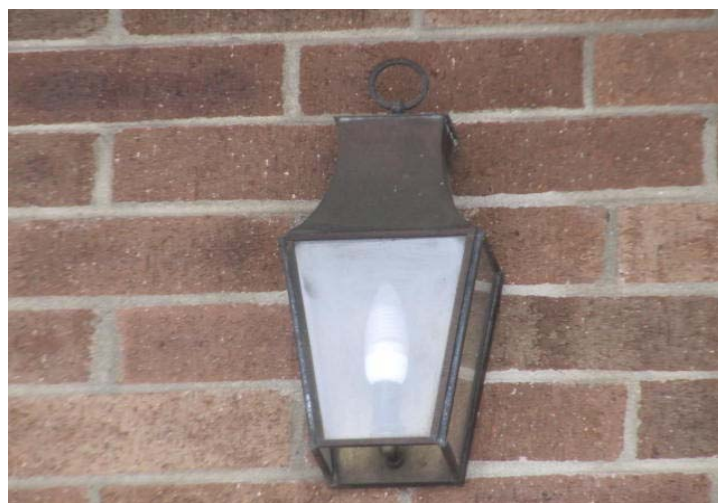
Typical wall sconce at unit balcony.

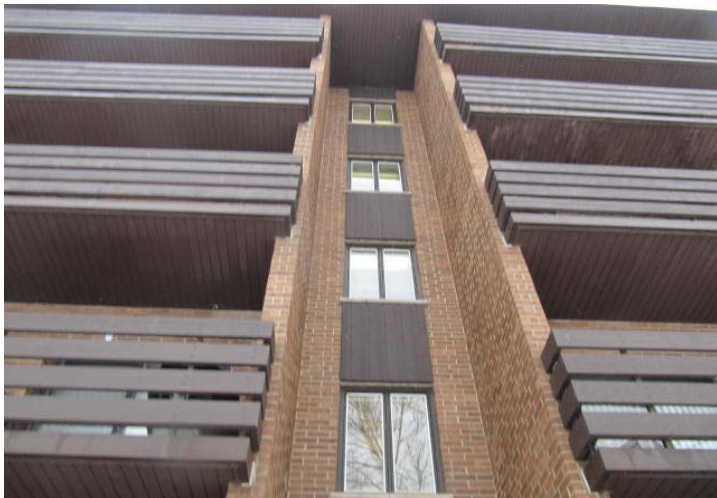
Overview of painted wood siding and railings.

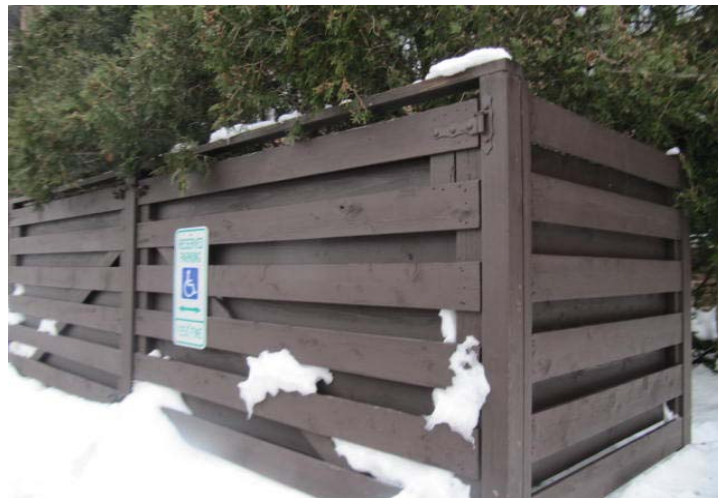
Painted transformer enclosure.

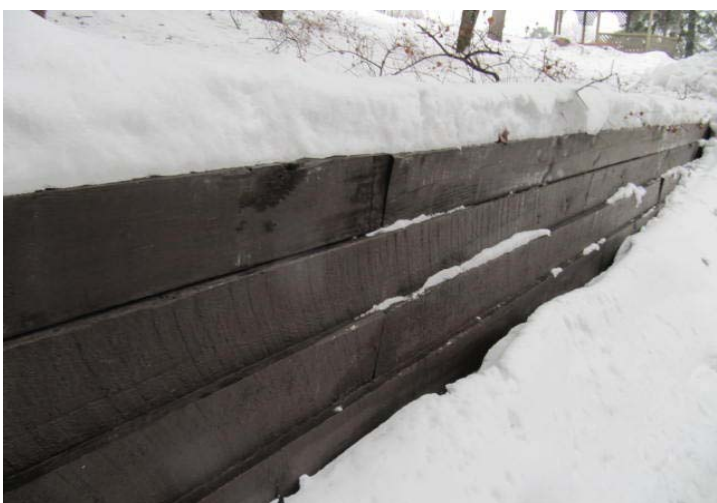
Painted timber retaining wall.

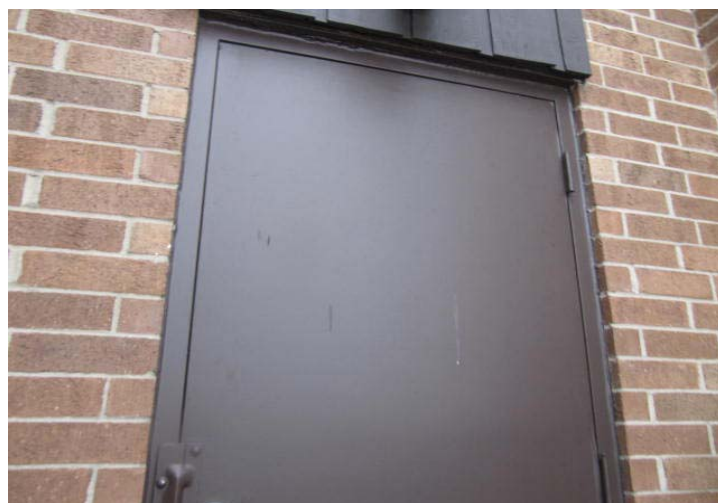
Paint finishes at exterior surface of solid door.

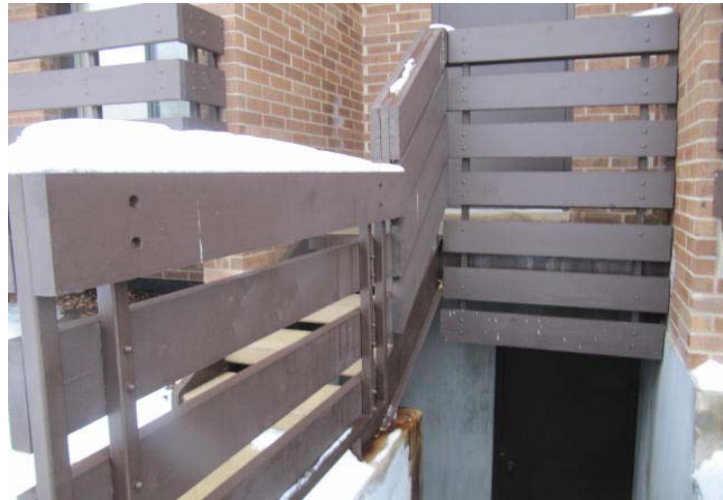
Railings at private stairwell door.

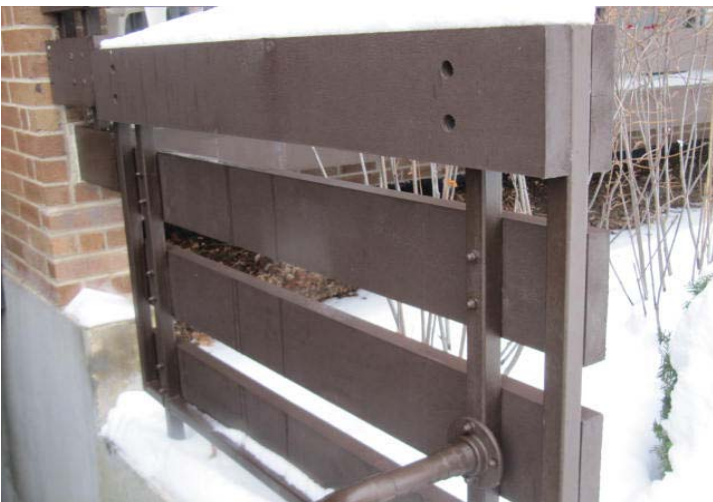
Railings at private stairwell door.

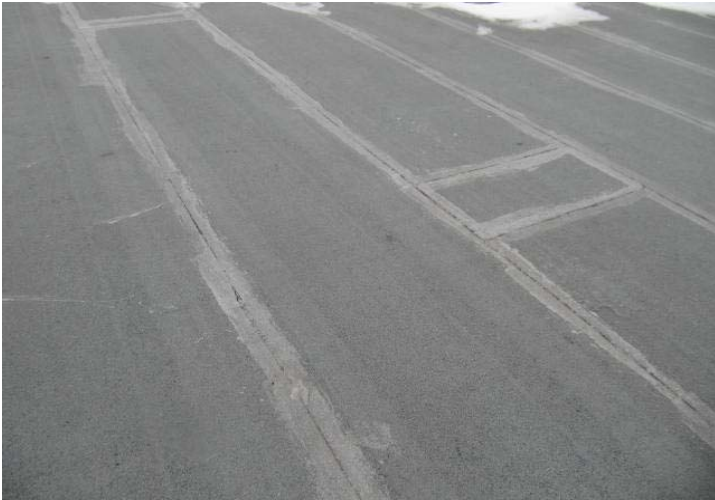
Overview of flat modified bitumen roof.

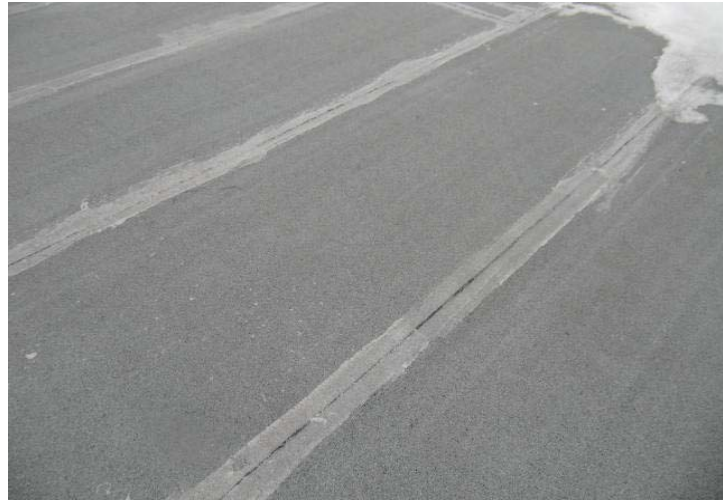
Overview of flat modified bitumen roof.

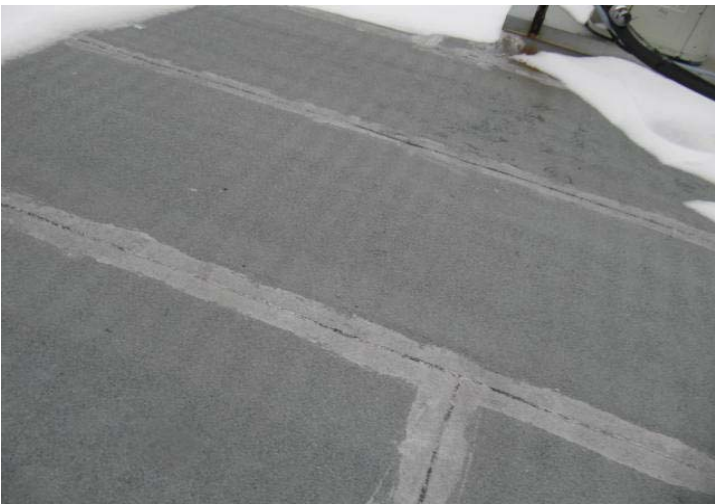
Modified bitumen roof, in good overall condition.

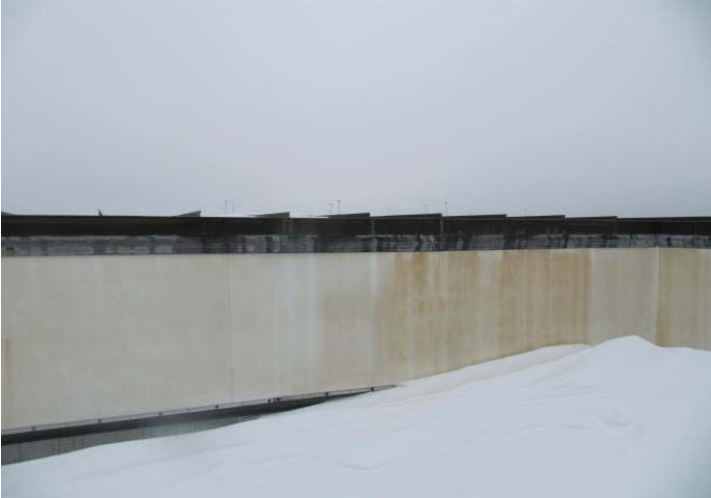
Overview of parapet wall at building roof.

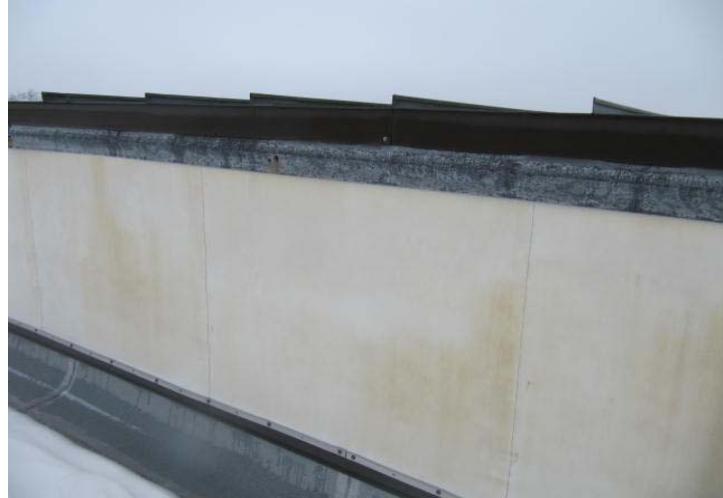
Overview of parapet wall at building roof.

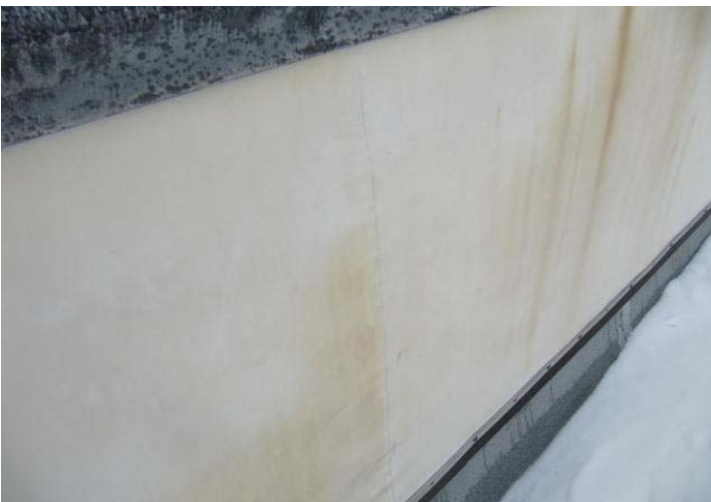
TPO membrane at vertical parapet wall surface.

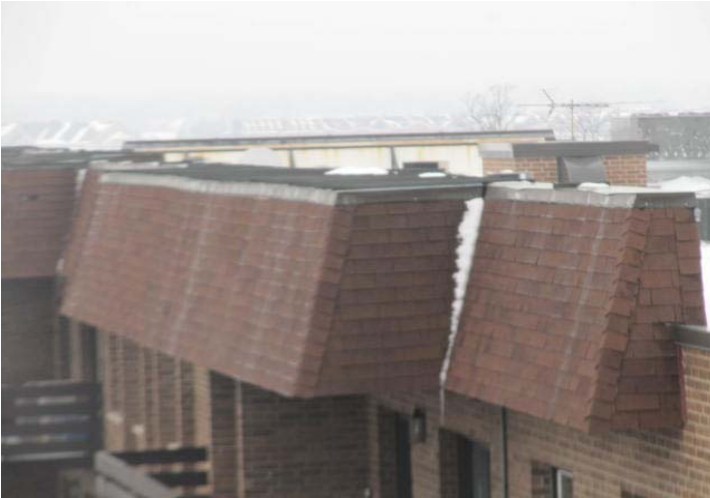
Asphalt shingles at mansard roofs.

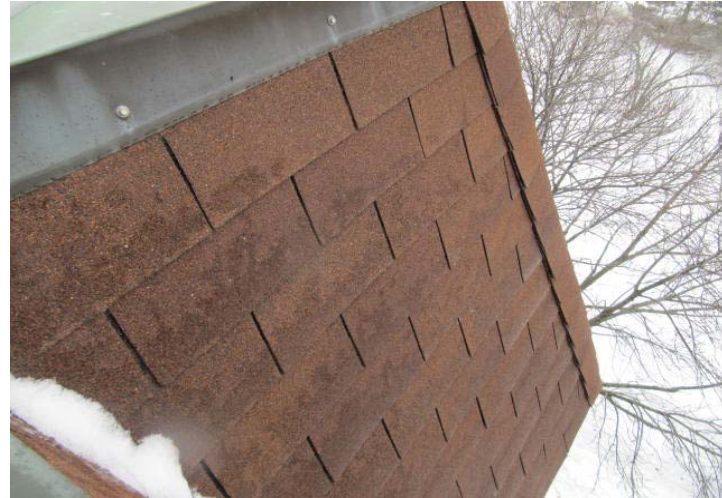
Asphalt shingles, in fair condition.

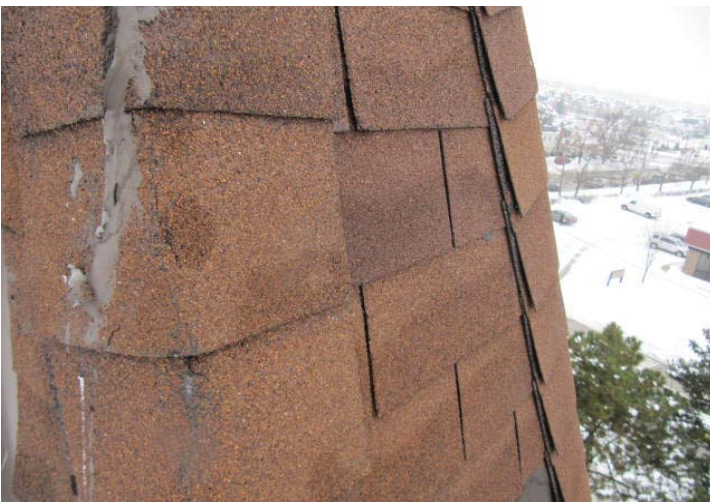
Asphalt shingles, in fair condition.

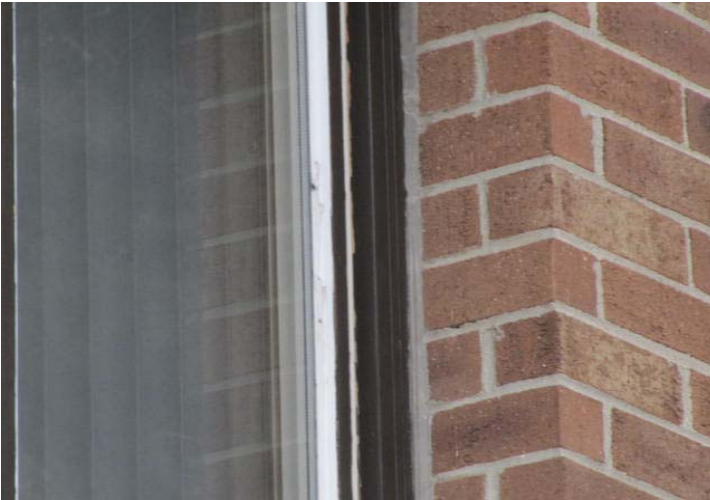
Sealant at perimeter of unit window.

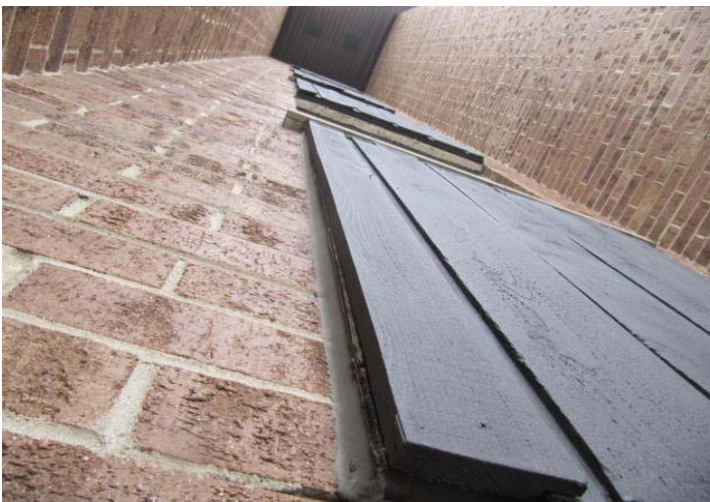
Sealant between masonry façade and wood siding.

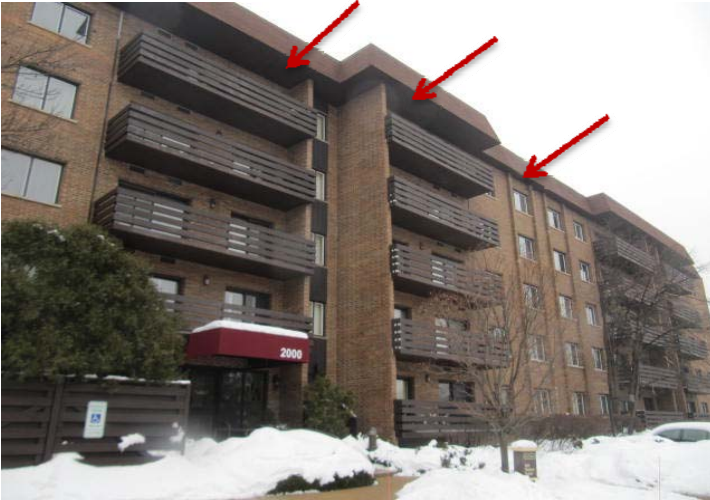
Overview of soffits at mansard roofs.

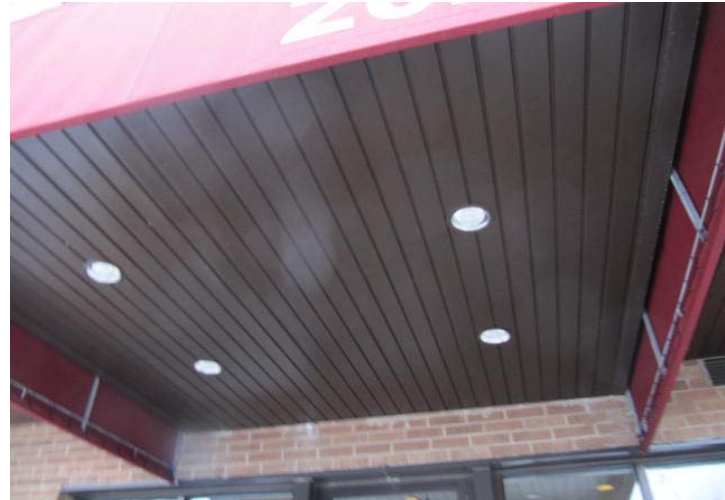
Soffit at underside of entry canopy.

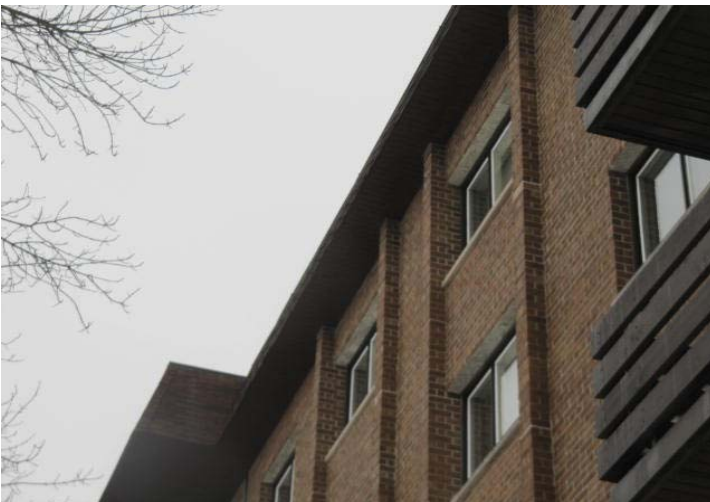
Overview of soffits at mansard roofs.

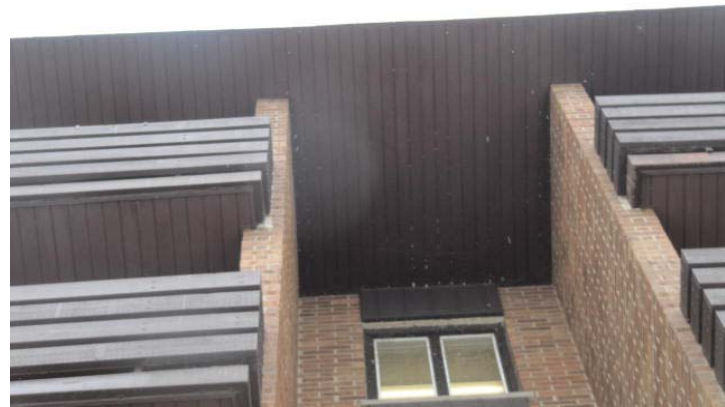
Aluminum soffits, in good overall condition.

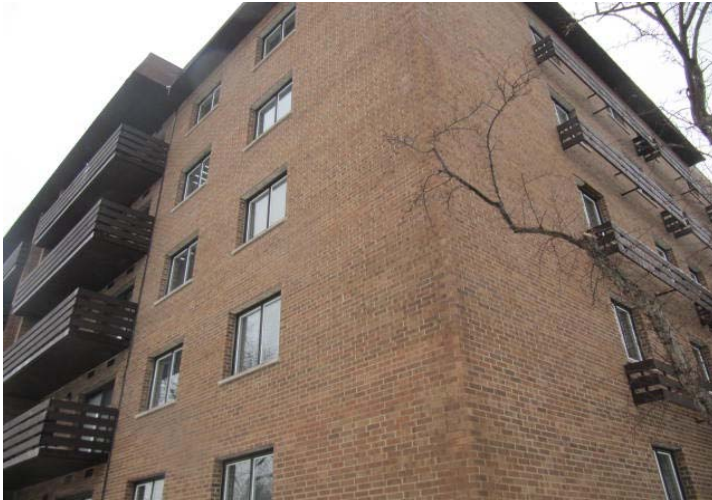
Overview of masonry façade.

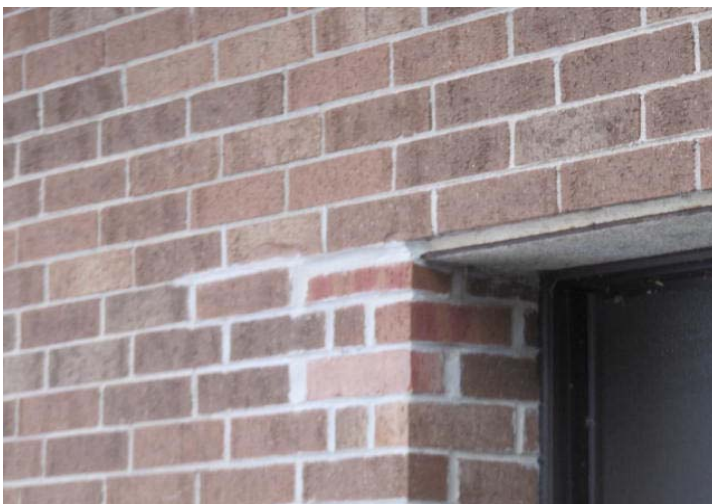
Evidence of past repointing at masonry mortar joints.

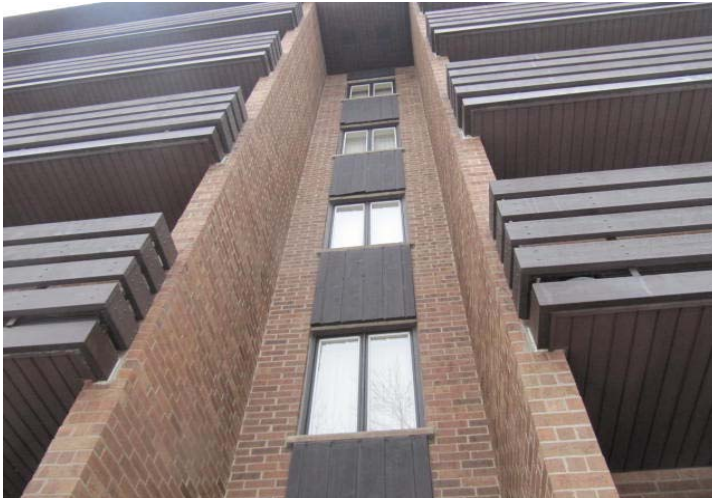
Overview of wood siding between stairwell windows.

Wood siding panels are in good overall condition.

Component includes the replacement of the wood siding located between vertical stacks of windows at interior private stairwells. The wood siding is in good overall condition at 30 years of age. With continued routine paint finishes, the wood siding is anticipated to last up to another 15 to 20 years. Replacement in 2034 coincides with exterior door replacements.

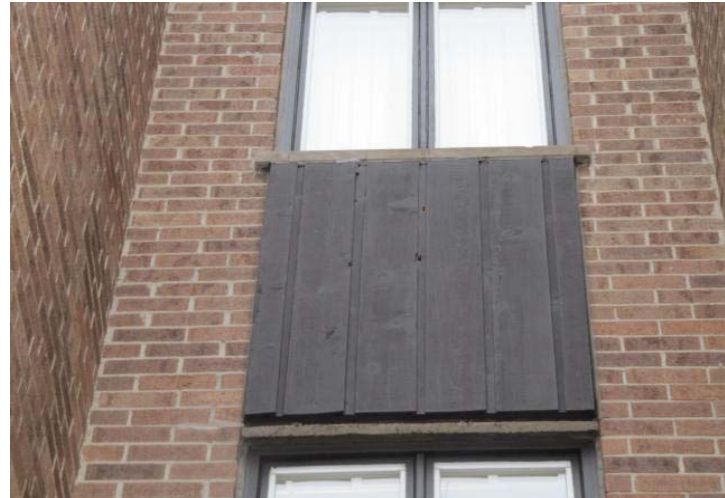
Original wood siding, at 30 years of age.

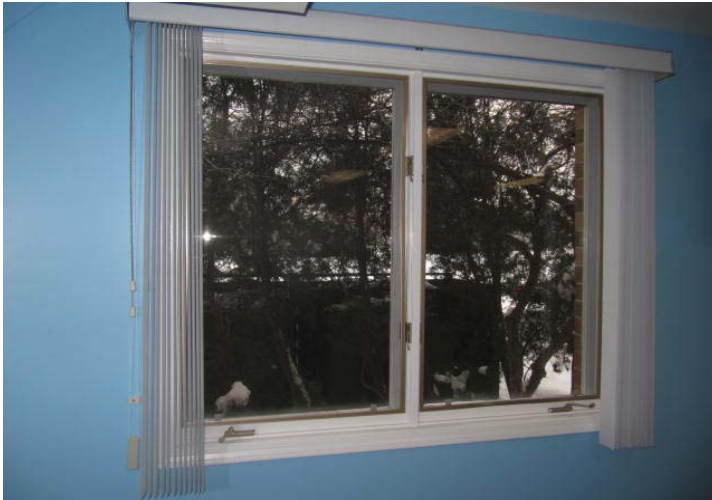
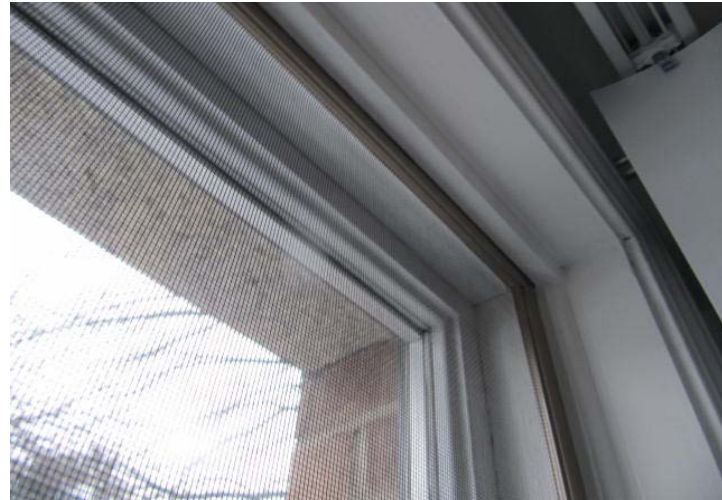
Interior view of window at exercise room.

Interior view of wood casing at common window.

Common window at private stairwell.

Casement window with turn-crank.

Special Conditions
Total quantity includes the following: windows at the exercise room, windows at the meeting room, and windows at interior private stairwells. Original wood clad windows are in fair overall condition at 30 years of age. Replacement of the common-area windows is forecasted for 2027 to coincide with the replacement of exterior sealants and masonry repairs. All windows and glass patio doors at homeowner units are the financial responsibility of individual homeowners.

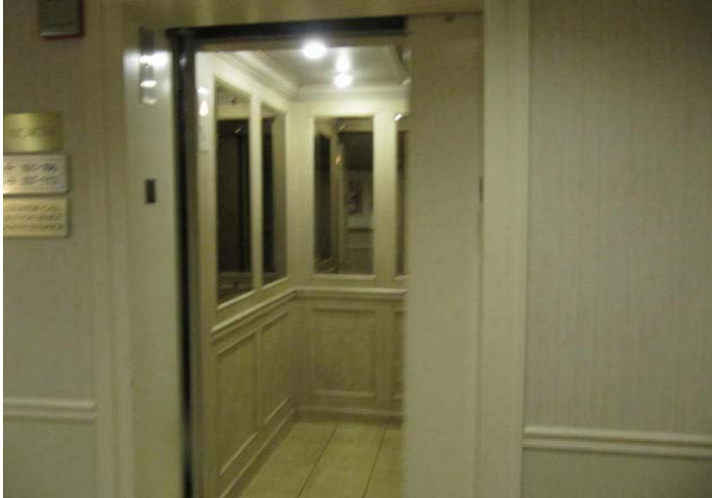
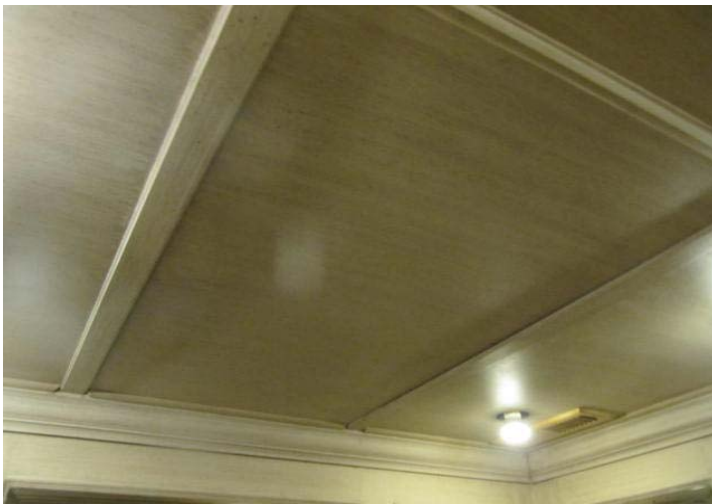
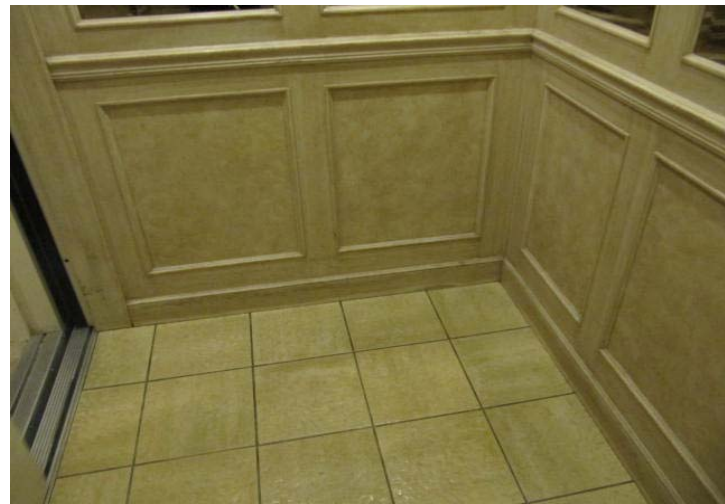
Overview of elevator cab interior.

Mirrored walls with wood trim.

Wood ceiling at elevator cab interior.

Tiled floor and wood wall panels at elevator cab interior.

Component includes renovations at the buildings' (4) elevator cabs. Existing finishes include wood wall panels with inset mirrors, wood ceiling panels with ceiling lighting, and ceramic tile at cab floors. The existing cab finishes are in fair overall condition, with worn wood finishes noted at several locations. Extensive renovations at existing cab finishes or replacement of cab finishes are forecasted within the next 10 to 15 years. Renovations in 2026 coincide with carpet and tile replacement, as well as interior paint finishes.

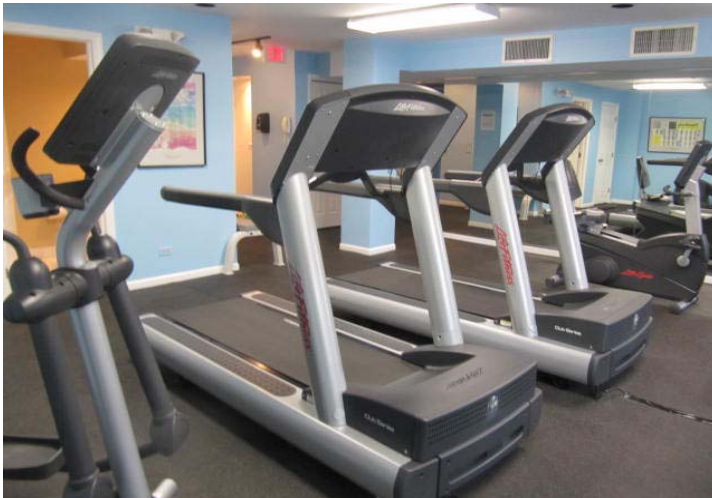
Overview of treadmills at exercise room.

Treadmills, purchased in 2013.

Running surface at treadmill.

Control panel at treadmill.

Special Conditions
Component includes the replacement of (2) treadmills at the exercise room. The exercise equipment was purchased in 2013 and is currently in very good condition. Future equipment replacement is forecasted every 10 years, beginning in 2024. Replacement coincides with the replacement of the remainder of cardio exercise equipment.

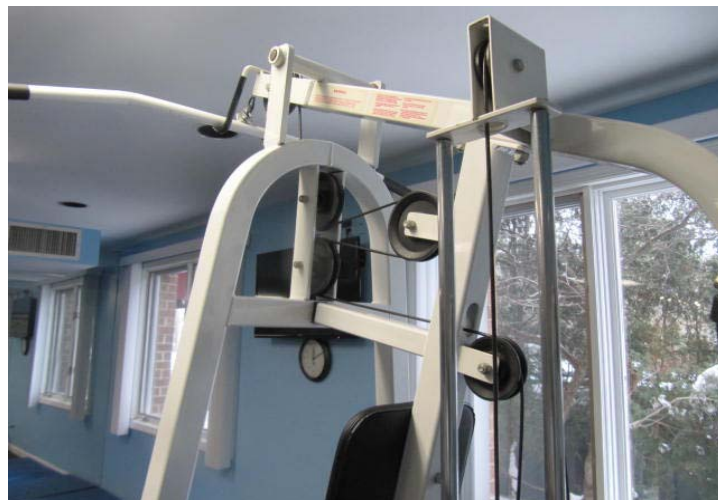
Overview of strength-training equipment

Hoists and pulleys at strength-training machine.

Upholstered seats at base of strength-training machine.

Upholstered weight bench.

Strength-training equipment allowance includes the following: (1) strength-training station and (2) upholstered weight benches. The exercise equipment was purchased in 2013 and is currently in very good condition. Future equipment replacement is forecasted every 12 years, beginning in 2026.

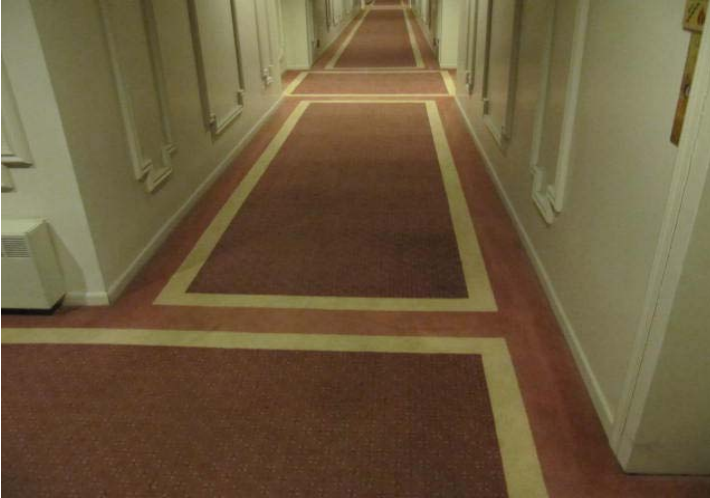
Overview of carpet flooring at hallway area.

Carpet flooring at end of hallway.

Total quantity includes all carpet flooring at the buildings' interior hallways, the meeting room, and the stairs at the entrance vestibules. Carpet flooring is approaching the end of its useful life. The carpet appears dated, many areas have matted surface textures, and there are stains present at isolated locations (near elevator doors). The association anticipates a near-term carpet replacement. Subsequent replacements are forecasted every 8 to 15 years thereafter to coincide with interior paint finishes.

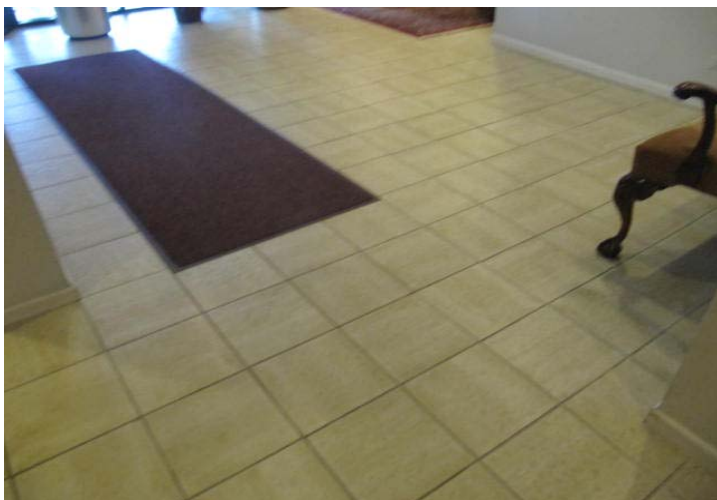
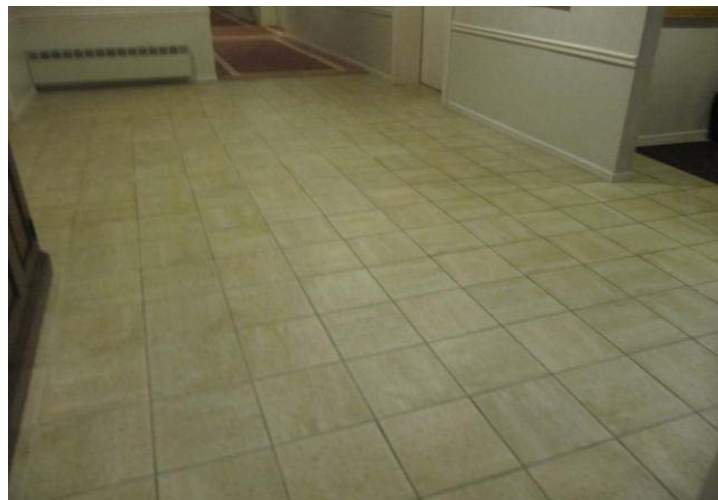
Overview of tile floor at lobby.

Typical style and coloring of floor tile.

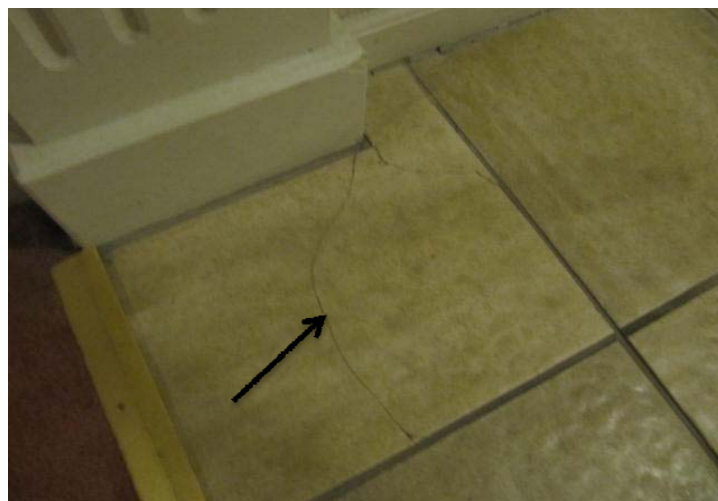
Isolated condition of cracked tile at lobby area.

Special Conditions
<p>Total quantity includes tile flooring located at the entrance vestibules, lobbies, and mail rooms. The tile is in fair overall condition at an unknown age, with isolated occurrences of cracked tiles. Replacement is forecasted for 2026 to coincide with carpet replacement, interior paint finishes, and the renovation of the elevator cab interiors.</p>

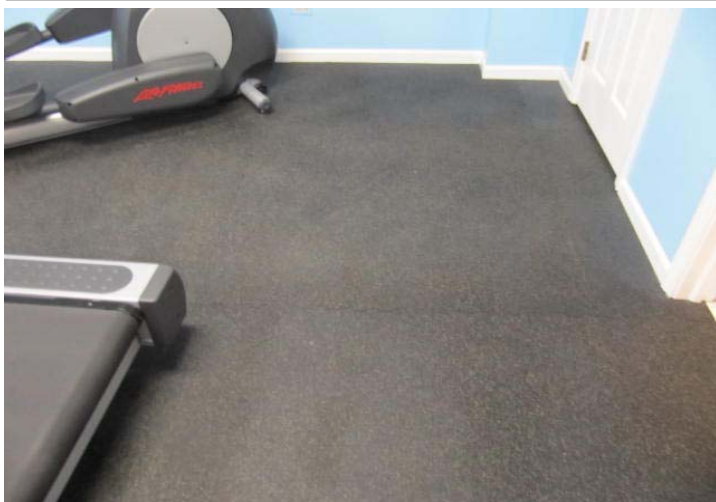
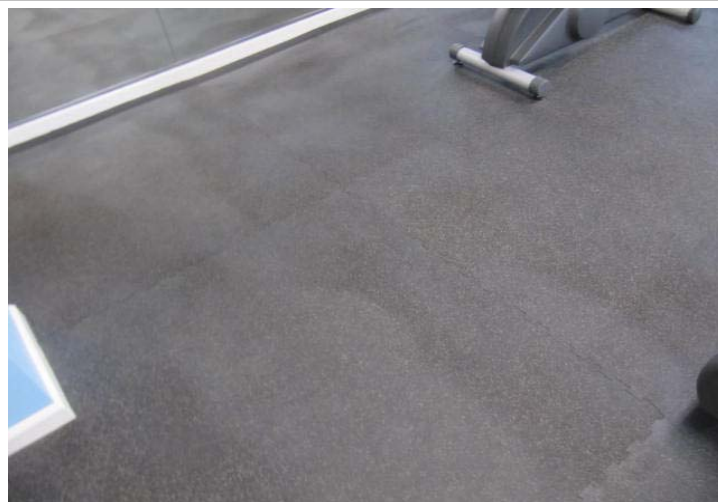
Overview of rubber sports flooring, installed in 2013.

Rubber sports flooring, in very good condition.

Special Conditions
<p>New rubber interlocking sports flooring was installed at the exercise room at Building 2000 in 2013. The flooring is currently in very good condition at less than 1 year of age. Future replacement of the sports flooring is forecasted for 2027 to coincide with interior paint finishes, tile replacement, and the replacement of carpet flooring.</p>

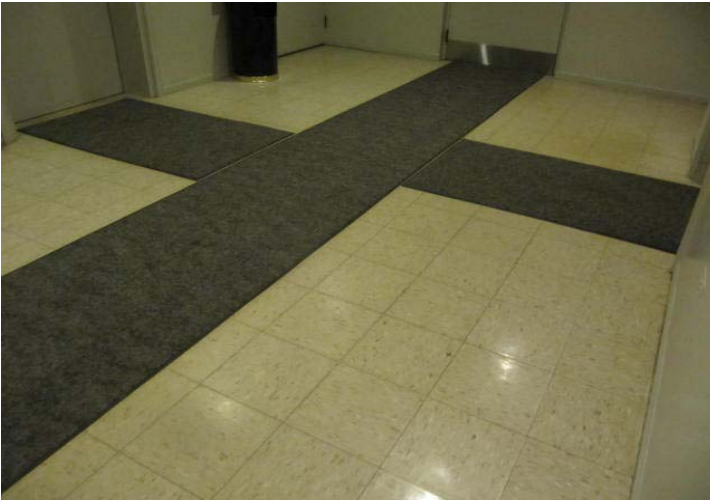
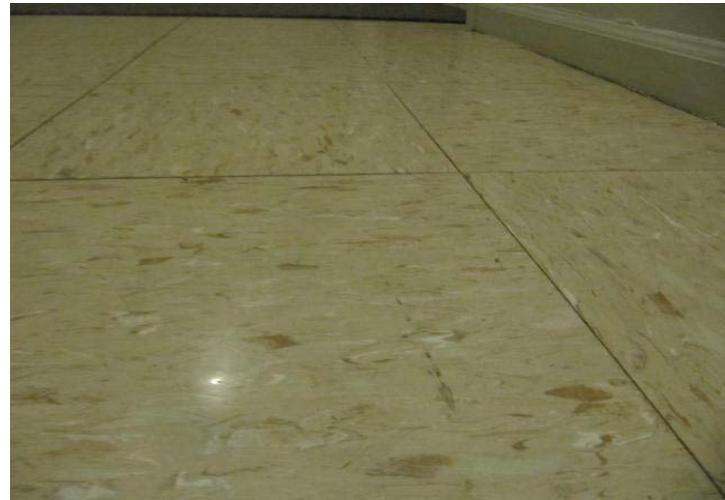
Overview of vinyl tile at lower level (with floor mats).

Vinyl tile at lower level garage elevator lobby.

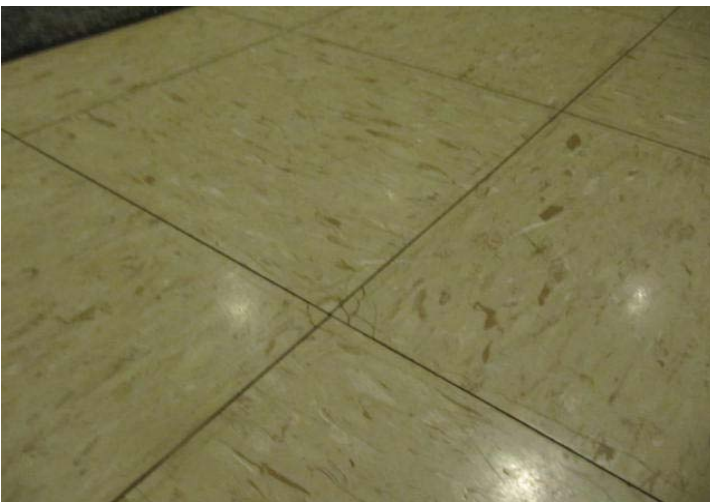
Hairline cracks at vinyl tile at lower level elevator lobby.

Total quantity includes all resilient vinyl tile flooring at the lower level elevator lobbies at the parking garages. The vinyl tile is 30 years of age and is currently in fair condition. Tile shows hairline cracks and is chipped at isolated locations. Replacement of the vinyl tile is recommended within the next 10 years. Other areas of vinyl tile (at storage rooms) should be replaced as needed from the association's operating budget.

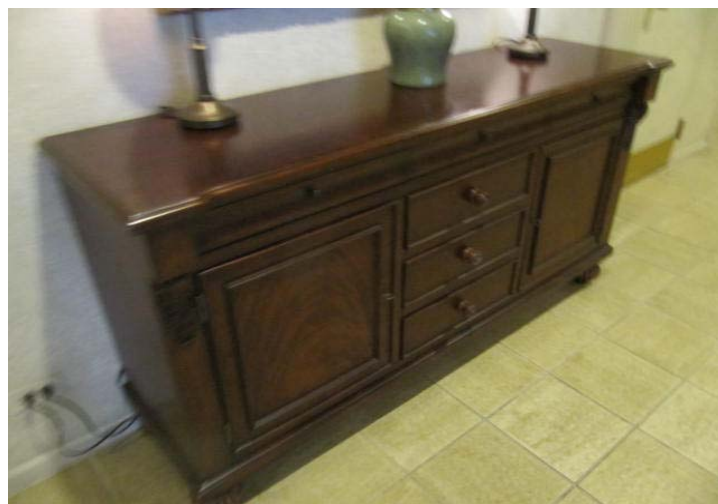
Wood cabinet at building entrance lobby.

Special Conditions
Total quantity includes the following furnishings located at the (2) building lobbies: (4) upholstered sitting chairs, (1) wood armchair, (1) settee, (2) end tables, (2) rugs, (2) wood cabinets. Lobby furnishings are in good overall condition. Future replacement is forecasted in 2027 to coincide with the replacement of floor tile, carpet, and interior paint finishes.

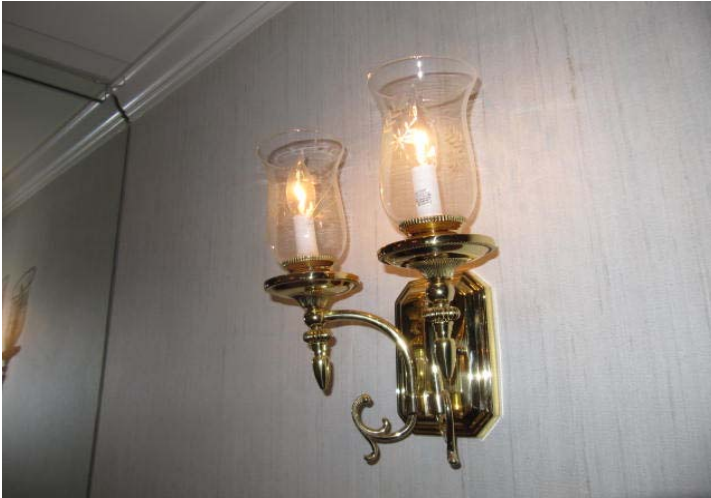
Sconce fixture at entrance lobby.

The majority of interior light fixtures at hallways, lobbies, entrance vestibules, the Exercise Room, Meeting Room, and lower level elevator lobbies are original and are 30 years of age. The association anticipates a near-term replacement. Replacement in 2015 coincides with the replacement of carpet flooring and interior paint finishes at hallways and common rooms. A subsequent replacement of all interior light fixtures is forecasted 25 to 30 years thereafter.

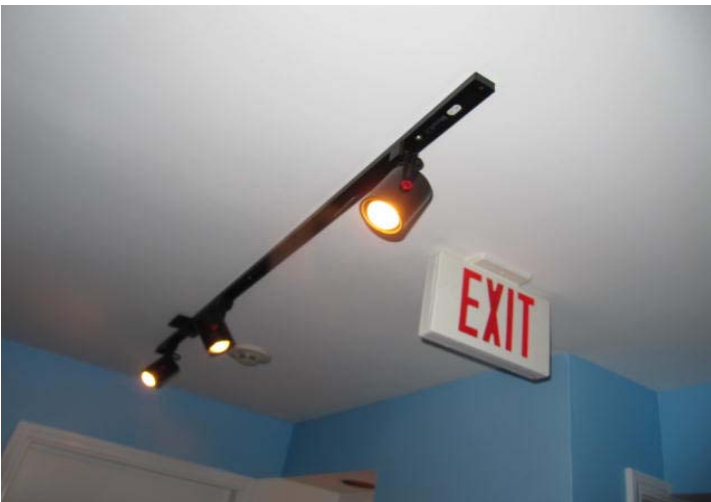
Track light fixture at Exercise Room.

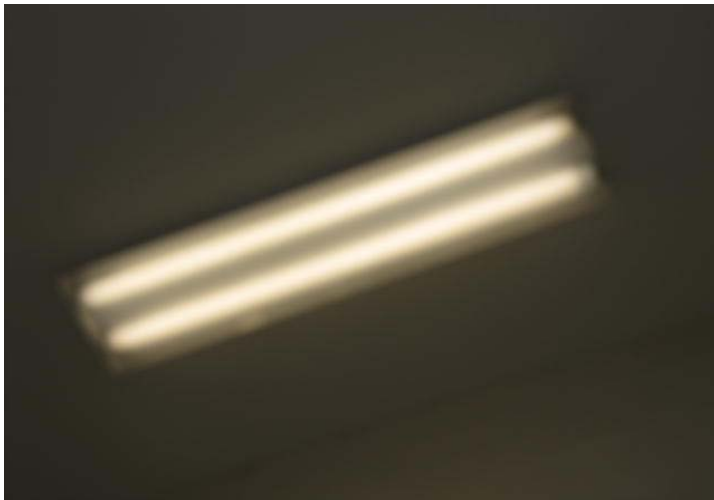
Interior light fixture at interior private stairwell.

Total quantity includes all fluorescent interior light fixtures at building stairwells, including the (4) stairwells leading from hallway areas as well as the (12) stairwells leading from private interior stairwells (stairs that lead directly from homeowner units to exterior). The age of the stairwell light fixtures is unknown, but the fixtures are in good overall condition. Replacement coincides with stairwell paint finishes.

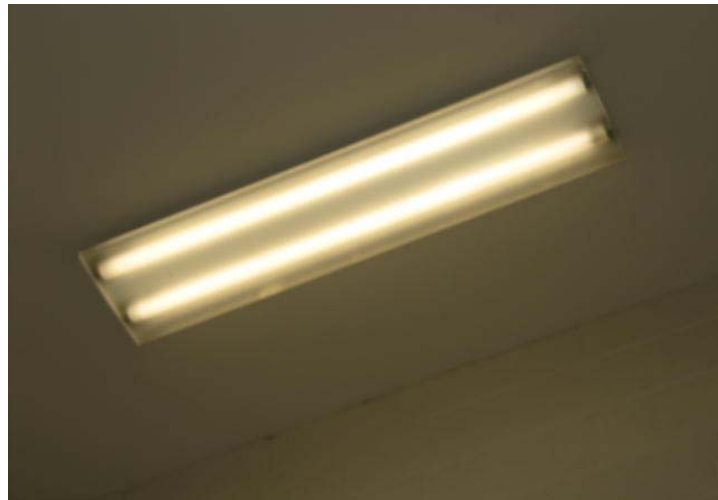
Interior light fixture at interior private stairwell.

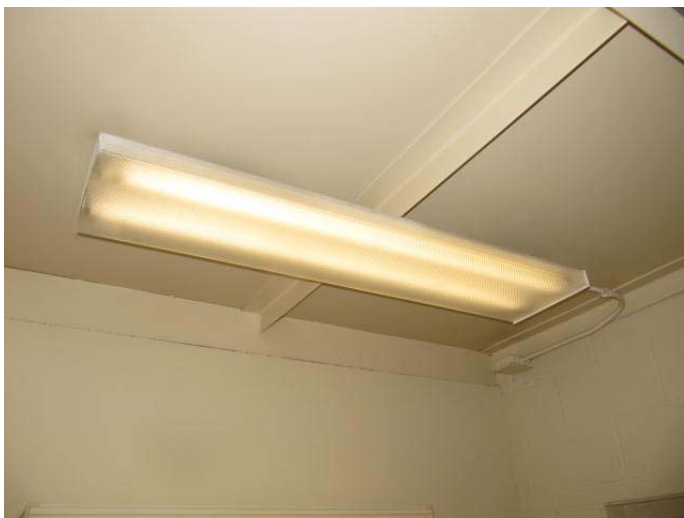
Interior light fixture at stairwell.

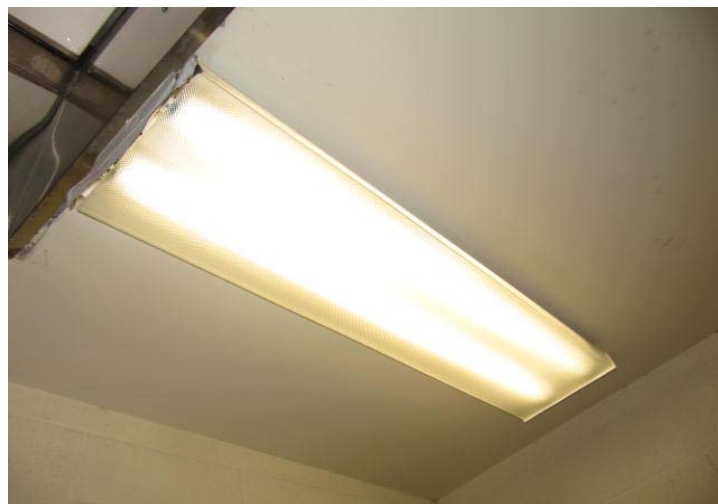
Light fixture at stairwell connected to hallway.

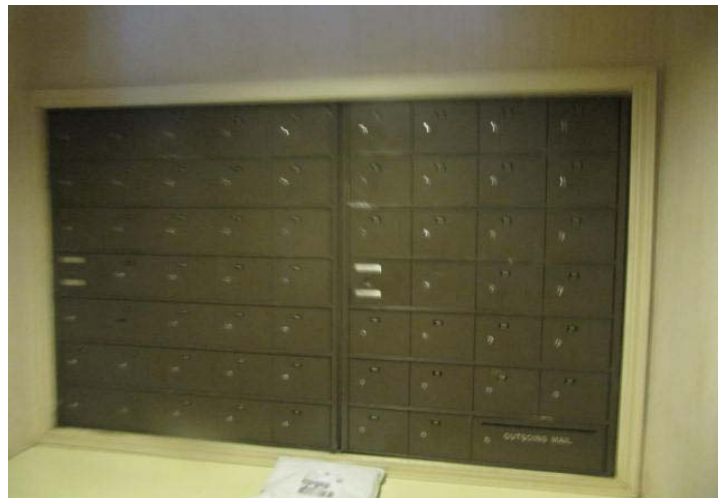
Resident mailboxes at lobby.

Component includes the replacement of interior aluminum mailboxes and surrounding trim / millwork. The original mailboxes are 30 years of age and show deteriorating finishes. Additionally, wood trim at the mailbox surrounds has chipped edges and worn finishes. Replacement of the mailboxes in 2015 coincides with other interior renovations, such as carpet and interior light fixture replacement as well as interior paint finishes.
