The Valley Lo Towers I Condominium Association

RESERVE STUDY
For
Valley Lo Towers I

Glenview, IL
Date of Inspection
January 10, 2014

BUILDING RESERVES, INC.

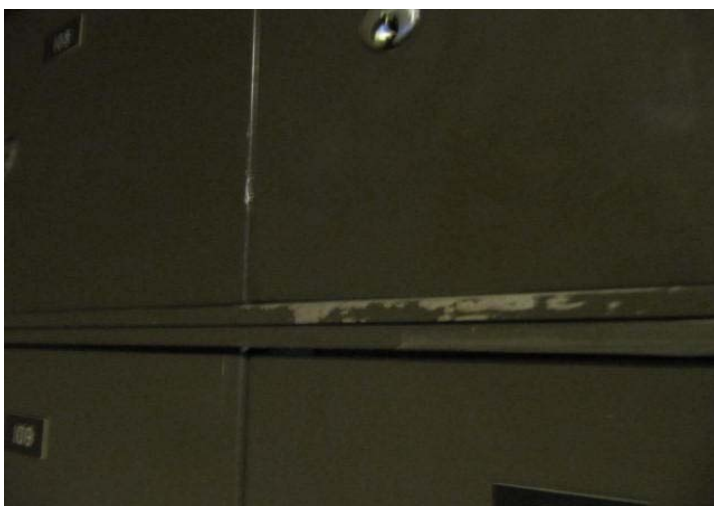
Worn finishes at aluminum mailboxes.

Component includes the replacement of interior aluminum mailboxes and surrounding trim / millwork. The original mailboxes are 30 years of age and show deteriorating finishes. Additionally, wood trim at the mailbox surrounds has chipped edges and worn finishes. Replacement of the mailboxes in 2015 coincides with other interior renovations, such as carpet and interior light fixture replacement as well as interior paint finishes.

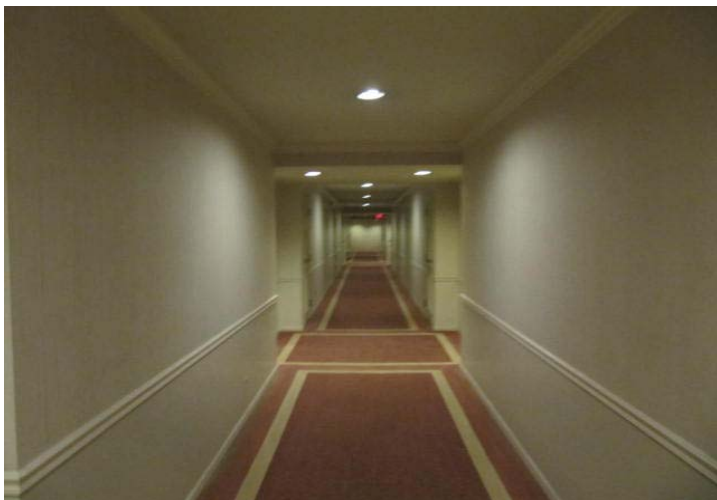
Overview of painted walls and ceiling at hallway.

Component includes paint finishes at the buildings' hallways, lobbies, entrance vestibules, the Meeting Room, the Exercise Room, and the lower level garage elevator lobbies. Interior paint finishes are forecasted for 2015 to coincide with carpet replacement, light fixture replacement, and mailbox replacement. Subsequent paint finish applications are forecasted every 11 years thereafter.

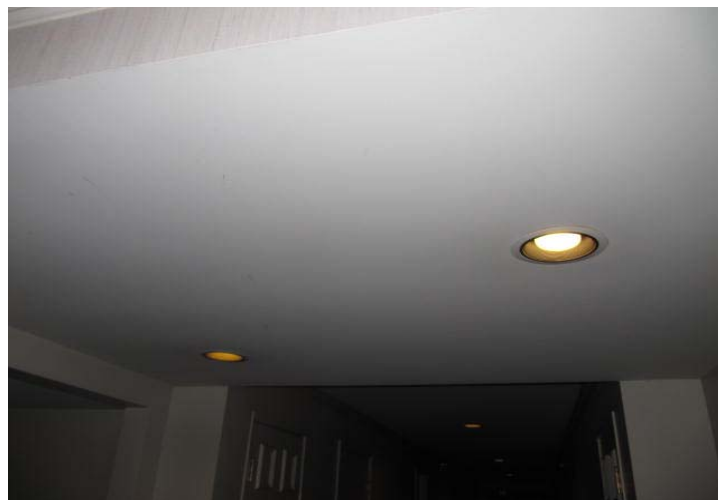
Painted ceiling surface at hallway.

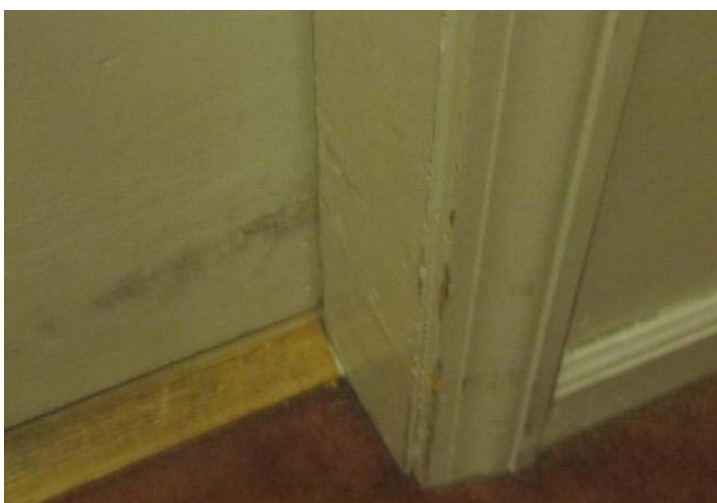
Worn paint finishes at trim; Markings at painted door.

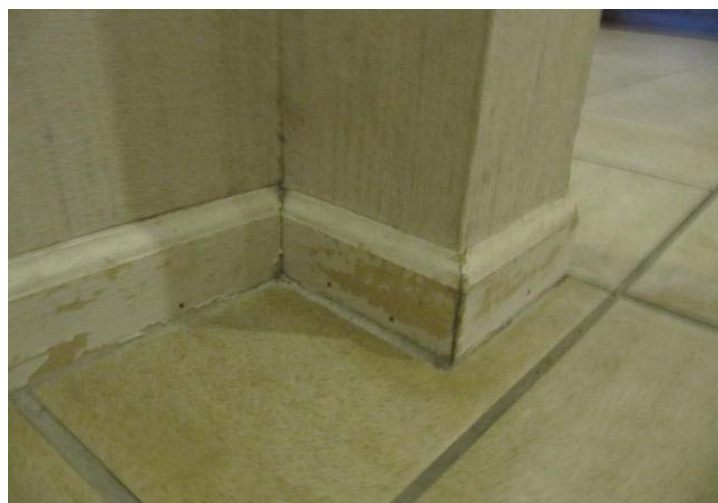
Worn paint finishes at base trim at lobby.

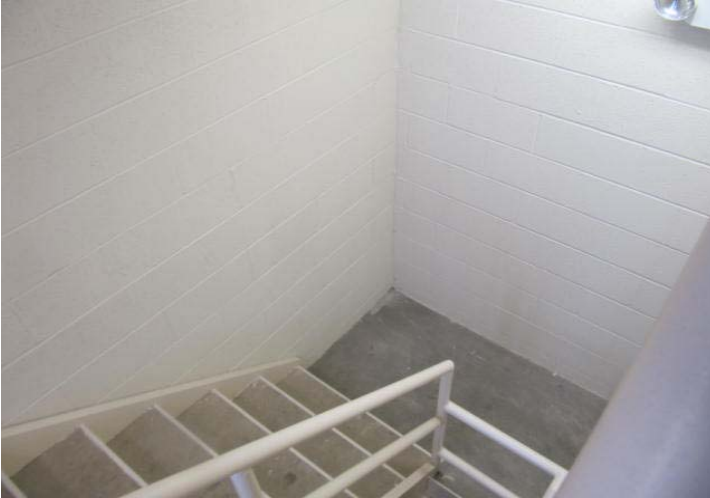
Painted walls at stairwell interior.

Special Conditions
Total quantity includes painted walls, ceilings, sides of stair stringers, fronts and backs of stair risers, bottoms of stair treads, railings, handrails, and interior faces of solid doors. All painted finishes are included at the buildings' (4) stairwells leading from hallways to the exterior as well as at the (12) private stairwells leading directly from units to the exterior. Stairwell paint finishes coincide with the replacement of the light fixtures at the stairwells.

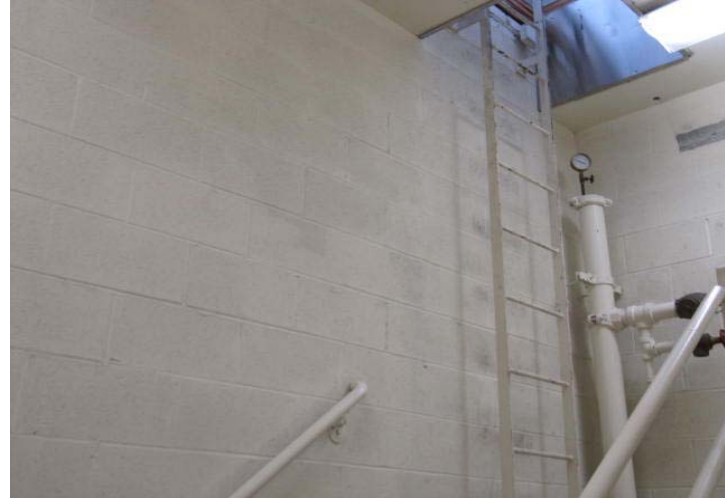
Painted concrete block walls at stairwell.

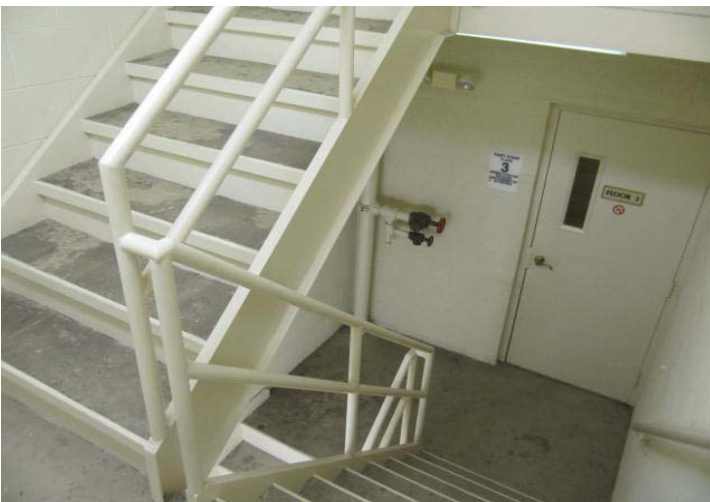
Painted metal railings and stairs.

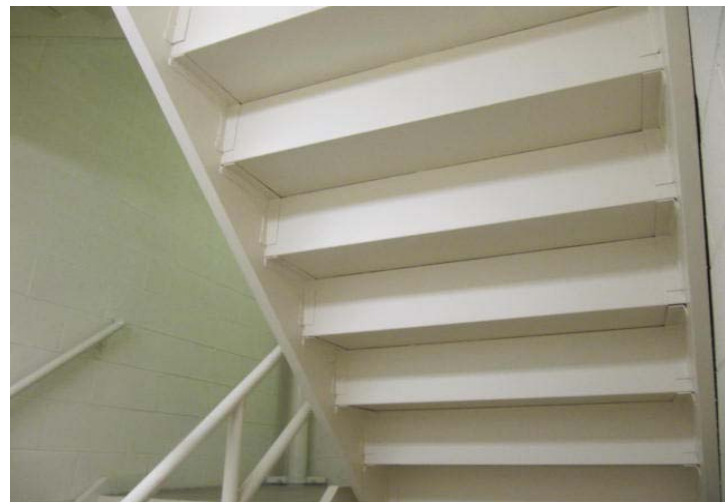
Painted underside of metal stair structure.

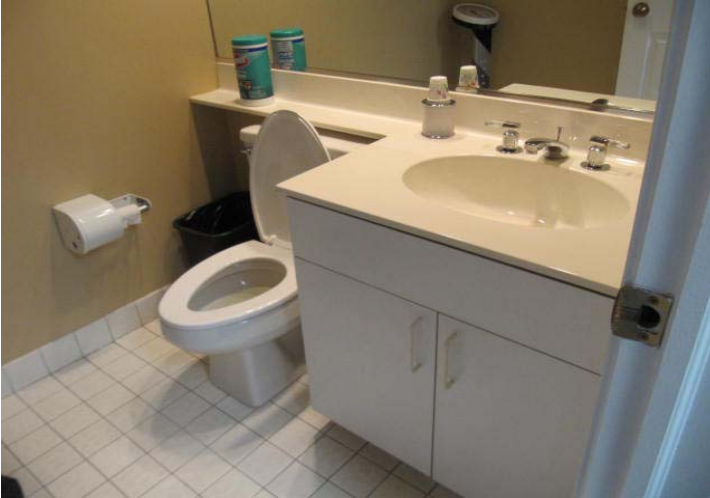
Overview of bathroom at exercise room.

Special Conditions
Restroom allowance includes the renovation of the restroom at the Exercise Room and the restroom at the Meeting Room, including the following: (2) sinks, (2) faucets, (2) toilets, (1) set of shower controls/faucet, (1) shower stall with glass enclosure and door, grab bars, mirrors, countertops, floor and wall tile, and restroom accessories. Renovations coincide with carpet replacement, tile replacement at the lobbies, and lobby furniture replacement.

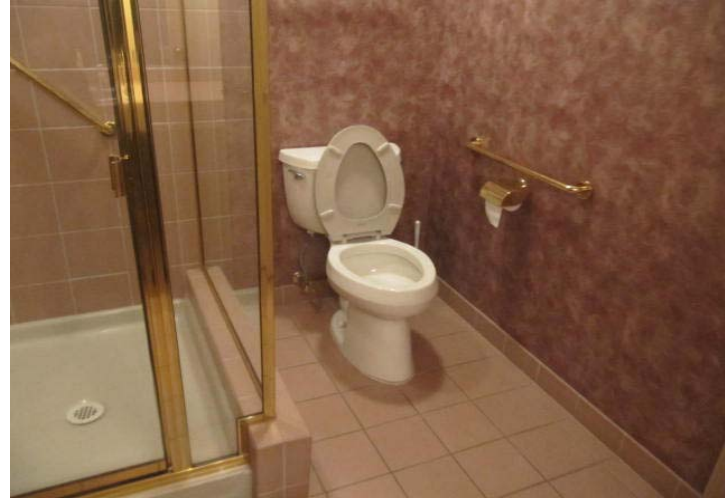
Overview of bathroom at meeting room.

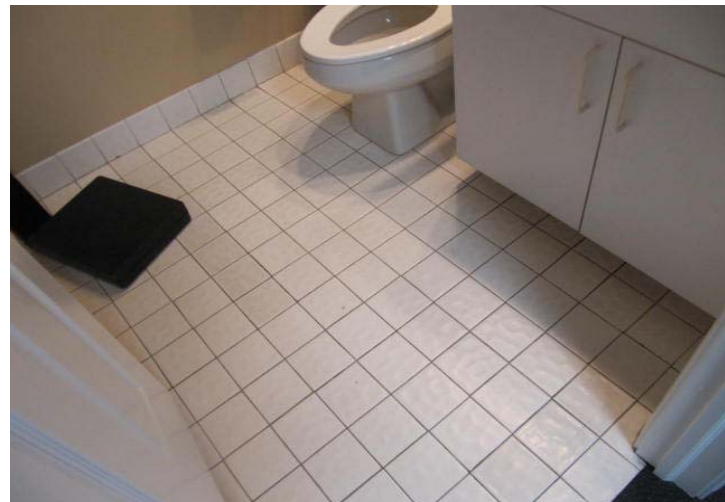
Tile flooring at bathroom floor.

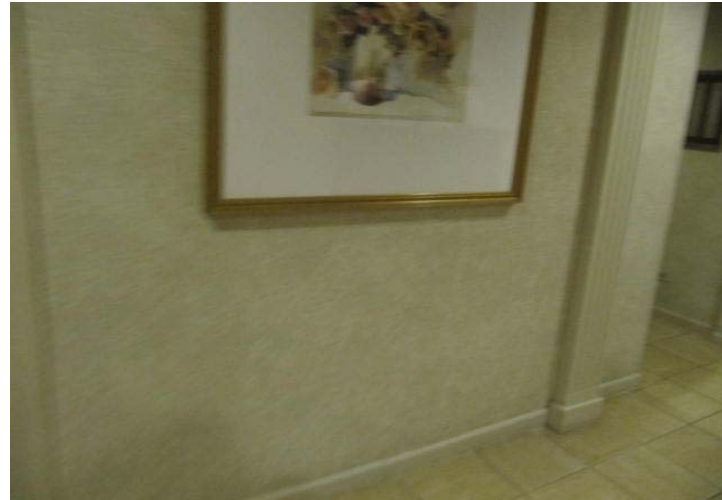
Wall coverings at lobby.

Total quantity includes all wall coverings at the (2) building lobbies as well as the Meeting Room. The wall coverings are in fair overall condition with markings at various locations. A near-term replacement is anticipated by the association. Wall covering replacement coincides with the replacement of carpet flooring.

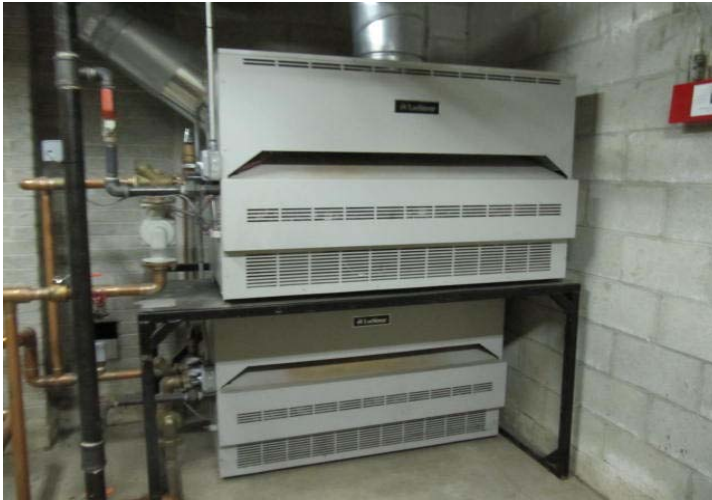
Overview of boilers providing domestic hot water.

Special Conditions
(4) domestic hot water boilers rated for 500-MBH input each are located in the lower level mechanical rooms. Component includes capital repairs at the boilers, in 2022 and again 15 years after proposed boiler replacement in 2028.

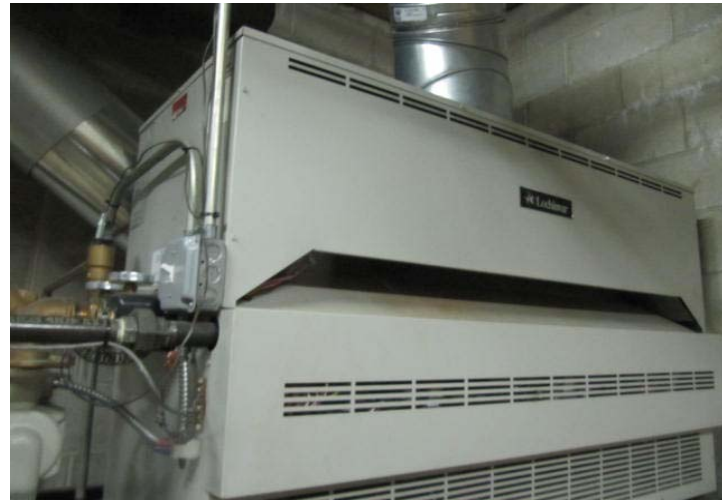
Domestic hot water boilers, at 9 years of age.

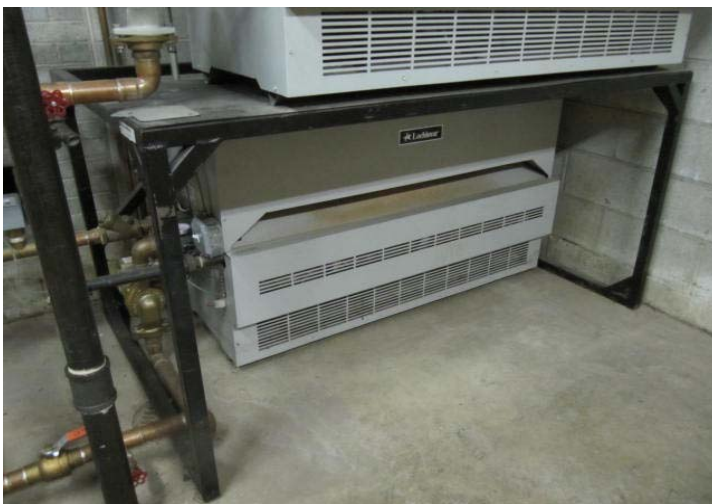
Lochinvar boilers at garage-level mechanical room.

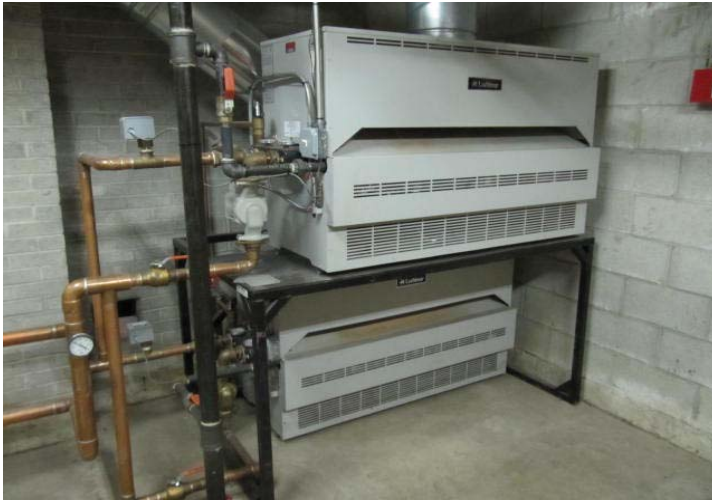
Overview of boilers providing domestic hot water.

(4) domestic hot water boilers rated for 500-MBH input each are located in the lower level mechanical rooms. The boilers were replaced in 2004 and are currently in good functional condition. Future replacement of the boilers is forecasted for 2028, to coincide with the replacement of the hot water storage tanks.

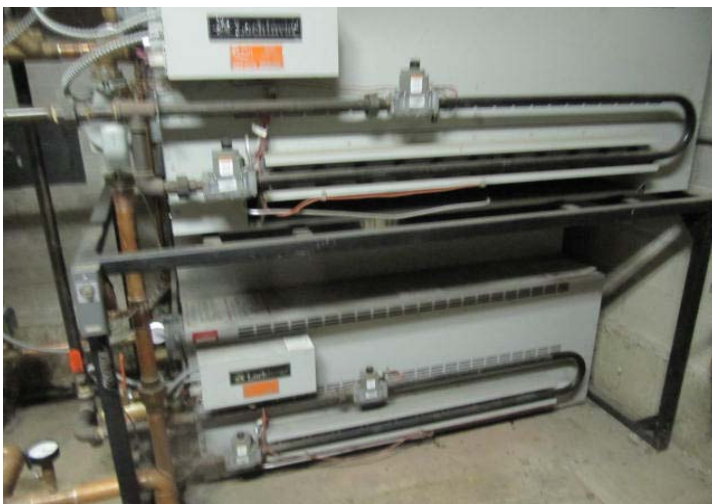
Lochinvar boilers at garage-level mechanical room.

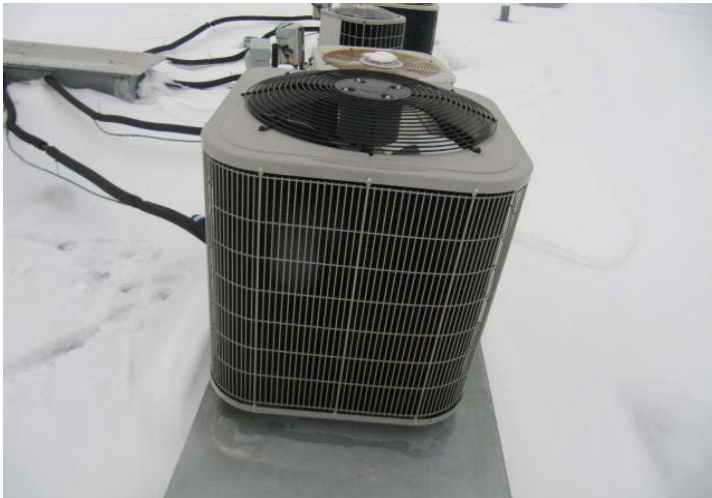
Overview of condensing unit at building rooftop.

The rooftop condensing unit serving the Exercise Room was replaced around 2011 and is currently in good functional condition at approximately 2 years of age. The condensing unit is rated for 3.0-ton cooling. Replacement cost includes all material, labor, and hoisting to roof level (as the unit will not fit through the existing roof hatch). Replacement of the condensing unit is forecasted at 20 years of age and coincides with the replacement of the interior fan coil unit serving the Exercise Room.

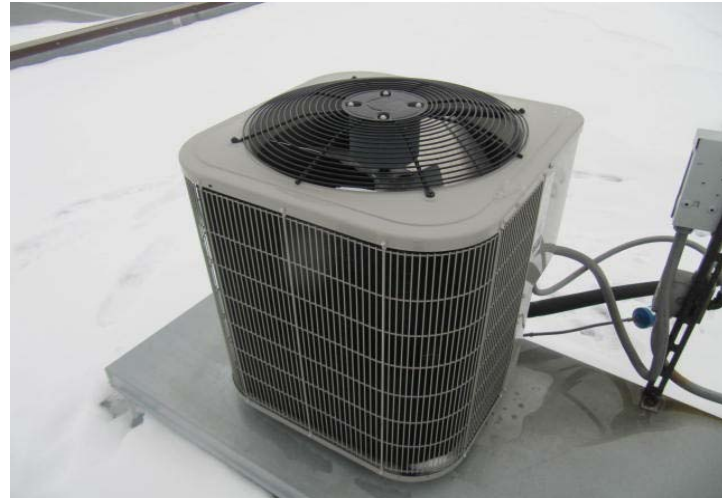
Condensing unit for exercise room.

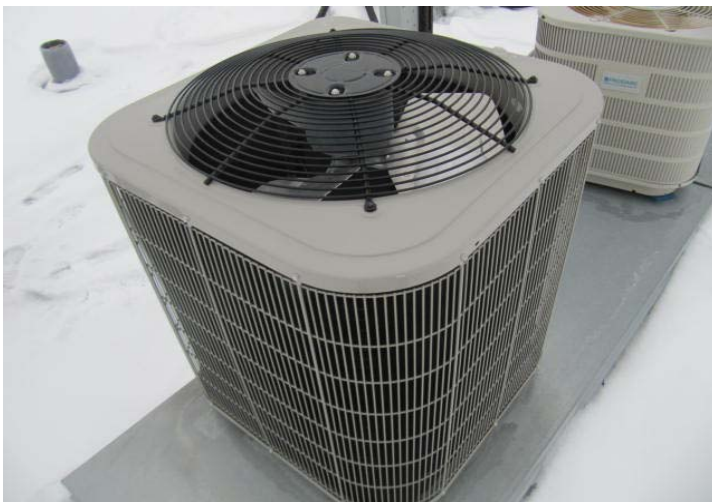
Condensing unit, replaced in 2011.

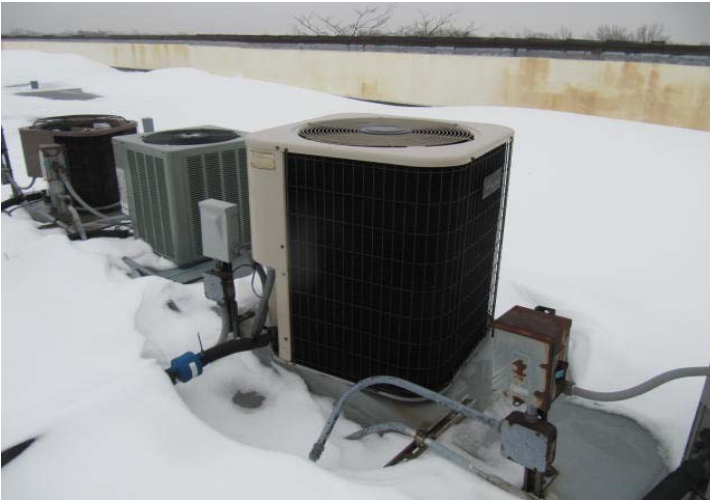
Overview of condensing unit at building rooftop.

The rooftop condensing unit serving the Meeting Room is currently rated for 5.0-ton cooling. Replacement with a lower capacity unit is recommended. Replacement cost includes new 3.0-ton condensing unit, labor, and hoisting to roof level (as the unit will not fit through the existing roof hatch). Replacement of the condensing unit coincides with the replacement of the interior fan coil unit serving the Meeting Room.

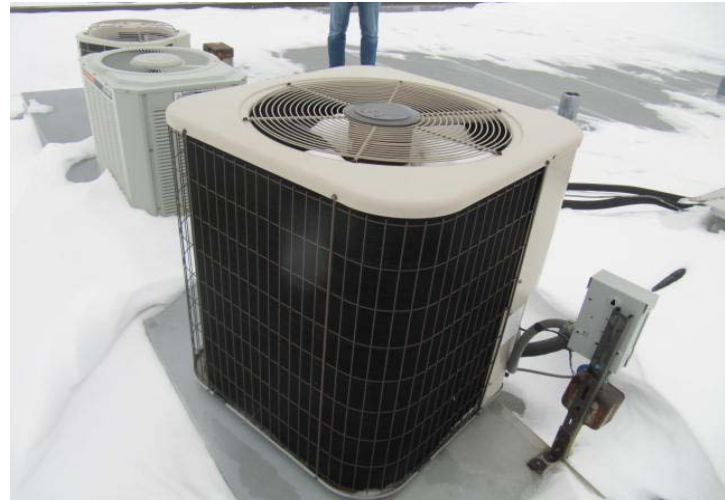
Condensing unit for meeting room.

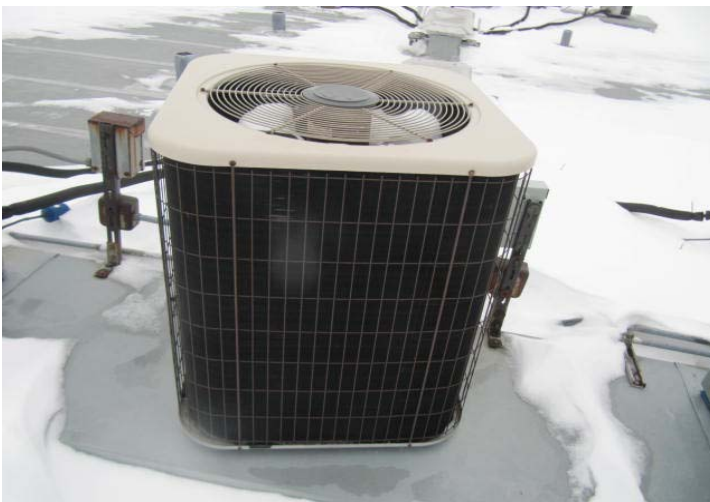
Condensing unit at building rooftop.

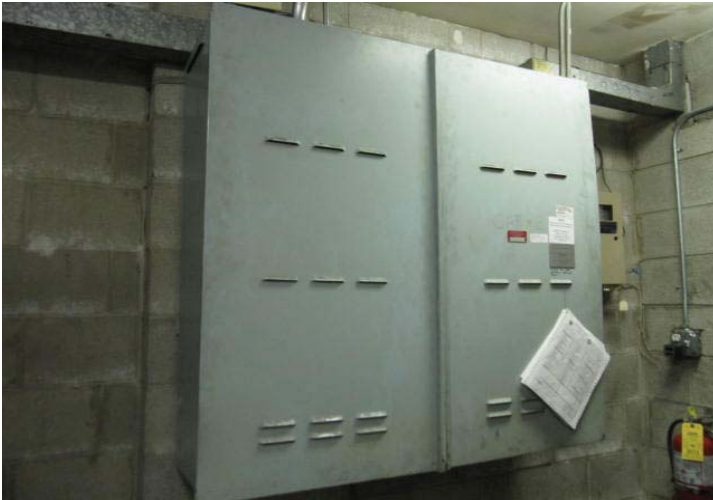
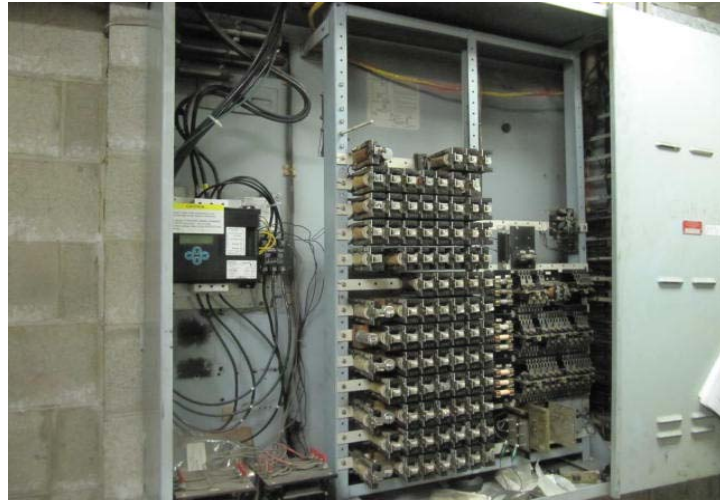
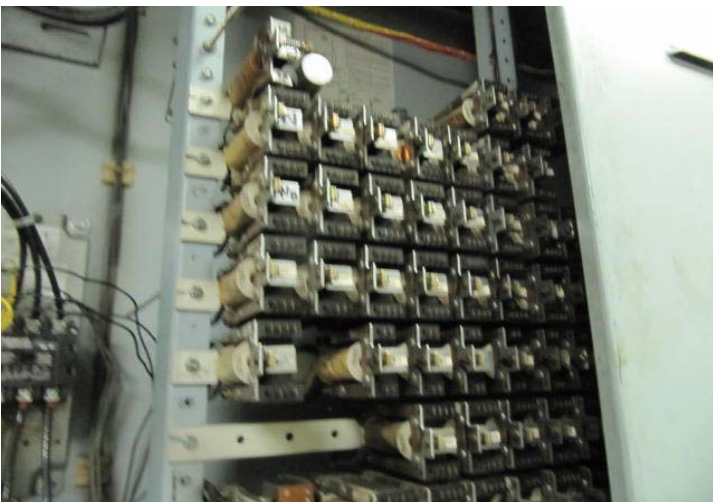
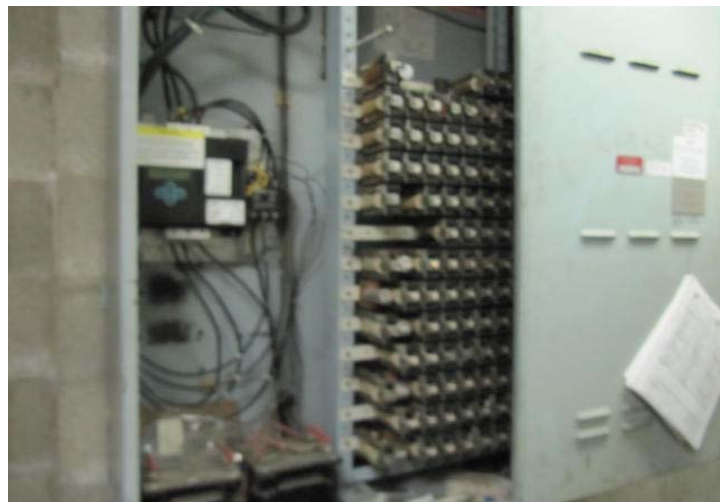
Overview of elevator controller.

Elevator controller at garage-level equipment room.

Original elevator controls, at 30 years of age.

Relay logic circuits at elevator control panel.

The existing relay logic circuit elevator controllers are in functional condition at 30 years of age, but are approaching the end of the typical useful life. A near-term modernization is forecasted and coincides with fixture replacement within and around the elevator cabs. New controller type includes a fully-programmable microprocessor-based controller.

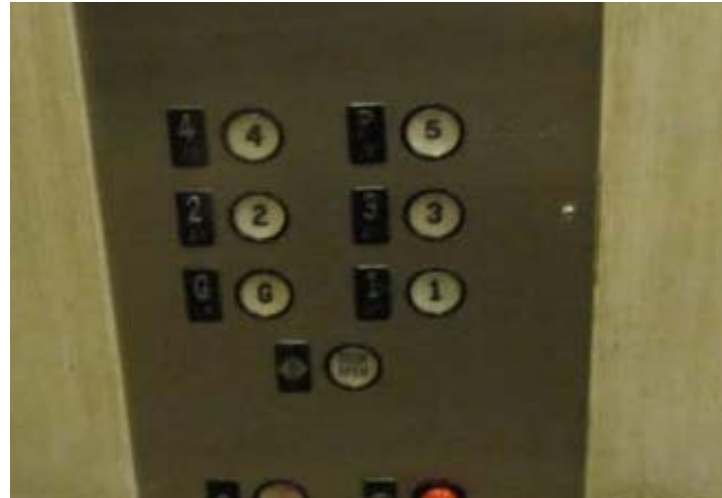
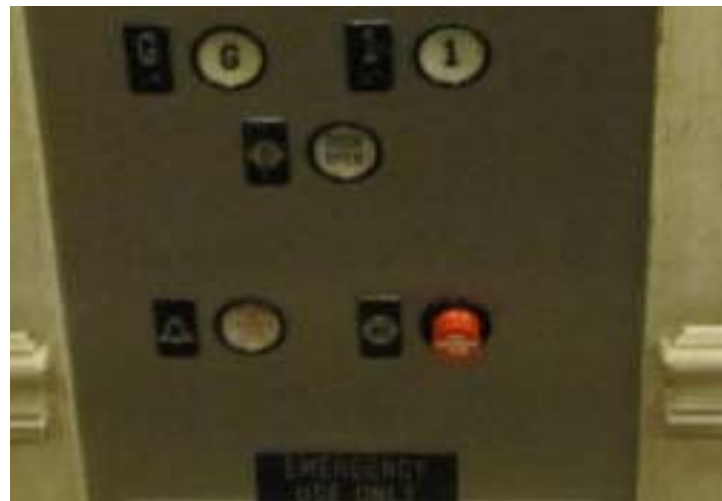
Fixtures at floor selector panel at cab interior.

Floor selector buttons at cab interior.

Component includes the replacement of the original elevator fixtures. Fixtures include buttons in elevator cabs, floor indicator panel/lights inside elevator cabs, floor push buttons at hallways, and up/down indicator lights. Original elevator fixtures are currently 30 years of age, and replacement is recommended within the next 5 years to coincide with the replacement of the elevator controllers.

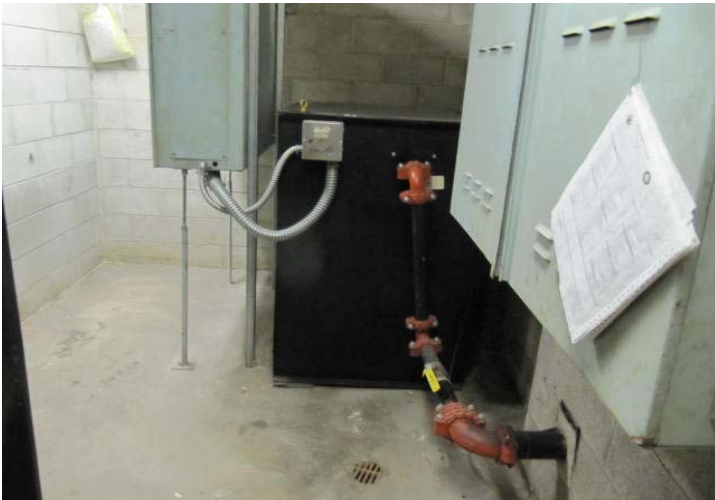
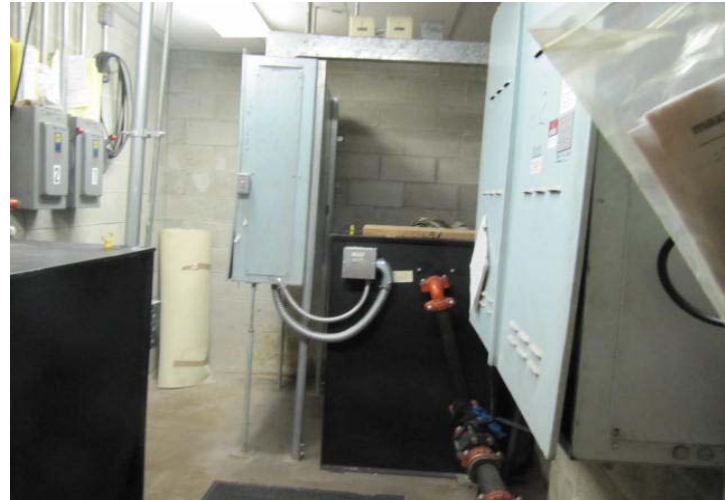
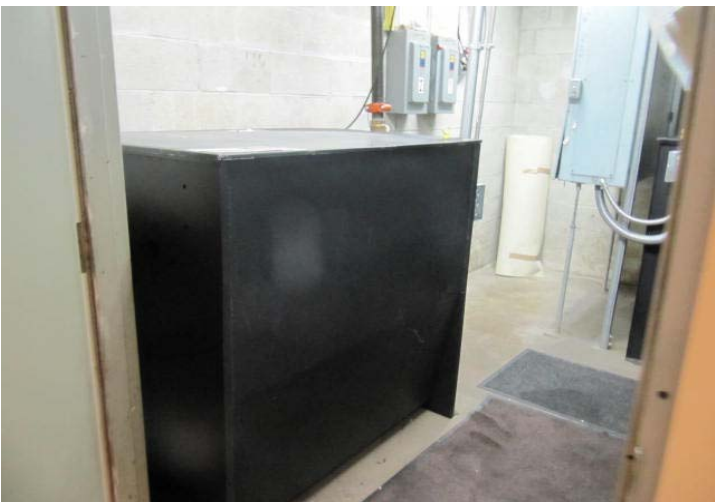
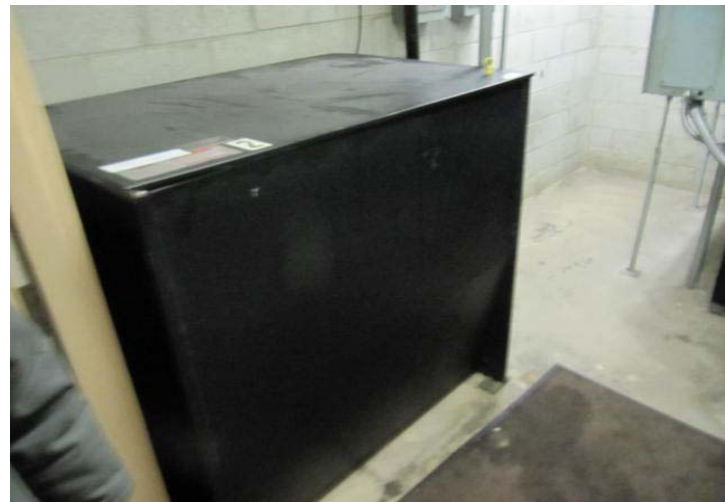
Overview of hydraulic elevator power unit.

Hydraulic power unit, replaced in 2005 - 2006.

Special Conditions
<p>(4) hydraulic power units were installed during the 2005-2006 modernization of the hydraulic elevators. The power units are currently in good functional condition, and replacement is recommended as the units reach an age of 30 to 35 years. Replacement includes metal housing, pump, all valves, and oil.</p>

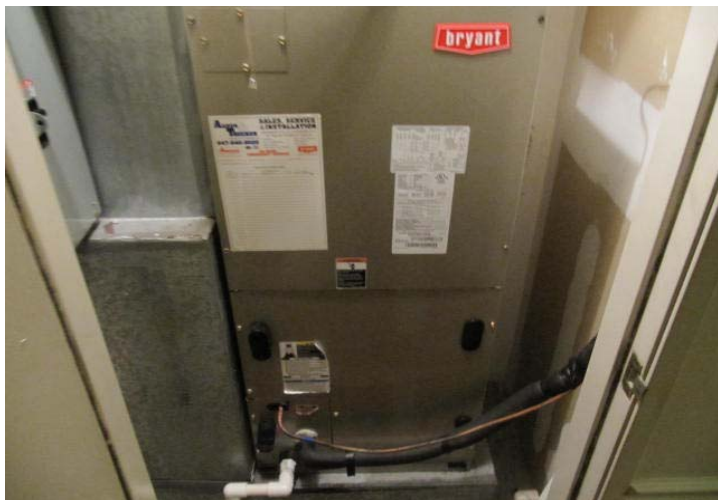
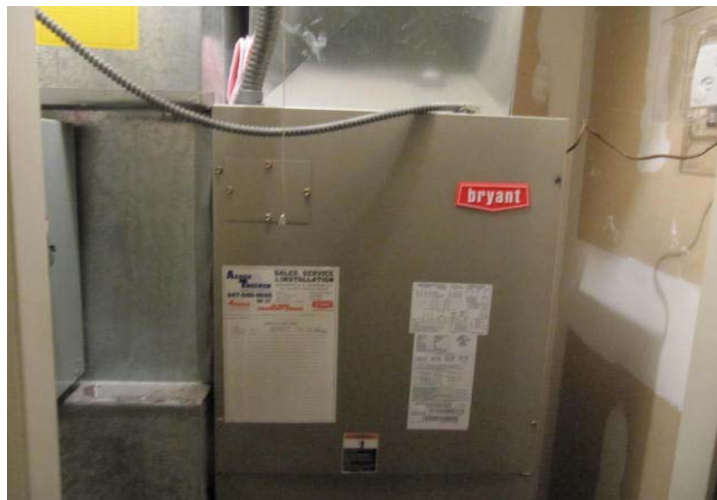
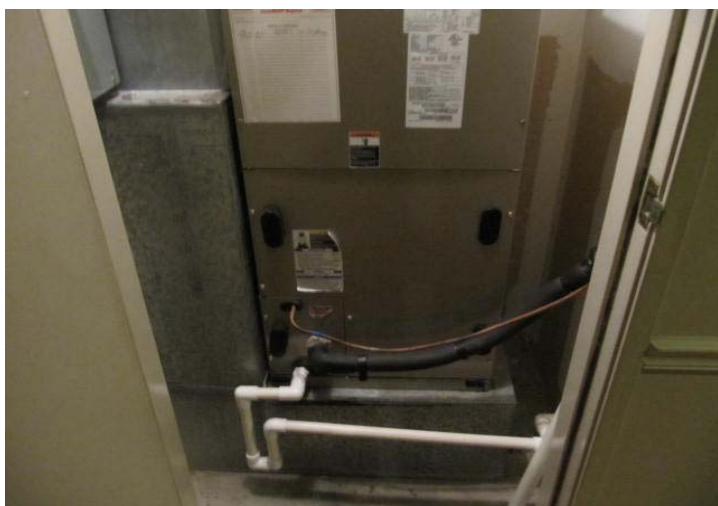
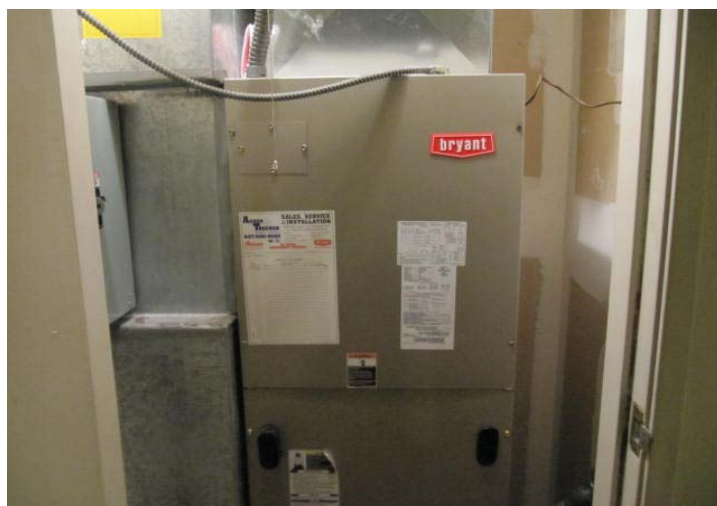
Overview of fan coil unit serving exercise room.

Fan coil unit, replaced in 2011.

Fan coil unit located at hallway closet.

Bryant brand fan coil unit.

The fan coil unit serving the Exercise Room was replaced around 2011 and is currently in good functional condition at approximately 2 years of age. Replacement cost includes all material and labor. Replacement of the fan coil unit is forecasted at 20 years of age and coincides with the replacement of the rooftop condensing unit serving the Exercise Room.

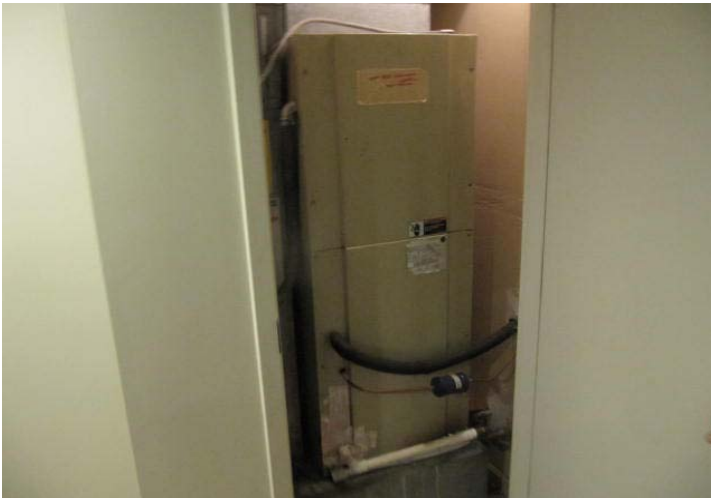
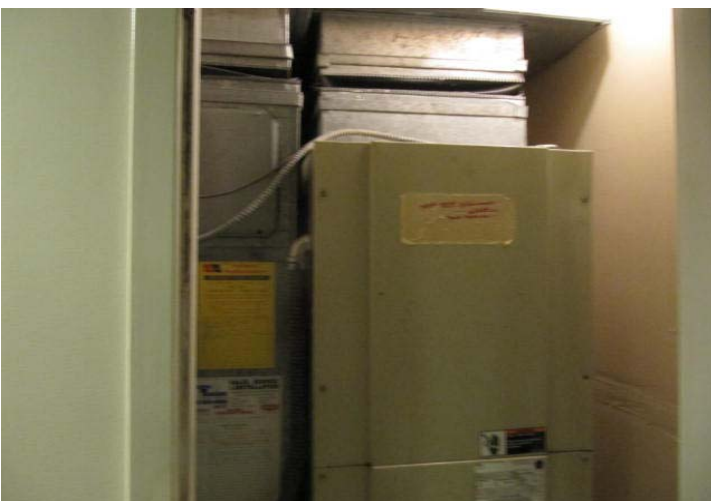
Overview of fan coil unit serving meeting room.

Meeting room fan coil unit, at unknown age.

Fan coil unit located at hallway closet near meeting room.

BDP Company brand fan coil unit.

The fan coil serving the Meeting Room is currently rated for 5.0-ton cooling. Replacement with a lower capacity unit is recommended. Replacement cost includes new fan coil unit (sized to match newer unit at Exercise Room). Replacement of the fan coil unit coincides with the replacement of the rooftop condensing unit serving the Meeting Room.

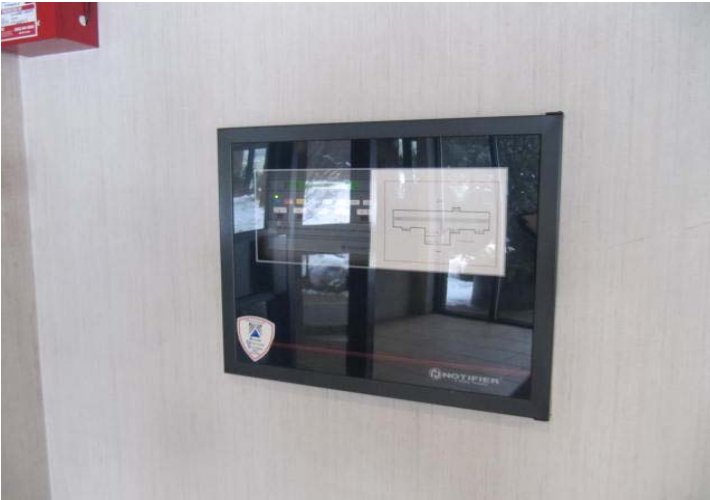
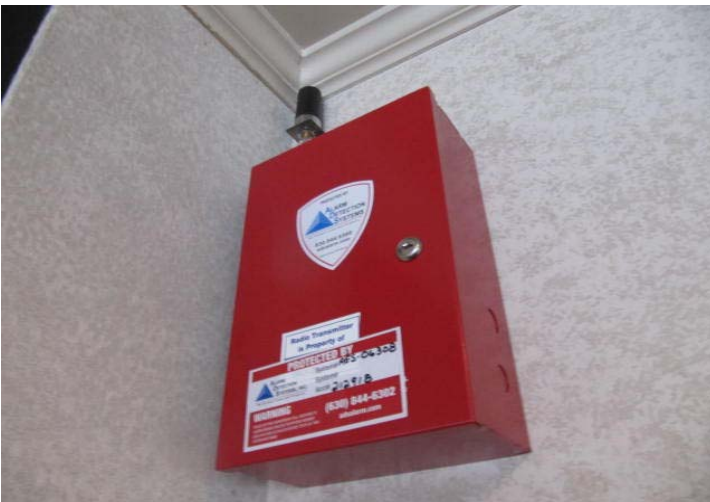
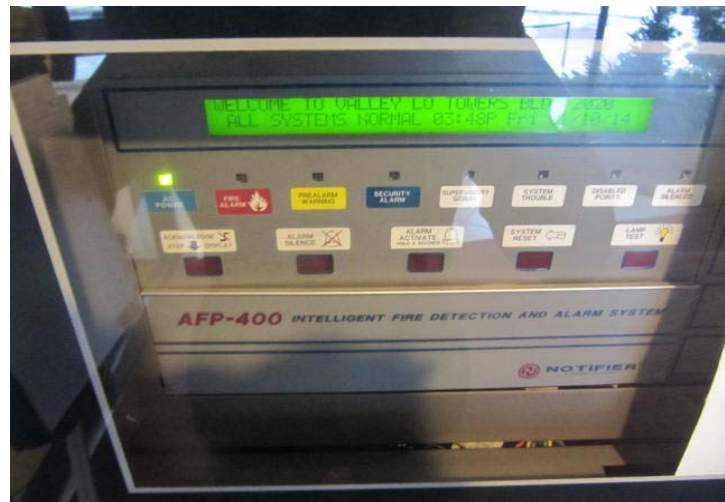
Overview of fire control panel at lobby.

NOTIFIER brand fire control panel.

Wireless transmitter for fire control panel.

Digital display at fire control panel.

The fire panels at the building's entrance vestibules are in good functional condition at an unknown age. Replacement cost includes addressable Notifier brand panel (or equivalent) and adjacent wireless transmitter. Replacement of the fire panel is recommended every 15 to 20 years due to changes in technology. Replacement coincides with the replacement of the emergency fire devices.

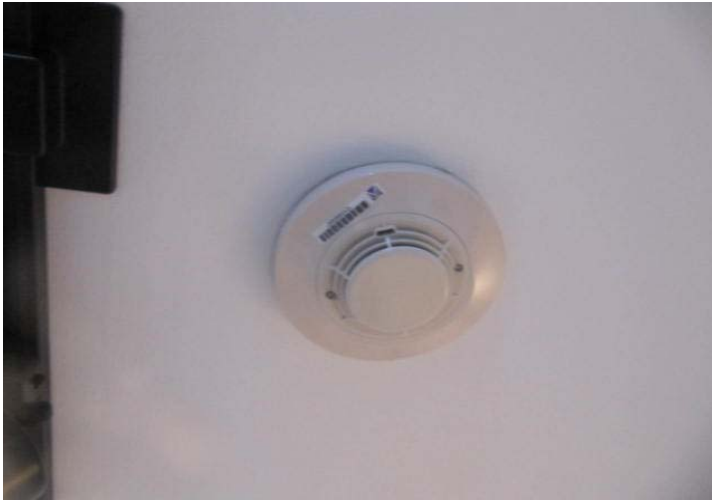
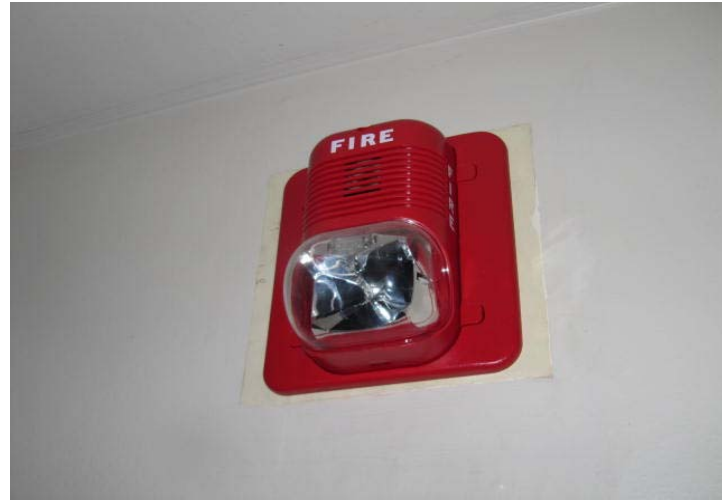
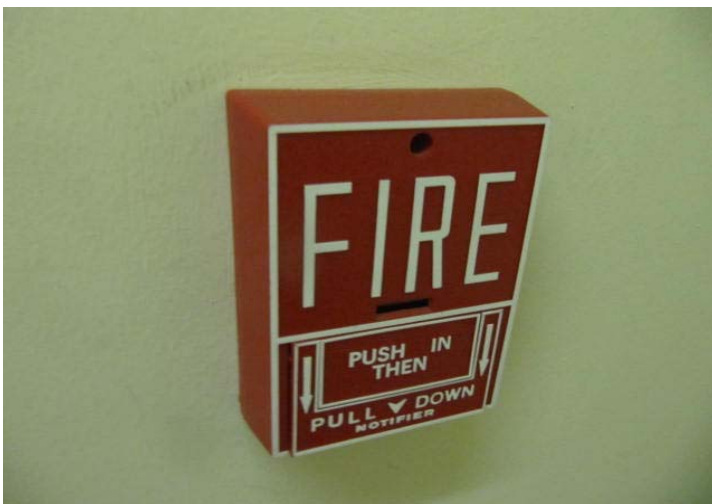
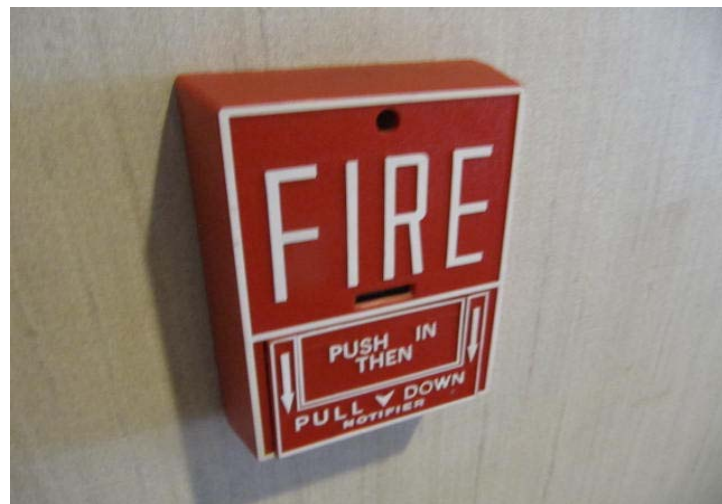
Ceiling mounted smoke detector.

Wall mounted horn / strobe.

Emergency manual pull station.

Emergency detection fire devices within both buildings include the following: (142) smoke detectors, (54) horn/strobes, (46) manual emergency pull stations, and (20) annunciators. Unit cost is an average cost per system, as the device counts vary slightly between the two buildings due to the difference between the Exercise and Meeting rooms. Replacement of the emergency devices coincides with the replacement of the fire detection control panels.

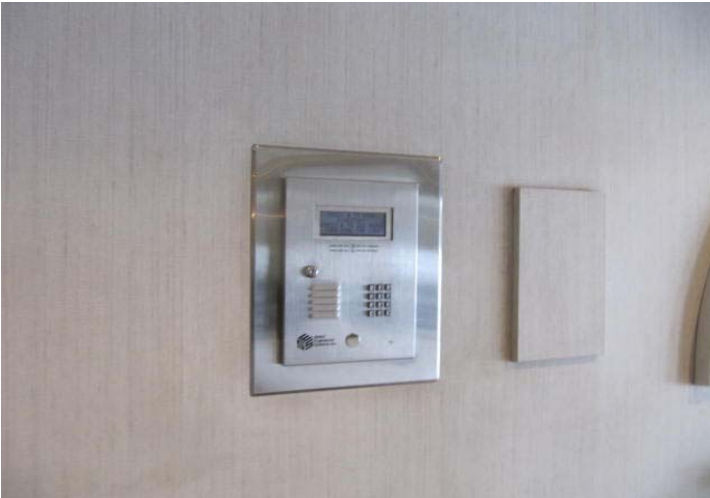
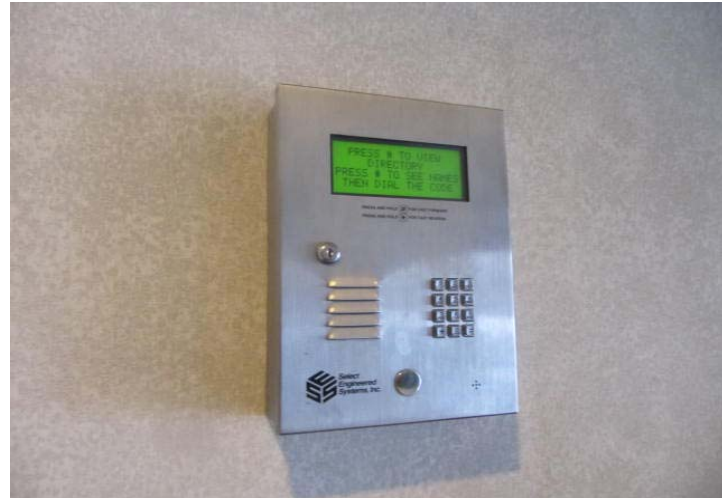
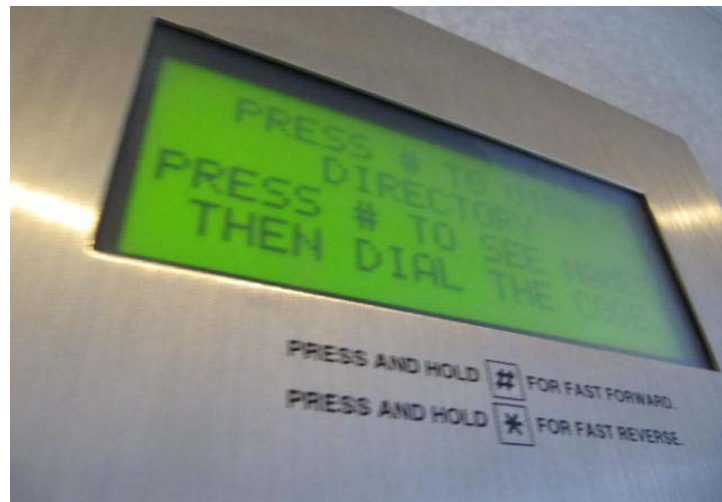
Overview of intercom entry panel.

Finishes and push buttons at panel are in good condition.

Digital display at intercom entry panel.

Intercom entry panels are located at each building's entrance vestibule. The exact age of the intercom panels is unknown, but they are thought to be approximately 10 years of age. Replacement of the intercom panels is forecasted when the panels reach an age of 20 to 25 years.

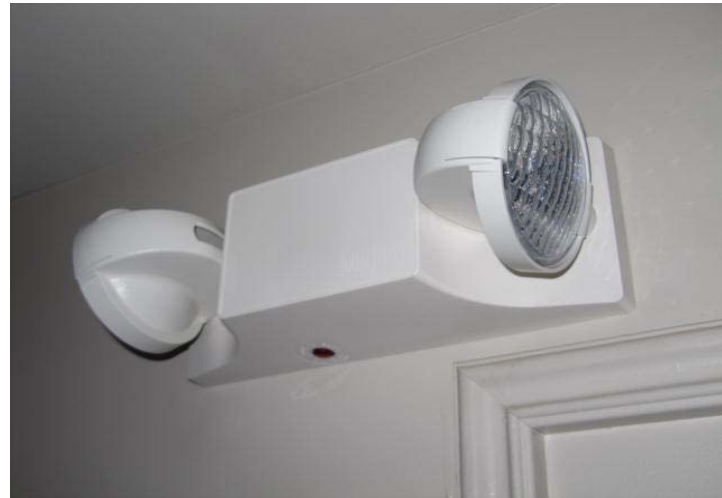
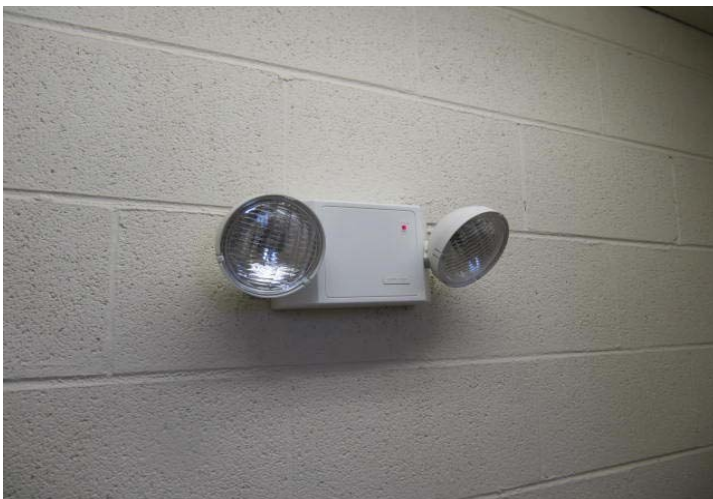
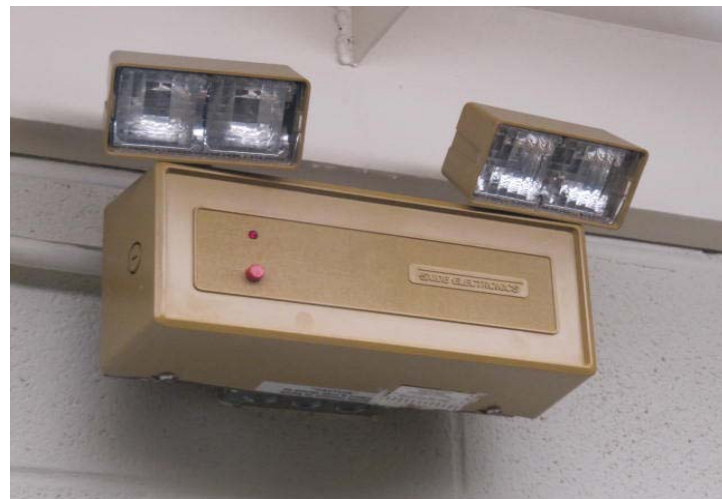
Twin beam emergency light fixture.

Newer emergency light fixture in good condition.

Older emergency light fixture, in functional condition.

Many of the emergency light fixtures throughout the buildings were replaced in 2005, and the remainder of fixtures are older. A phased replacement is forecasted due to the varied fixture ages. Replacement in 2030 coincides with the replacement of the emergency exit signs.

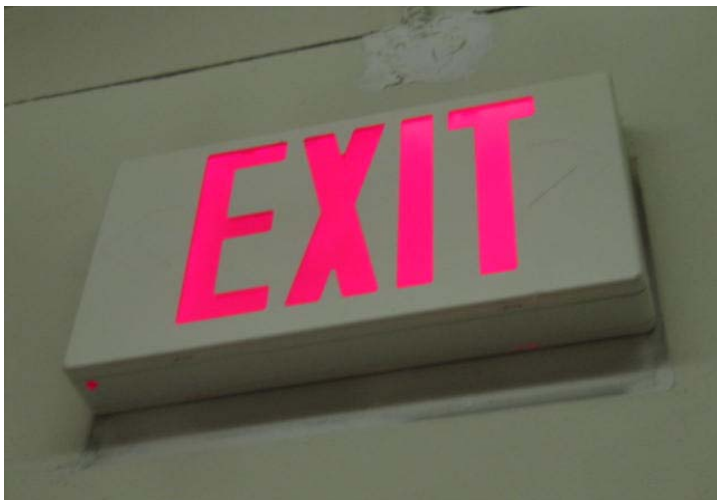
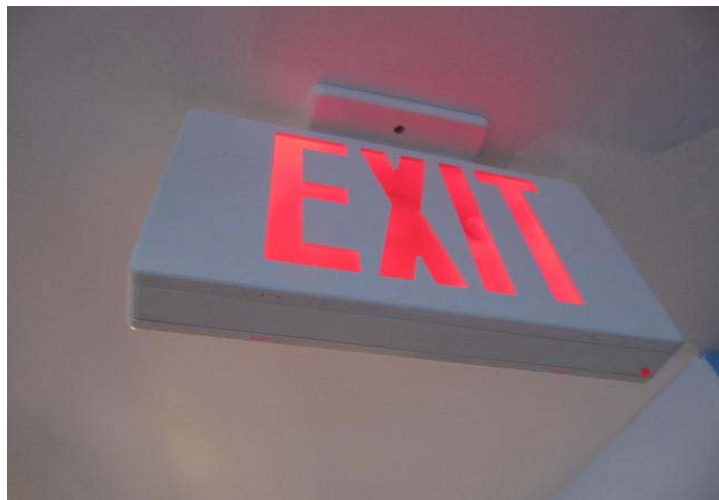
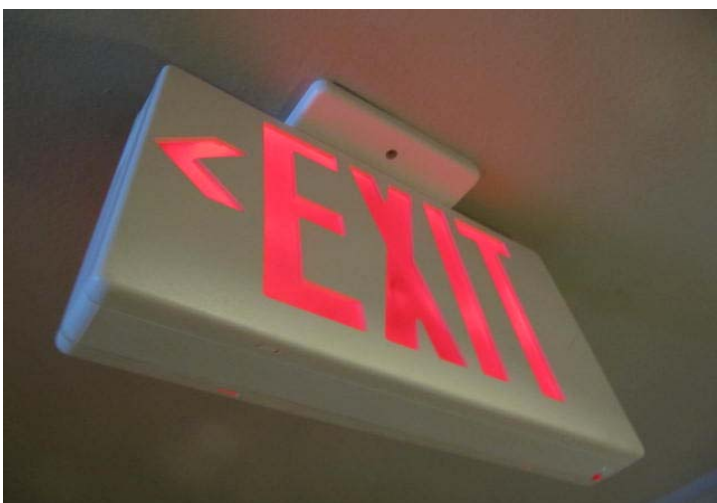
Wall mounted emergency exit sign.

Ceiling mounted double-sided emergency exit sign.

Emergency exit sign, at 9 years of age.

Special Conditions
Emergency exit signs were replaced in 2004 and 2005 and are currently in good overall condition. Replacement is forecasted for 2030, when the fixtures reach an age of 25 years. Replacement coincides with the replacement of the emergency twin beam light fixtures.
