The Valley Lo Towers I Condominium Association

RESERVE STUDY
For
Valley Lo Towers I

Glenview, IL
Date of Inspection
January 10, 2014

BUILDING RESERVES, INC.

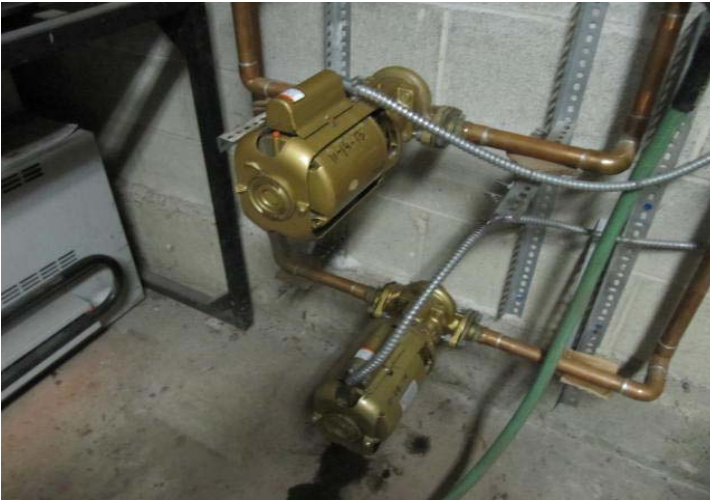
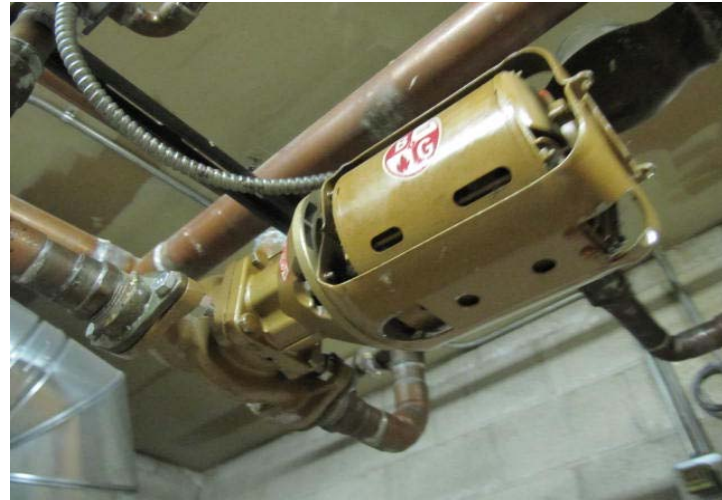
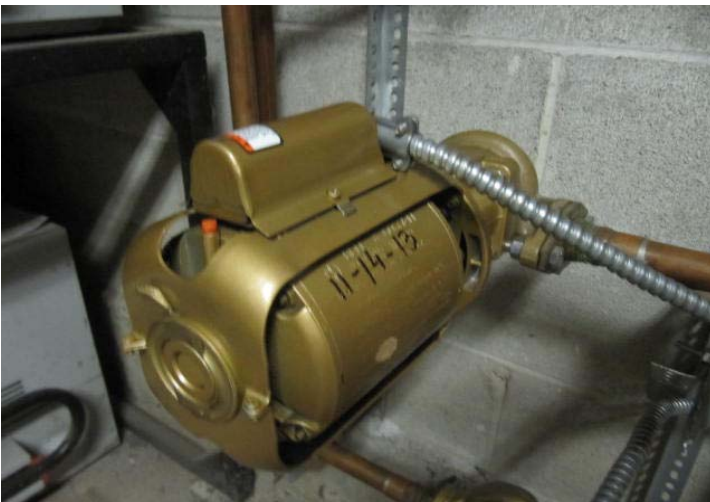
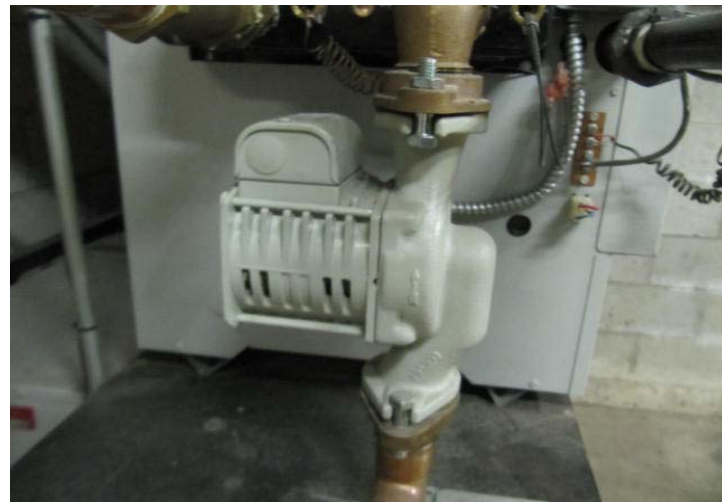
Overview of domestic hot water circulation pump.

Circulating pump for domestic hot water.

Pump motor, replaced in 2013.

Total quantity includes (4) circulating pumps serving the domestic hot water heaters and (3) additional circulation pumps. Total quantity includes all pumps at both lower level mechanical rooms. Pumps are in good overall condition and vary in age, as pumps have been replaced as needed in past years. Unit cost is an average cost among all pumps.

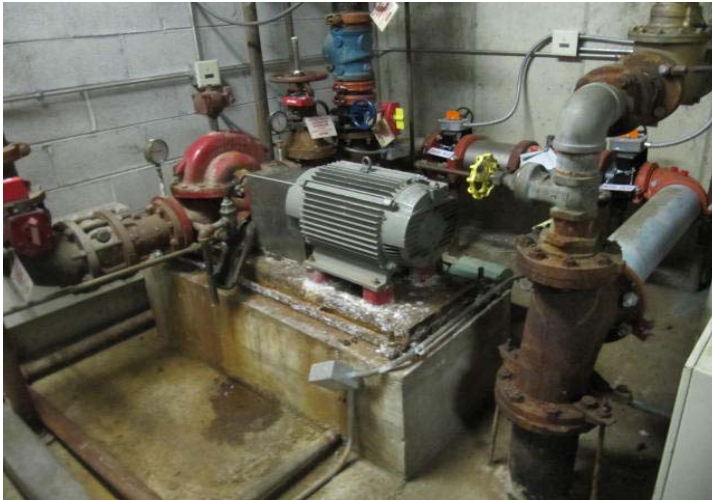
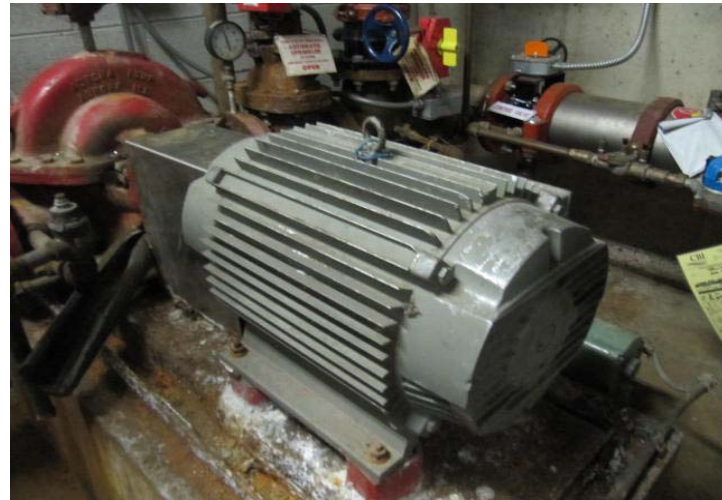
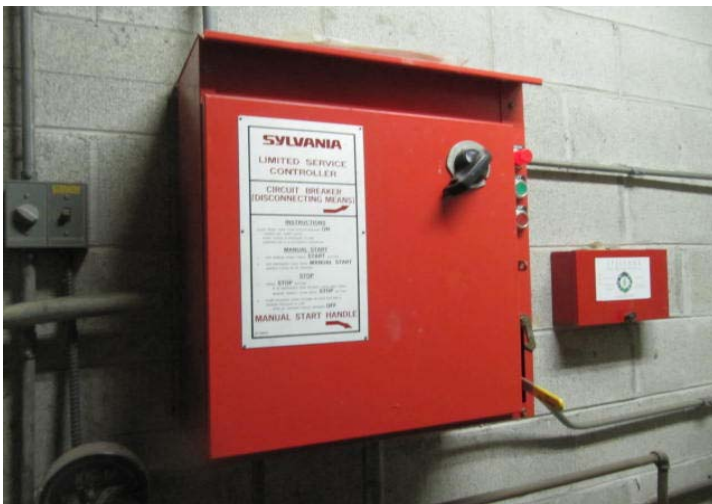
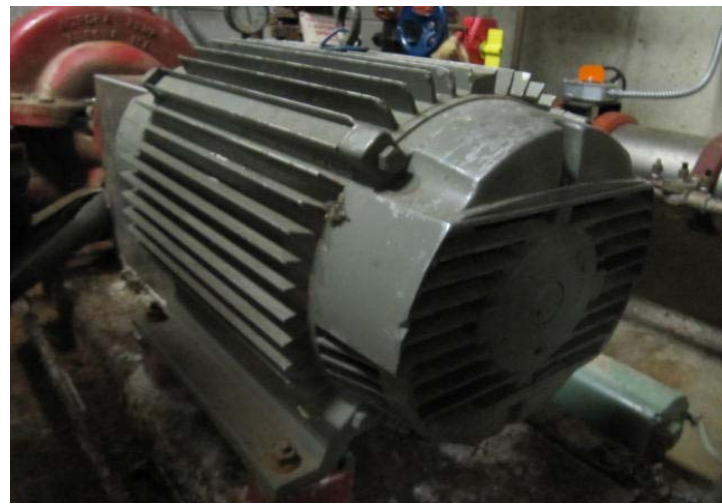
Overview of fire pump.

Fire pump, in functional condition at 30 years of age.

Sylvania Limited Service Controller with manual start.

Fire pump, rated for 30-Horespewr.

Special Conditions
<p>(1) fire suppression pump serves the (2) buildings. The original fire suppression pump is in functional condition at 30 years of age. Replacement cost includes a fire suppression pump at 30-HP / 1,755-RPM with associated controls and jockey pump. Replacement is forecasted for 2029, when the pump reaches an age of 45 years.</p>

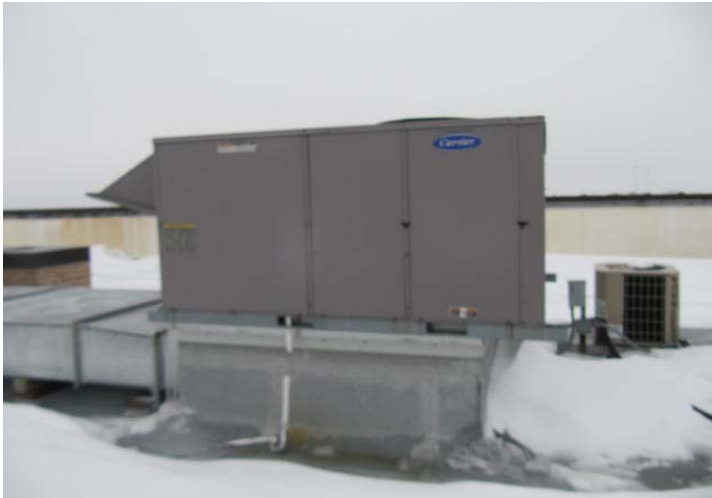
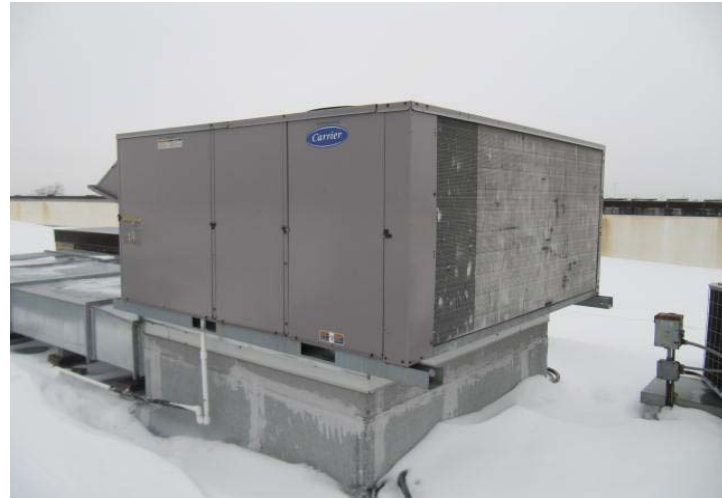
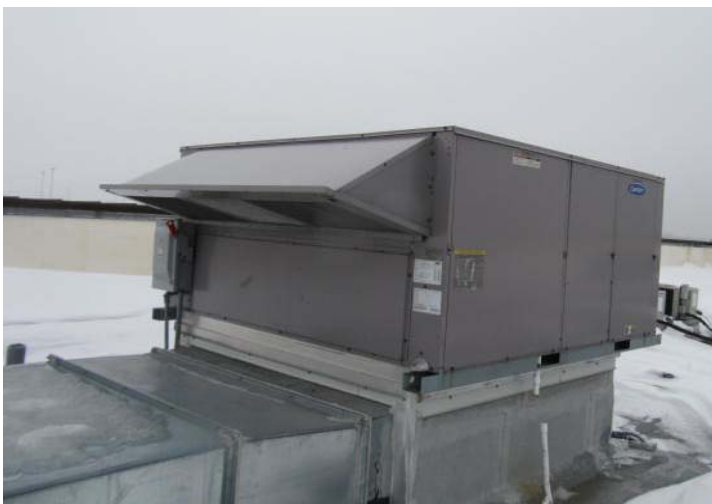
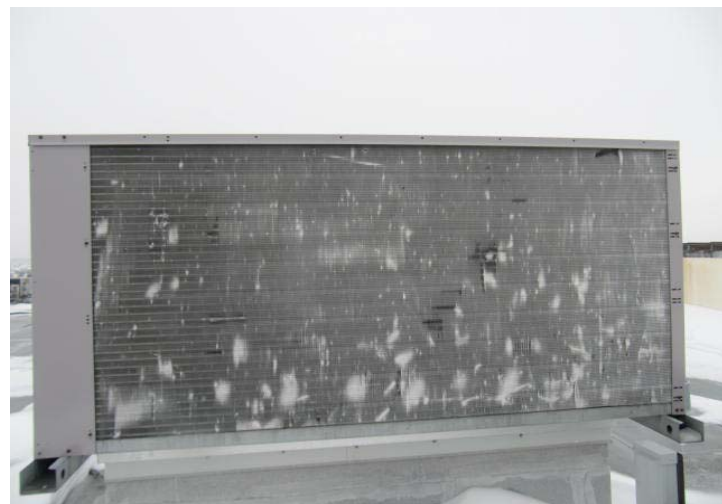
Overview of rooftop heating and cooling unit.

Carrier brand rooftop heating and cooling unit.

Side view of rooftop heating and cooling unit.

(2) rooftop heating and cooling units are located at each building roof. The rooftop units are rated for 20.0-ton each. Unit cost includes all material, labor, and hoisting to roof level. The existing Carrier brand units were installed in 2005+/- and are currently in good functional condition. Future replacement of the rooftop heating and cooling units is forecasted when the units reach 22 years of age.

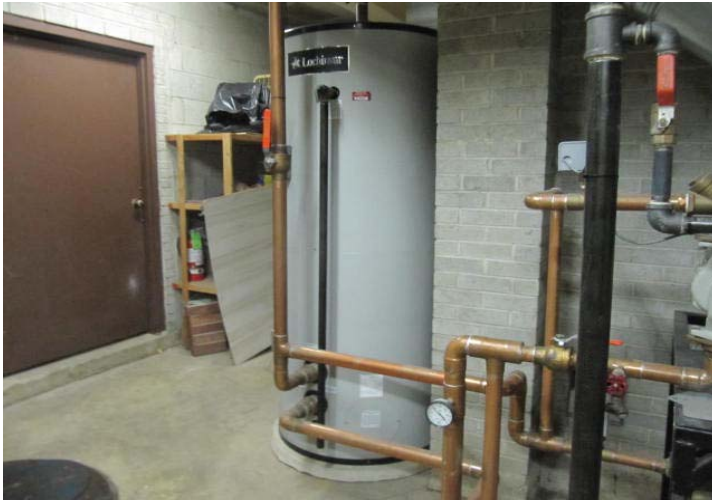
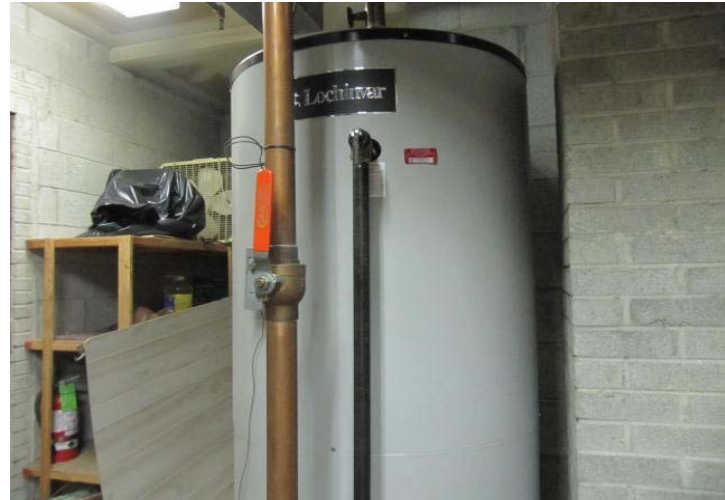
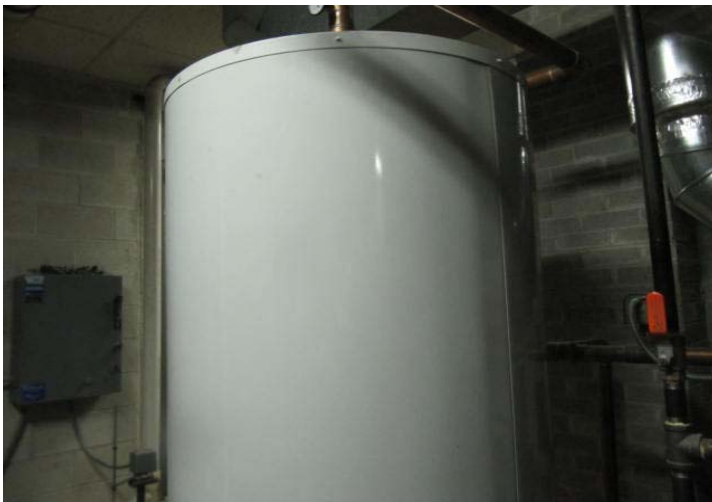
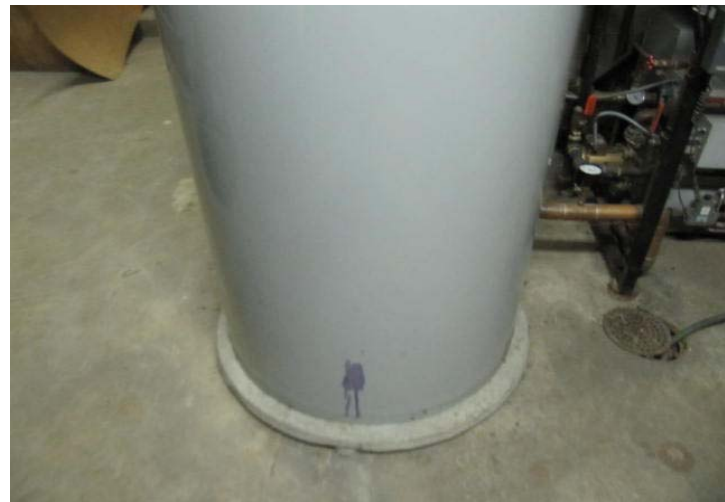
Overview of domestic hot water storage tank.

Lochinvar hot water storage tank.

Hot water storage tank, in good condition.

Storage tank with 200-Gallon capacity.

(2) storage tanks at 200-gallon capacity each are located in the lower level mechanical rooms. The storage tanks were replaced in 2004 and are currently in good functional condition. Future replacement of the storage tanks is forecasted for 2028, to coincide with the replacement of the hot water boilers.

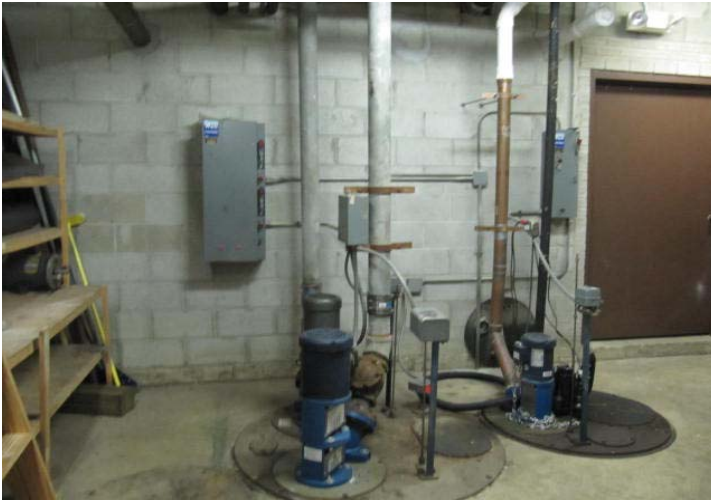
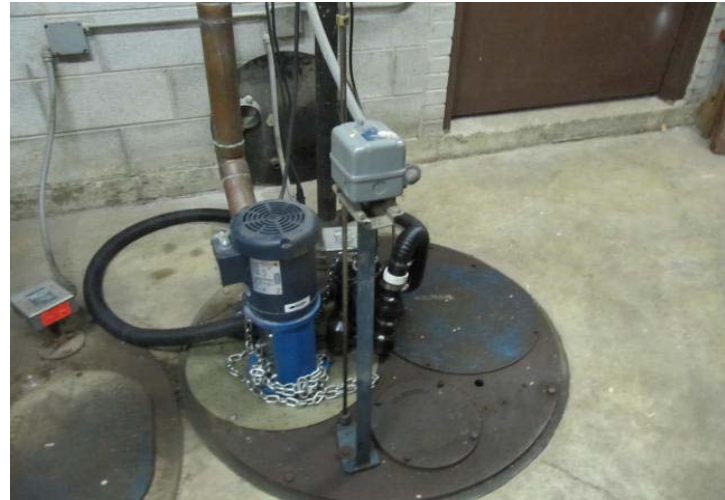
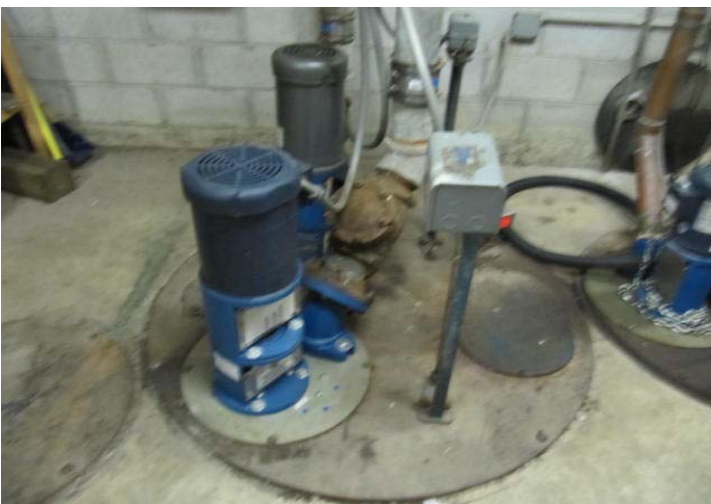
Overview of sump pump stations at mechanical room.

Sump pump station with controls.

Sump pumps vary in age and condition.

Special Conditions
Total quantity includes (3) sump pumps with associated controls located at the lower level mechanical rooms at both buildings. Sump pumps range in capacity from 1.0-Horsepower to 2.0-Horsepower and appear to vary in age and condition. A phased replacement of the sump pumps is forecasted, beginning in 2022.

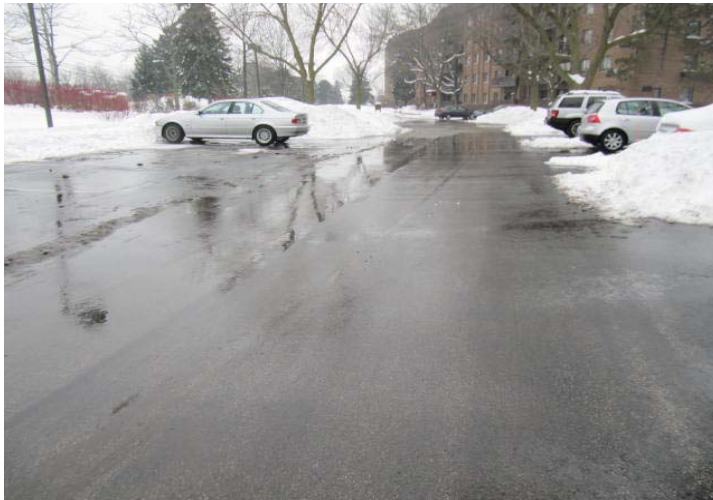
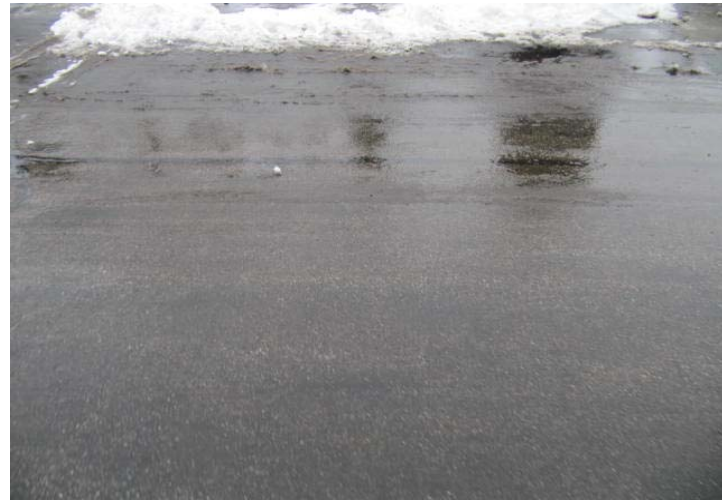
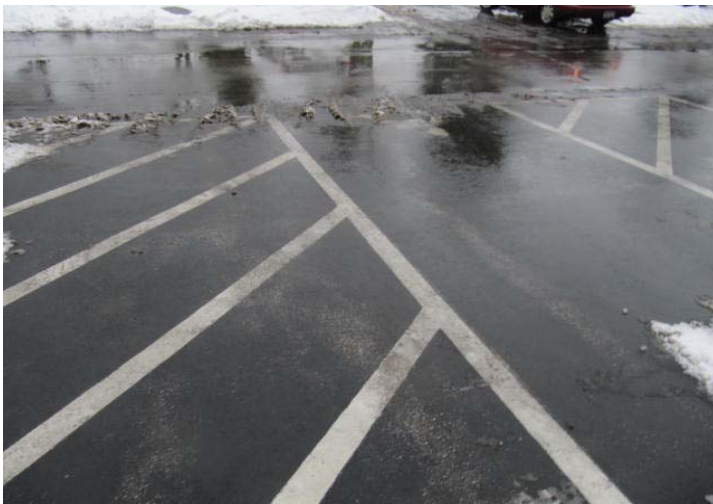
Overview of asphalt pavement at parking lot.

Pavement is smooth and level.

Clear marking at handicap parking stall.

Special Conditions
Total quantity includes all asphalt pavement at the parking lots, garage entrance drives, and the fire lane at the rear of the buildings. Component includes crack routing and filling, spot patching, seal coat application, and striping as required. Seal coating and repairs are forecasted every 5 years, except the year in which the parking lot pavement is fully replaced.

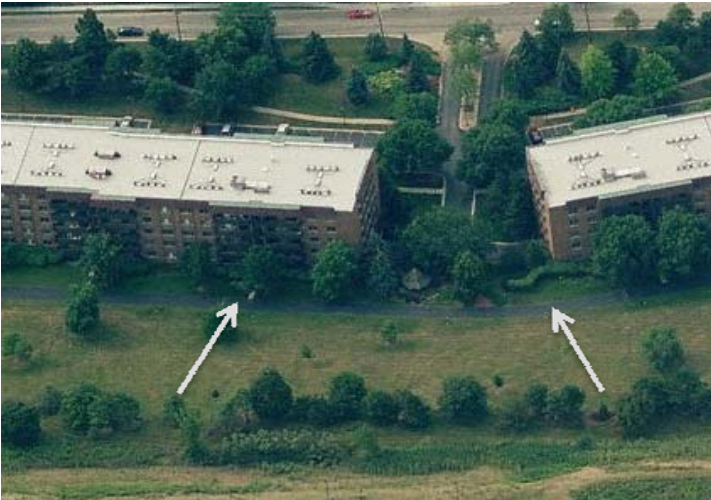
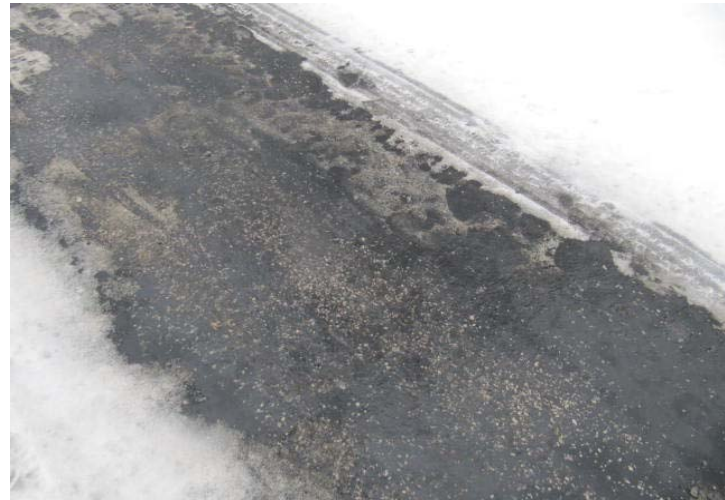
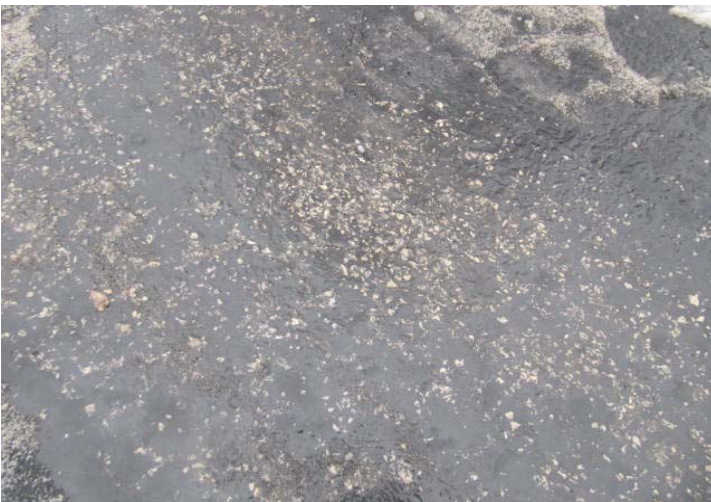
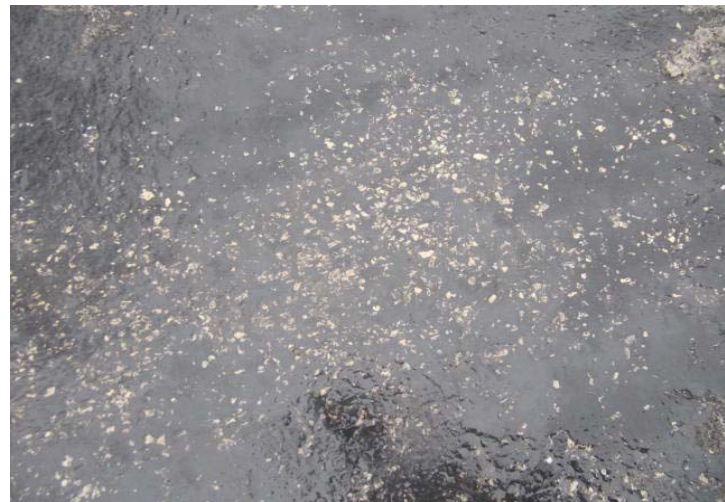
Aerial view of pavement at fire lane.

Typical surface condition at fire lane pavement.

Total quantity includes the fire lane at the rear of the buildings. The age of the pavement is unknown, and the fire lane pavement is in fair overall condition. Areas of sunken / unlevel pavement were noted. Replacement time is based upon current condition assessment and coincides with seal coating and repairs at the parking lot pavement.

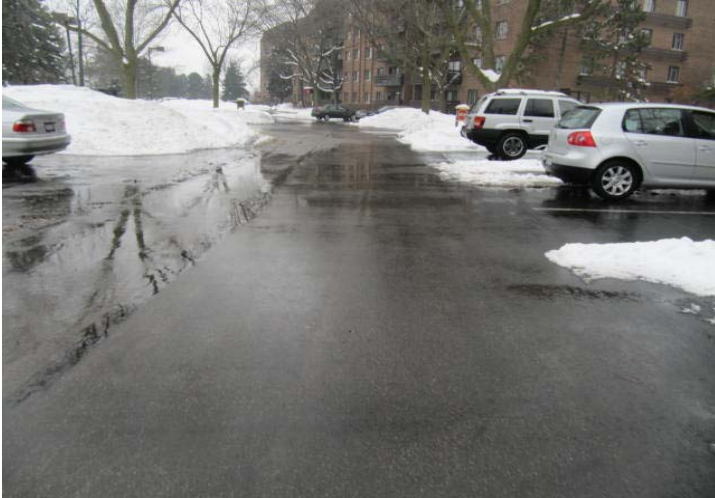
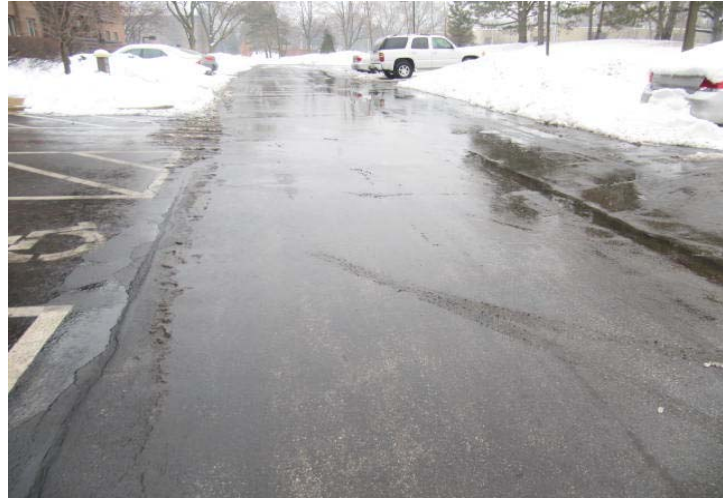
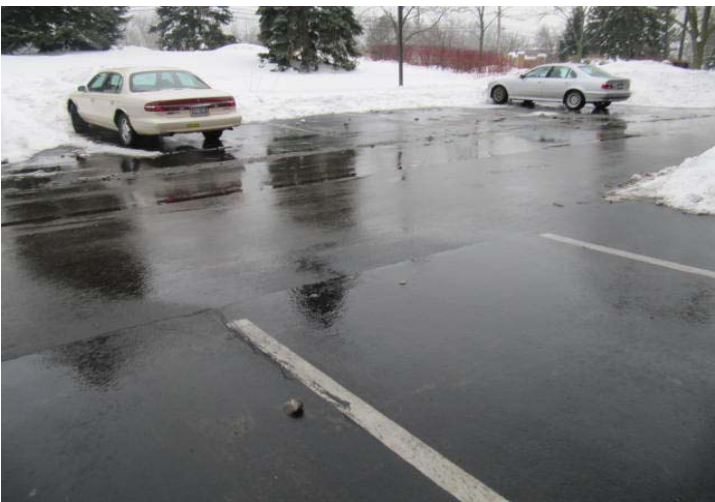
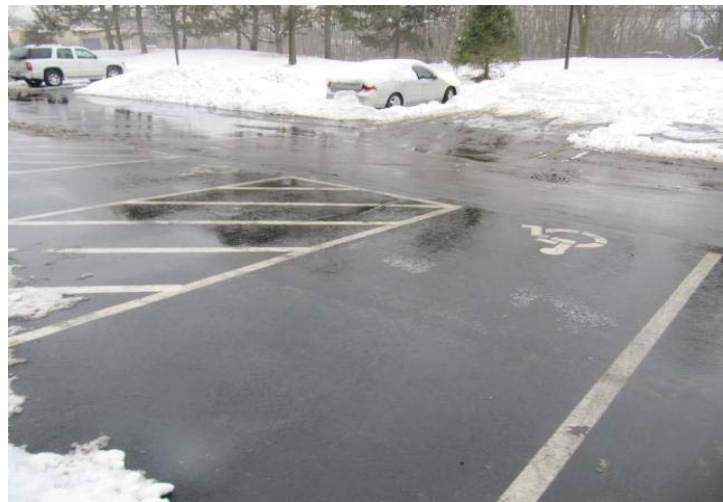
Overview of asphalt pavement at parking lot.

Asphalt pavement at drive aisle.

Asphalt pavement at parking bays.

Special Conditions
Total quantity includes all asphalt pavement at the parking lot and entrance drives leading to underground garages. The asphalt pavement is in good overall condition and was replaced 7 years ago. Future replacement is forecasted for 2027, when the pavement reaches an age of 20 years.

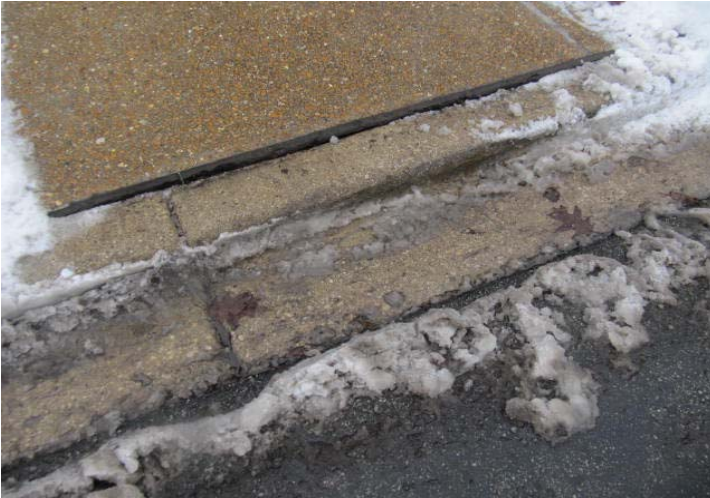
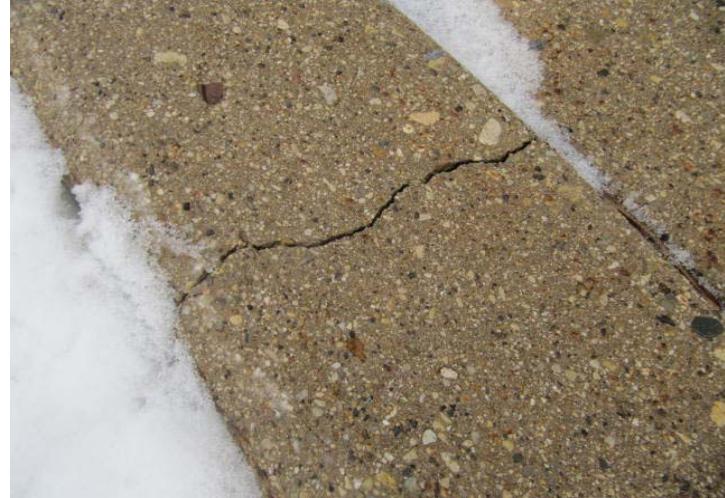
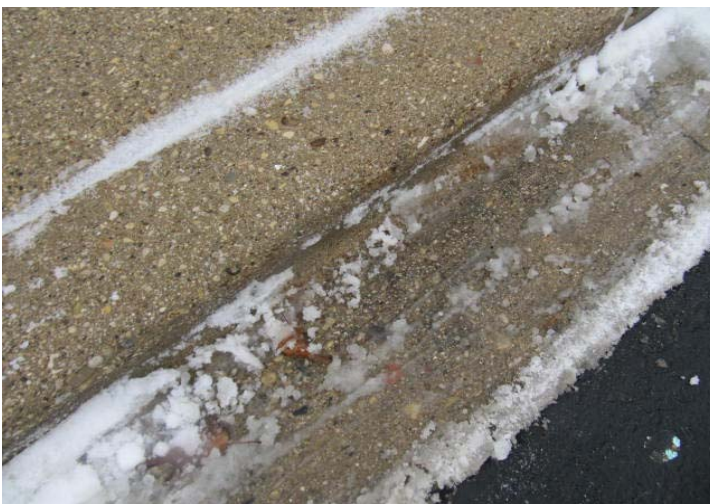
Concrete curb and gutter at perimeter of parking lot.

Cracked concrete curb at parking lot.

Raised concrete curb and gutter at parking lot.

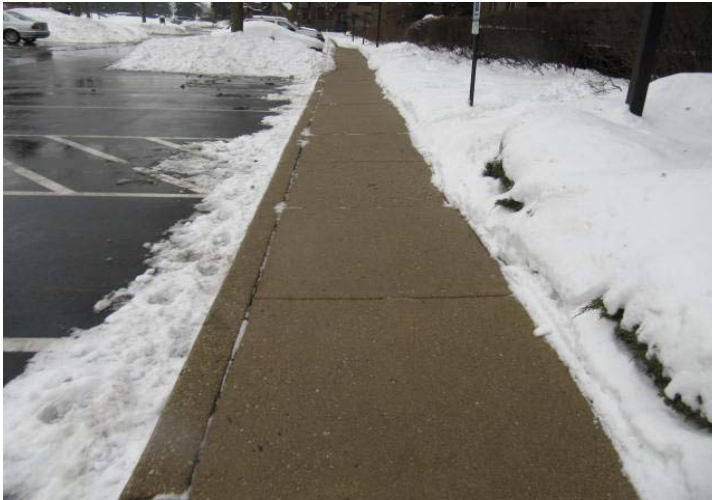
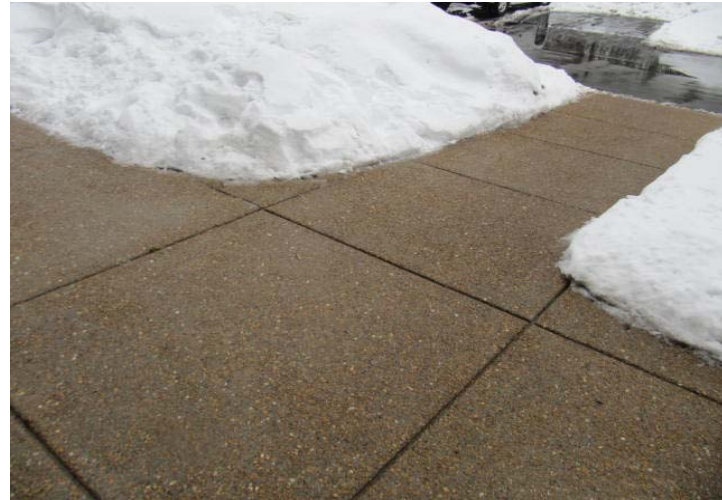
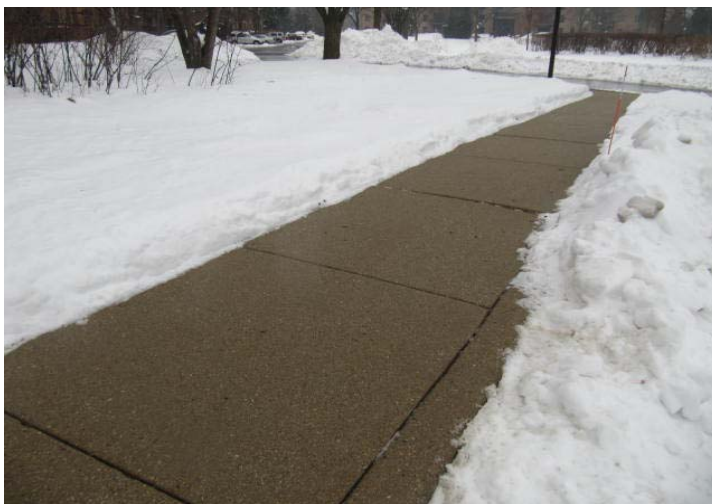
Overall Current Condition:	Fair		
Useful Life in Glenview, IL	to 65	Years	
Full or Partial Replacement:	Partial	40.0%

Overview of concrete sidewalk.

Concrete sidewalk, with exposed aggregate finish.

Area of sidewalk in good overall condition.

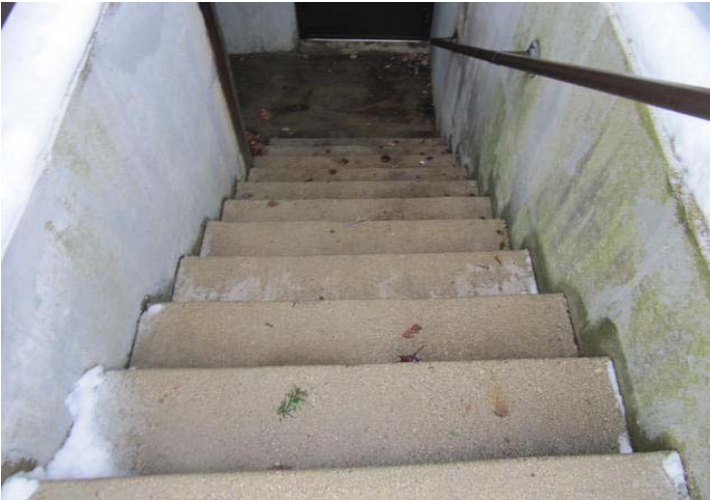
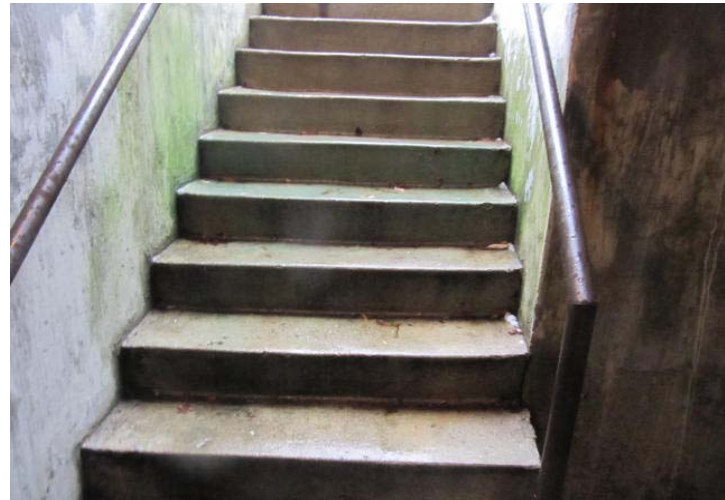
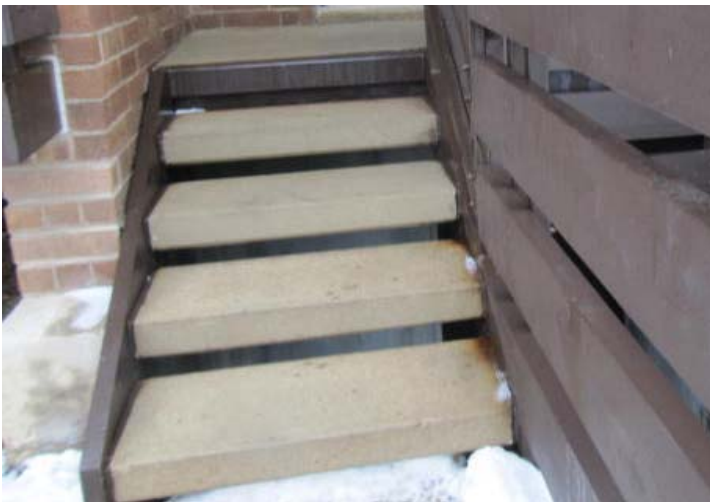
Overall Current Condition:	Fair
Useful Life in Glenview, IL	to 65 Years
Full or Partial Replacement:	Partial 40.0%

Overview of concrete stairs leading to lower level.

Concrete formed stairs, viewed from garage level.

Concrete stair treads leading to private stairwell.

Special Conditions
Total quantity includes all concrete stairs and concrete landings at the lower level stairwells leading from the garages and from the internal private stairwells leading directly from units. Unit cost is an average cost among all formed concrete stairs, concrete treads, and concrete landings. A 40% phased replacement is forecasted over the next 30 years. Replacements coincide with the replacement of concrete curbs, concrete gutters, and concrete sidewalks.

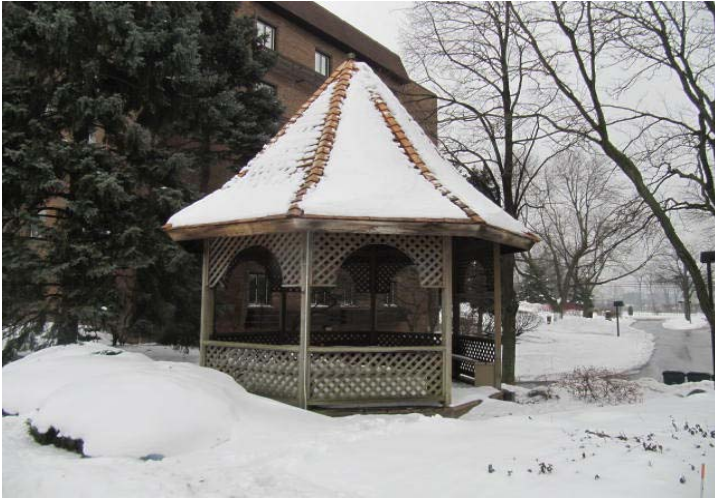
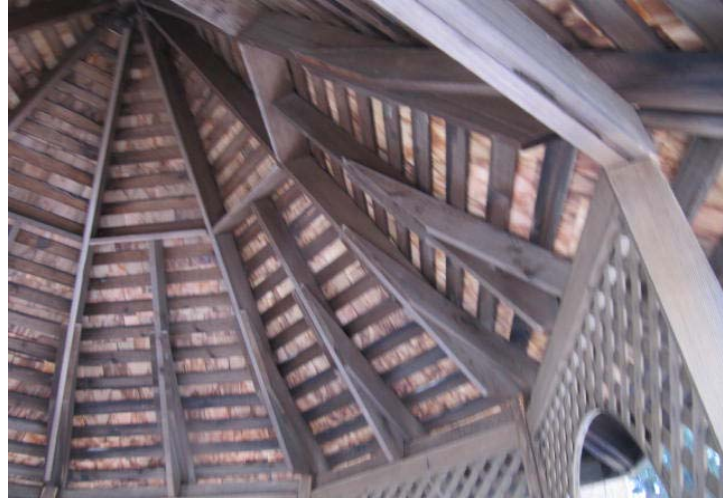
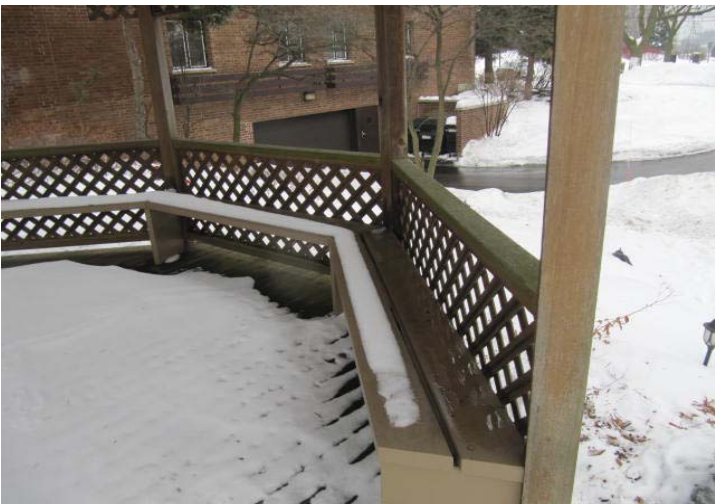
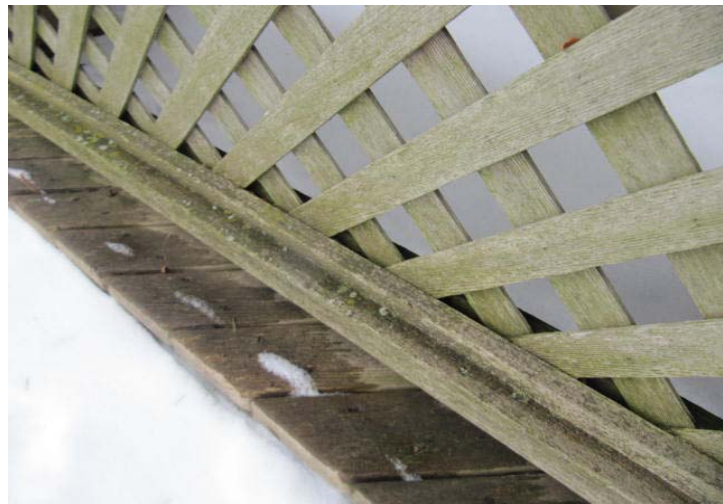
Overall Current Condition:	Good
Useful Life in Glenview, IL	20 to 25 Years
Full or Partial Replacement:	Full

Overview of wood gazebo.

Gazebo roof, replaced in 2013.

Railings and benches at gazebo.

Lattice panel and wood floor boards.

Component includes the replacement of the wood gazebo structure. The wood gazebo component vary in age, as the roof was recently replaced in 2013. Full replacement of all gazebo components is anticipated in 2027. Prior to full replacement, all staining / sealing should be performed as needed and should be funded from the association's operating budget.

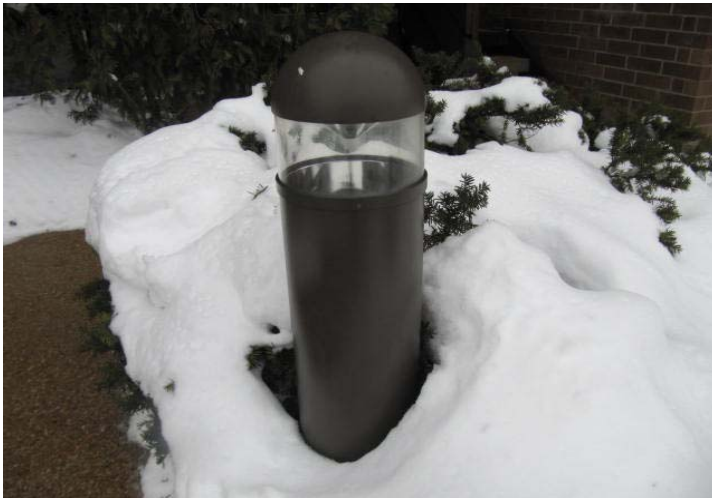
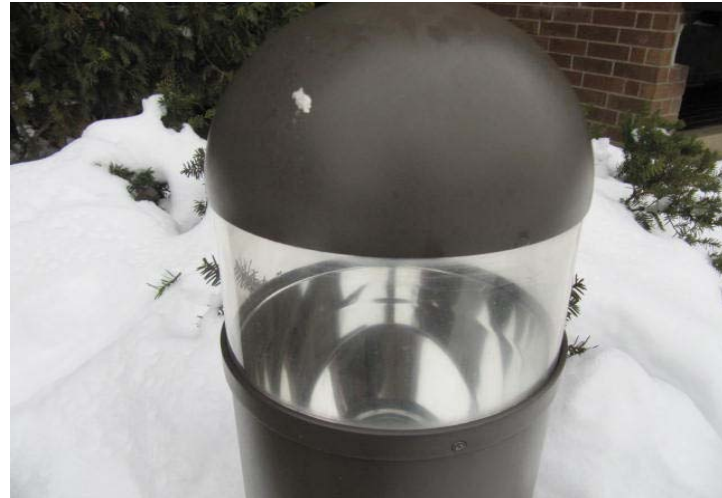
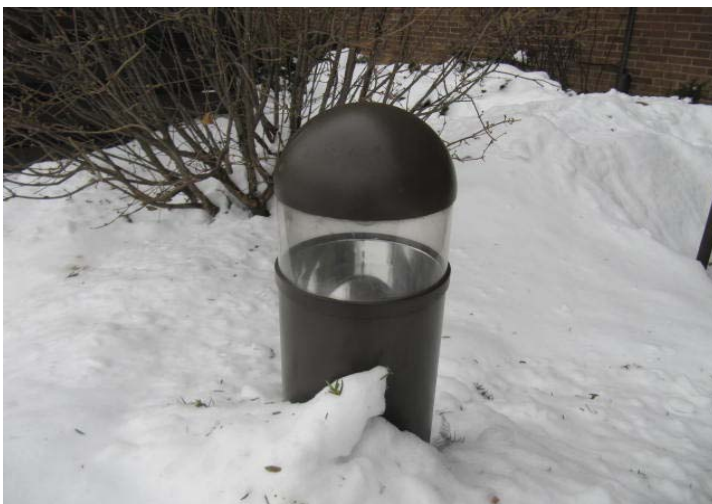
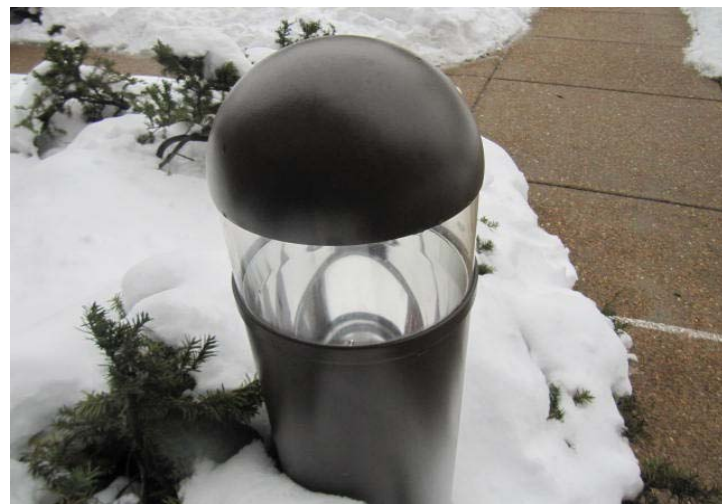
Overview of bollard light fixture.

Bollard light fixture near building entrance.

Typical style and condition at bollard light fixture.

Newer bollard light fixture, in very good condition.

(2) light bollards fixtures are located near the main building entrances. The exact age of the bollard is unknown, but they were recently replaced are in very good condition, with good finishes. Replacement of the bollard light fixtures is recommended between 20 and 25 years of age.

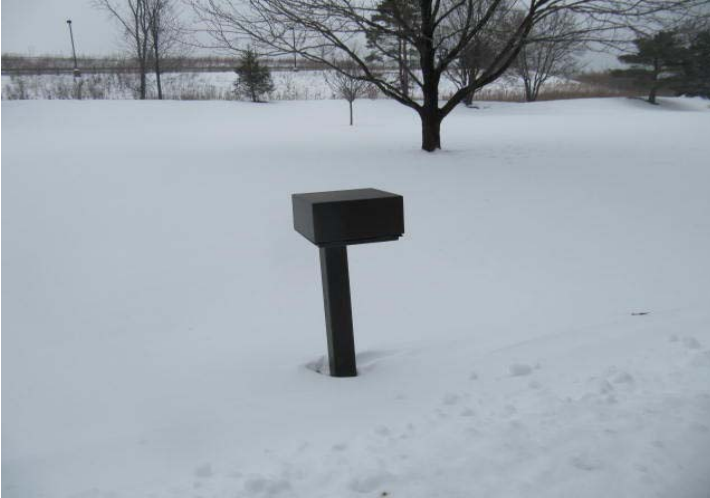
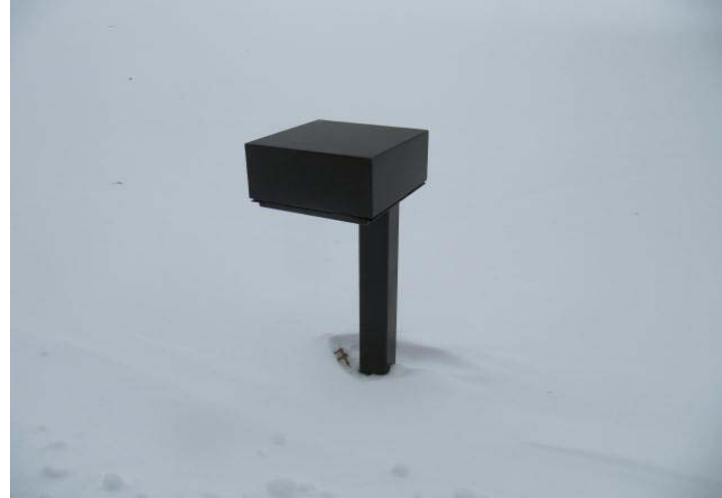
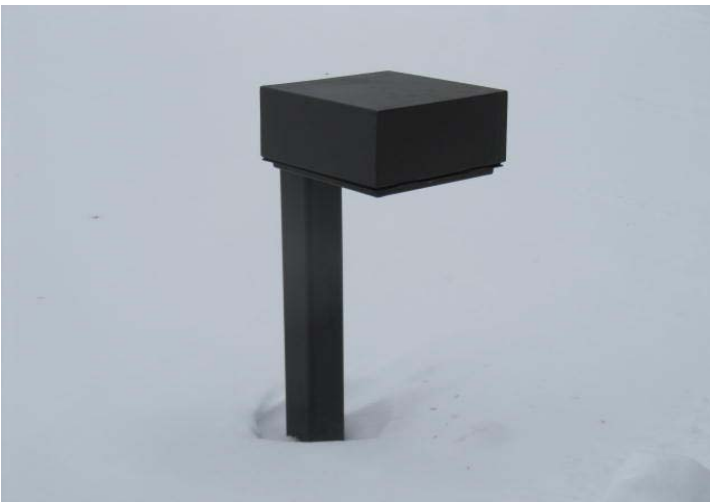
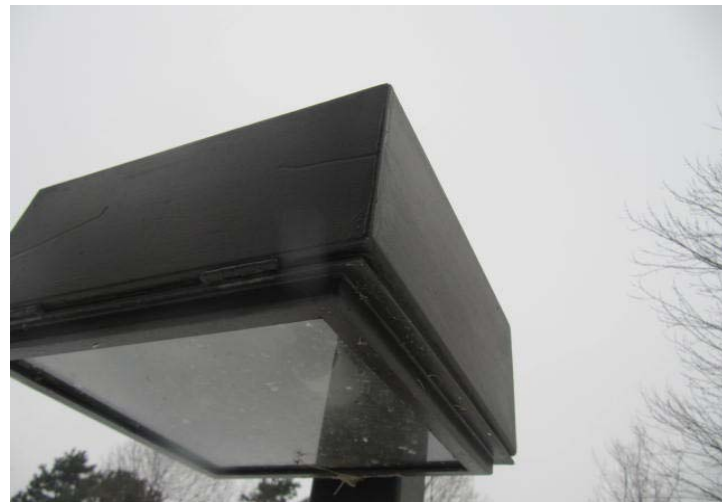
Typical light fixture along fire lane.

Shorter path light along fire lane.

Total quantity includes the shorter path lights located at the rear building facades along the fire lane. The light poles and fixtures are 30 years of age and are in fair overall condition. Replacement of the light poles and fixtures is forecasted within the next 10 years and coincides with the replacement of the light poles and fixtures located at the front parking lots areas.

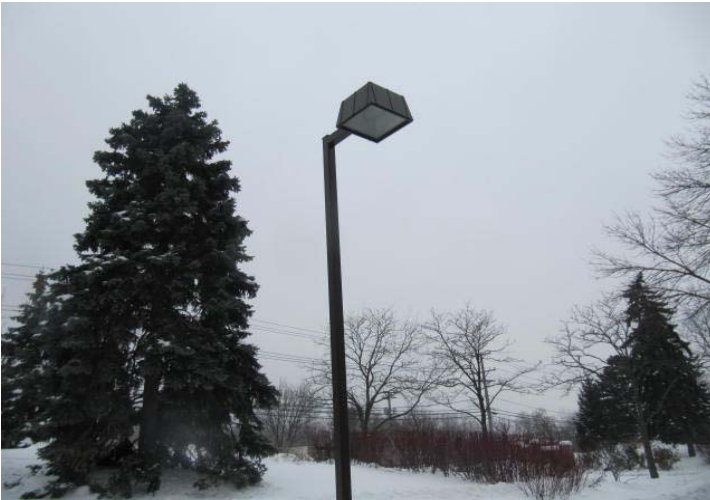
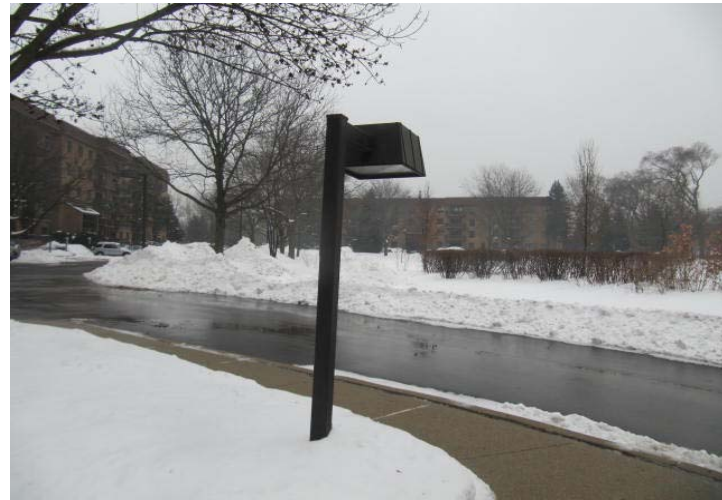
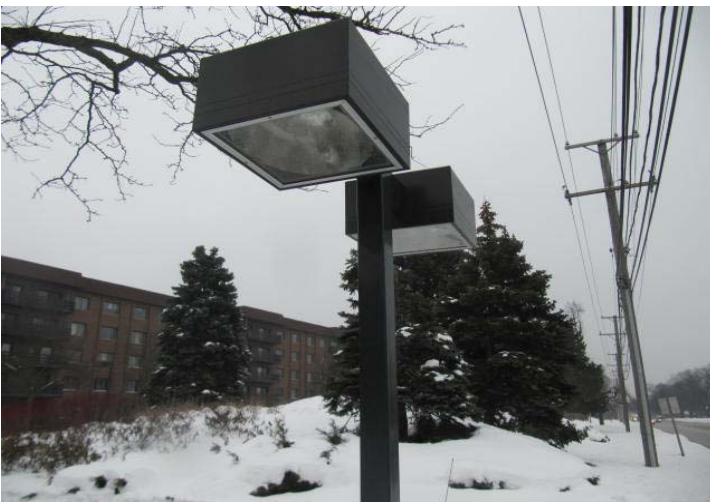
Overall Current Condition:	Fair	
Useful Life in Glenview, IL	30 to 40	Years
Full or Partial Replacement:	Full

Typical single-fixture light pole at parking lot.

Duplex fixture near property entrance.

Special Conditions
Total quantity includes (11) shorter light poles with single fixture, (1) shorter light pole with duplex fixture, (9) tall light poles with single fixture, and (1) tall light pole with duplex fixture. Unit cost is an average cost among all light poles and fixtures. The light poles and fixtures are 30 years of age and are in fair overall condition. Replacement of the light poles and fixtures is forecasted within the next 10 years and coincides with the replacement of the light poles and fixtures located at the front parking lots areas.

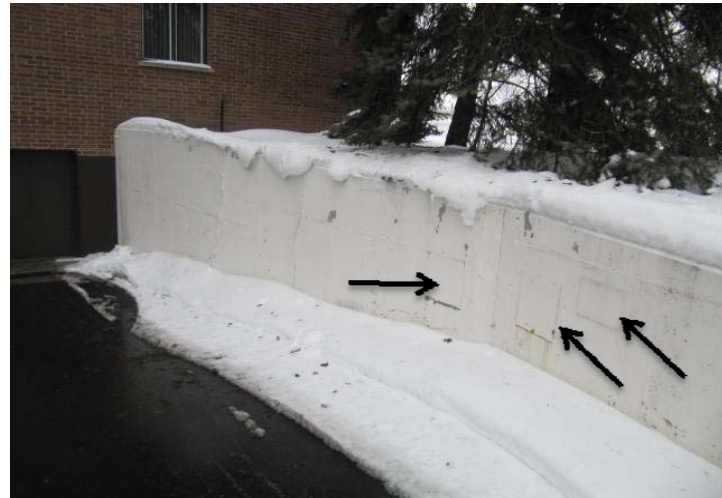
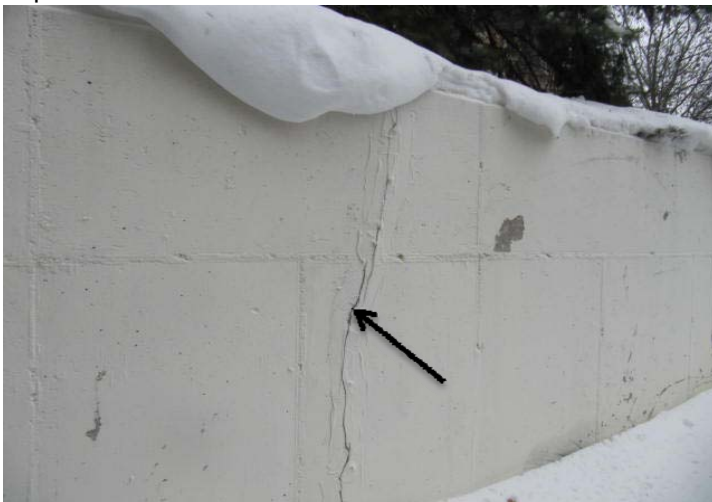
Overall Current Condition:	Fair
Useful Life in Glenview, IL	to 15 Years
Full or Partial Replacement:	Full

Overview of concrete retaining wall, with evidence of past repairs.

Retaining wall along garage entrance drive, with evidence of past repairs.

Crack at concrete retaining walls.

Component includes full inspection of the concrete retaining wall at (1) garage entrance drive, as well as crack repair and capital repairs as needed, every 10 to 15 years. Evidence of past repairs is present, and additional unaddressed cracks were noted. Paint finishes at the concrete walls are considered an operating expense.
