The Valley Lo Towers I Condominium Association

RESERVE STUDY
For
Valley Lo Towers I

Glenview, IL
Date of Inspection
January 10, 2014

BUILDING RESERVES, INC.

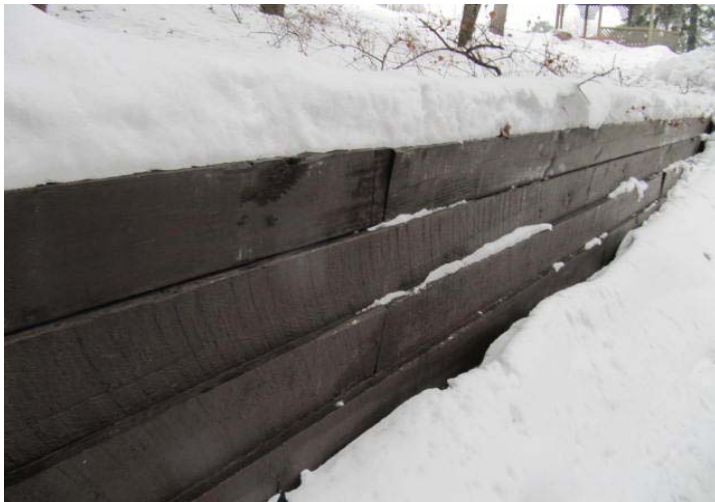
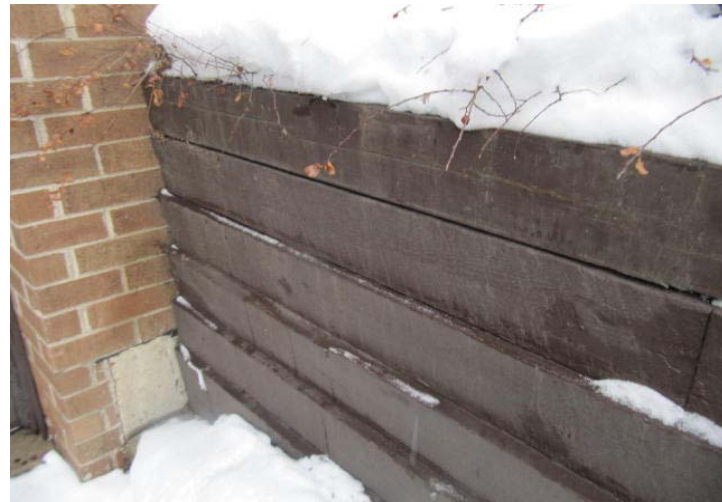
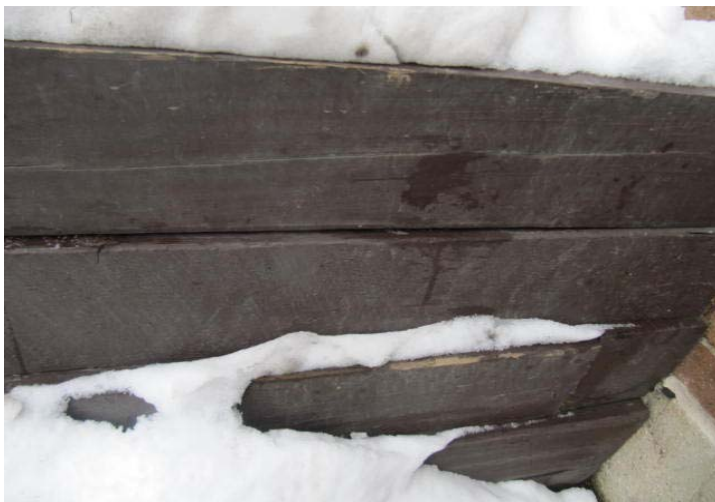
Timber retaining wall along entry drive to garage.

Timber retaining wall near garage entrance.

Typical timber retaining wall, with paint finishes.

Timber retaining walls are located at a portion of the garage entrance drives. Timber walls are in good overall condition at unknown ages. No signs of major wall movement and/or shifting were present. Unit cost includes removal of existing wood timber retaining walls and installation of new segmental masonry unit retaining walls which will provide greatly longevity.

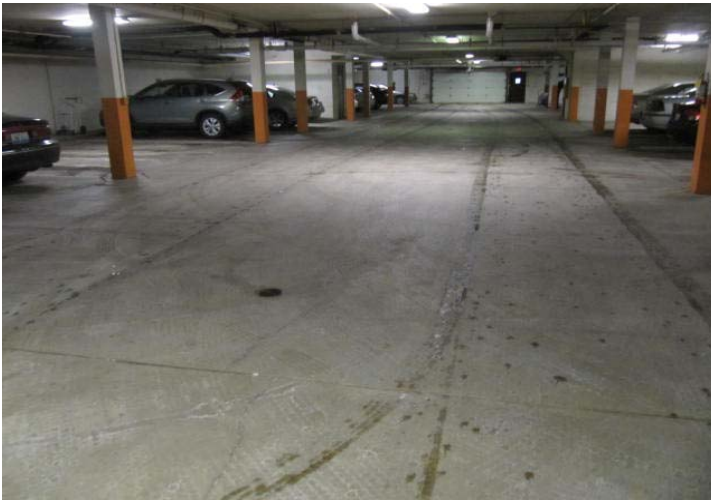
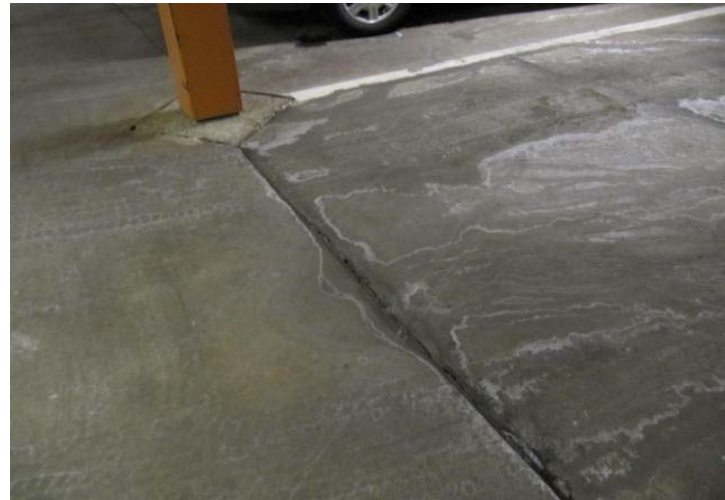
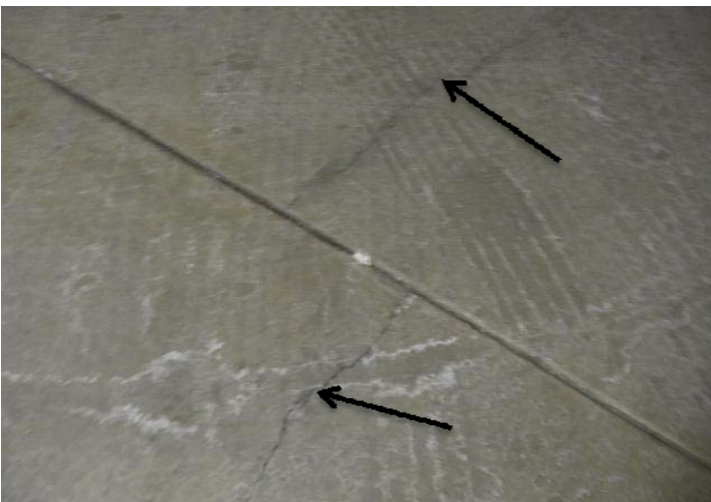
Overall Current Condition:	Fair	
Useful Life in Glenview, IL	to 90	Years
Full or Partial Replacement:	Partial	15.0%

Overview of concrete garage floor.

Control joint between parking bay and drive aisle.

Hairline cracks at concrete garage floor.

Component includes the phased partial replacement of the on-grade concrete floors at the underground parking garages. A phased 15.0% of all concrete is phased within the next 30 years. Concrete floors are in fair overall condition, with hairline cracks at various locations and isolated conditions of pitted concrete near garage doors. Phased replacements are anticipated, beginning in 2029.

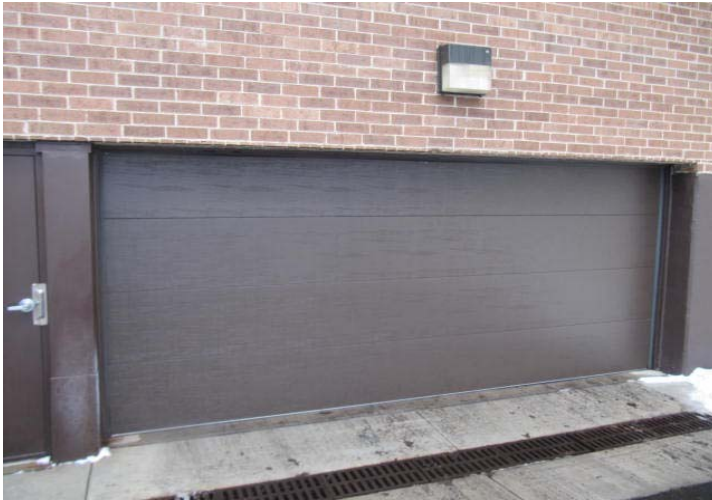
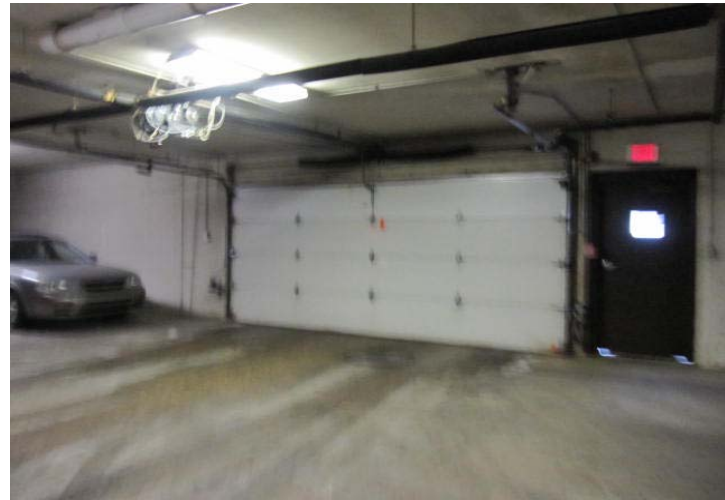
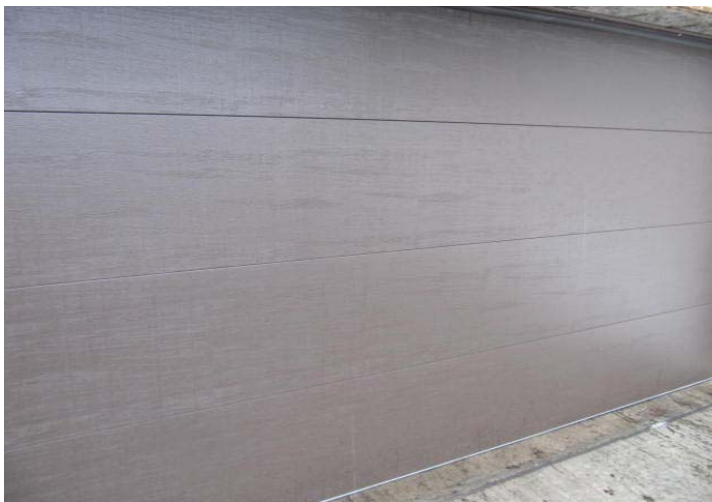
Overview of metal sectional garage door.

Interior view of garage door.

Exterior door finishes are in good condition.

Insulated, sectional door with springs, coils, and track.

Garage doors vary in age and condition, and a phased replacement is forecasted so that all garage doors are replaced within a 15-year period. Unit cost includes a metal sectional commercial-grade garage door with springs, tracks, and all hardware. Phased door replacement coincides with the phased replacement of the garage door operators. Phased replacement are anticipated, beginning in 2021.

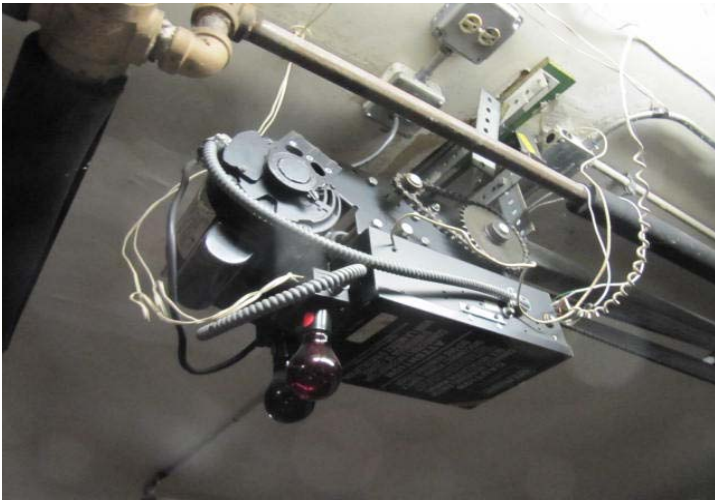
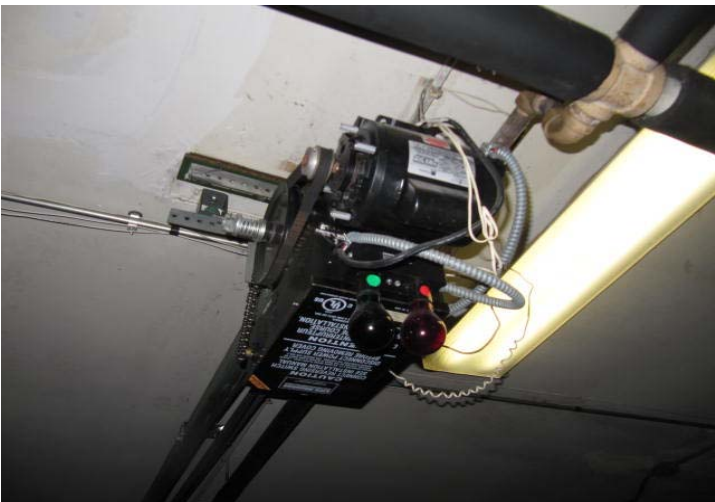
Garage door operator.

Lift Master garage door operator.

Garage door operator, with red/green lights.

Garage door operators vary in age and condition, and a phased replacement is forecasted so that all operators are replaced within a 15-year period. Unit cost includes a commercial-grade garage door operator with electric motor, rated for 0.5-0.75 Horsepower. Phased replacement are anticipated, beginning in 2021.

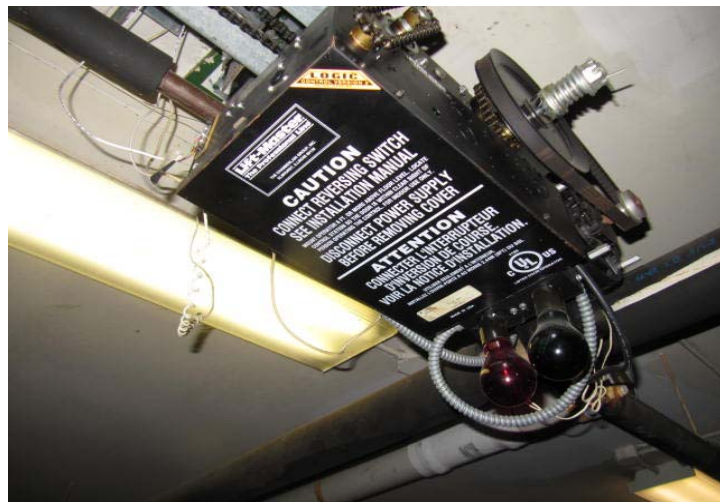
Garage door operator, with red/green lights.

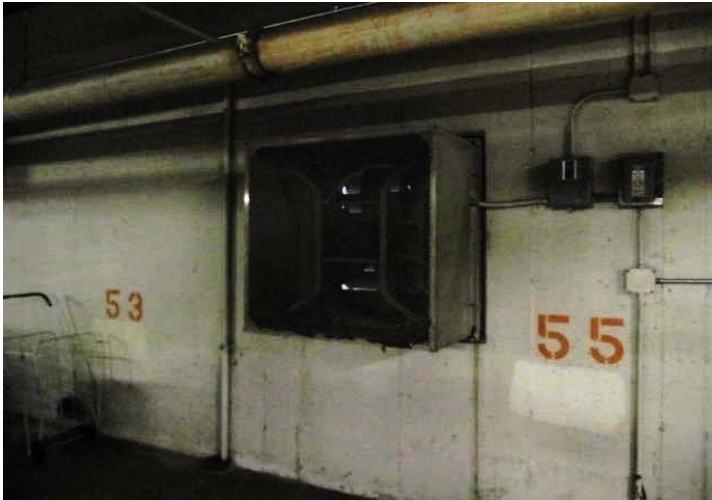
Overview of garage exhaust fan.

Special Conditions
<p>Component includes the replacement of the exhaust fans at the underground parking garages. Original garage exhaust fans are in functional condition at 30 years of age. Replacement of the exhaust fans is recommended within the next 10 years to maintain good air quality within the parking garages.</p>

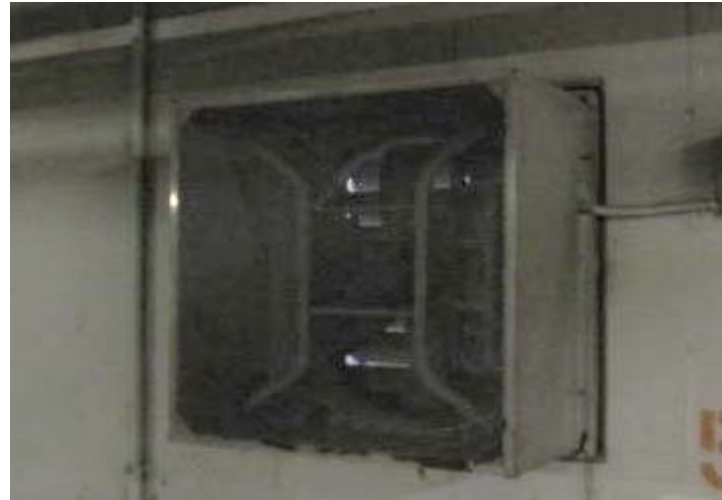
Typical sidewall garage exhaust fan.

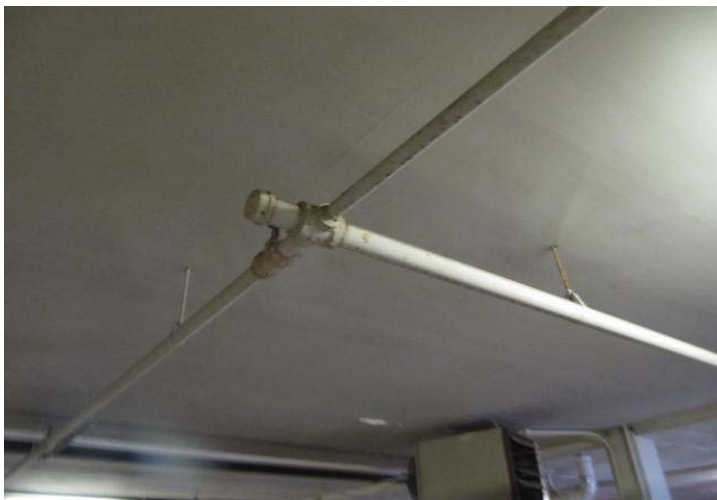
Overview of piping for fire suppression system.

Component includes the replacement of the fire suppression system serving the parking garages. The original fire suppression systems are in functional condition at 30 years of age. Replacement of the fire suppression systems is forecasted at the end of the typical useful life, in 2044.

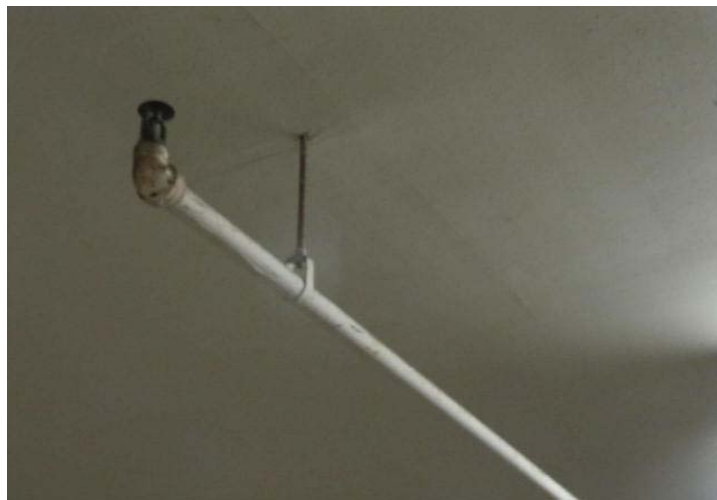
Sprinkler system piping and sprinkler head.

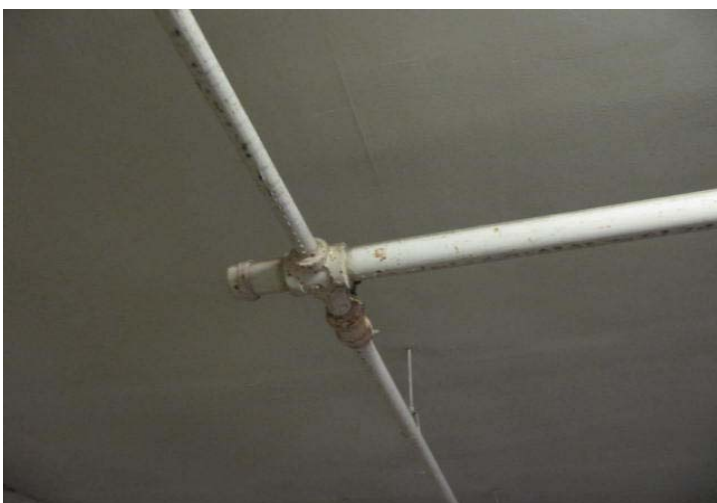
T-section at fire suppression system piping.

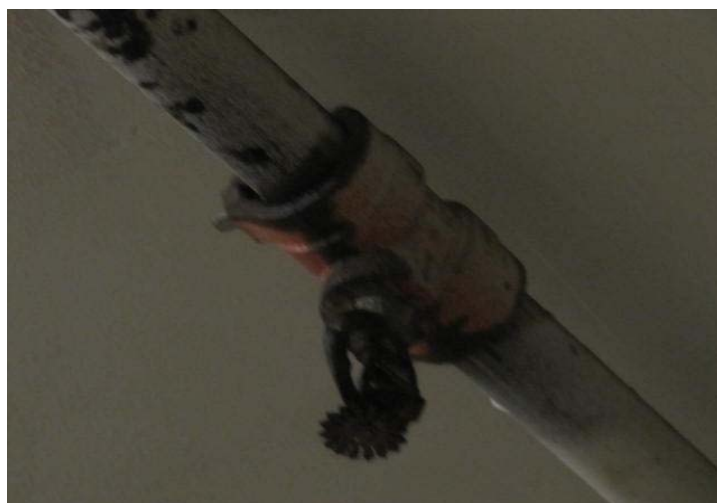
Typical fire sprinkler head.

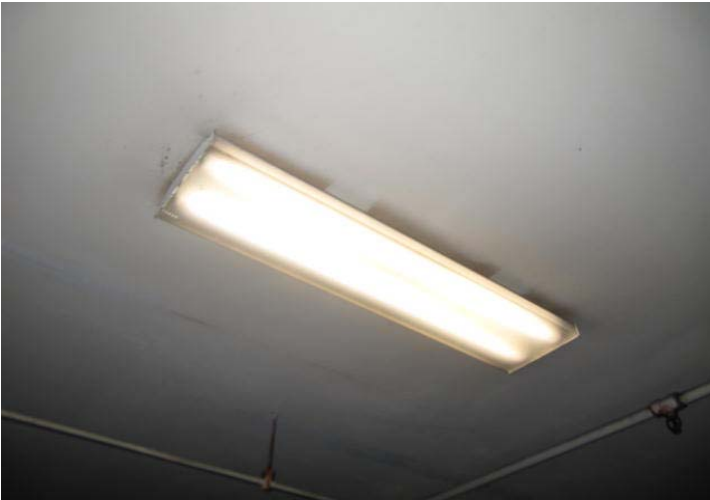
Typical fluorescent light fixture at parking garage.

Component includes the replacement of the light fixtures at the underground parking garages. The age of the garage light fixtures is unknown, but the fixtures are in functional condition. Replacement is forecasted for 2028. Replacement of the garage light fixtures coincides with the replacement of the interior light fixtures at the building stairwells.

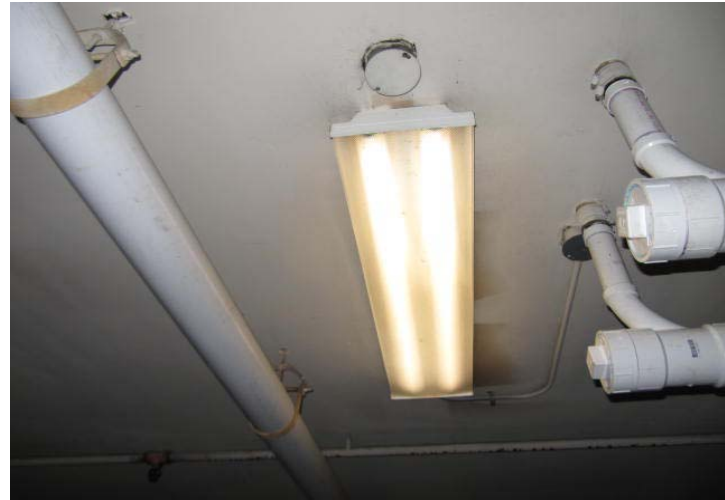
Typical fluorescent light fixture at parking garage.

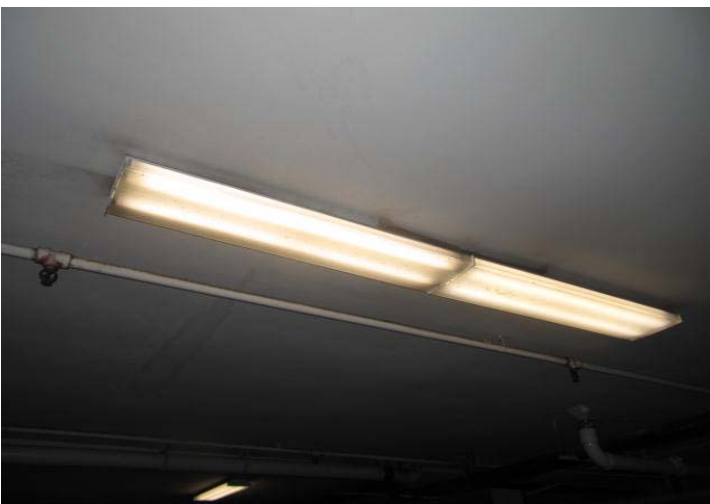
(2) light fixtures back-to-back

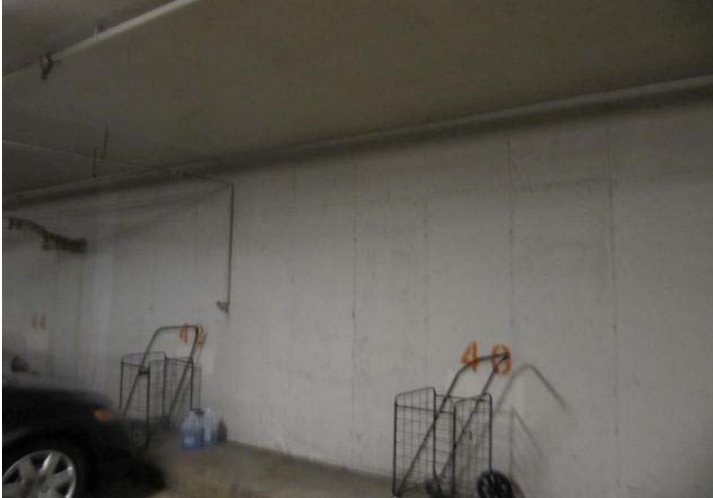
Overview of painted wall at parking garage.

Special Conditions
Total quantity includes all painted surfaces at the underground parking garage, including the following: painted perimeter walls, painted structural columns, interior faces of solid doors, and ceiling surfaces (including painted pipes). Garage paint finishes are in fair overall condition at an unknown age. Paint finishes are forecasted for 2023, and again 20 years thereafter.

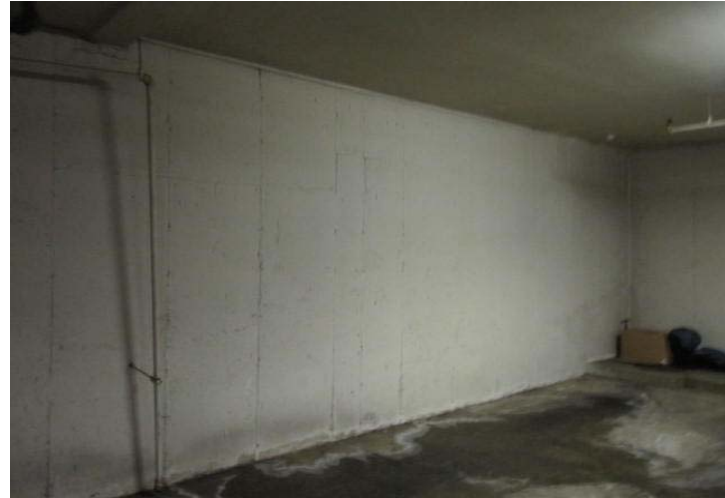
Overview of painted wall at parking garage.

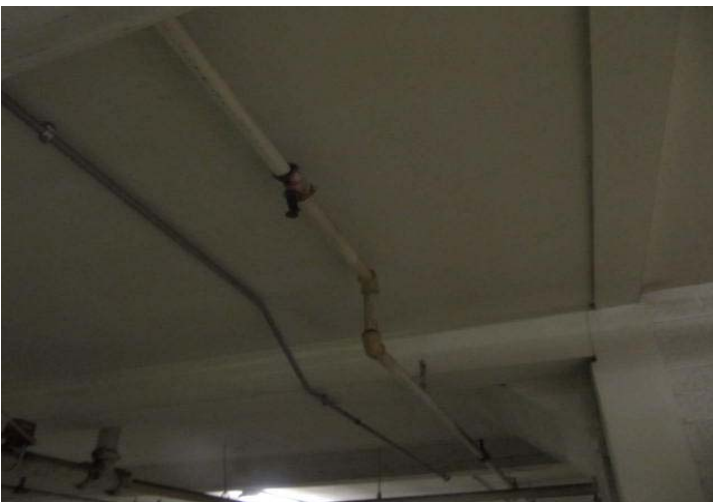
Painted ceiling surfaces at parking garage.

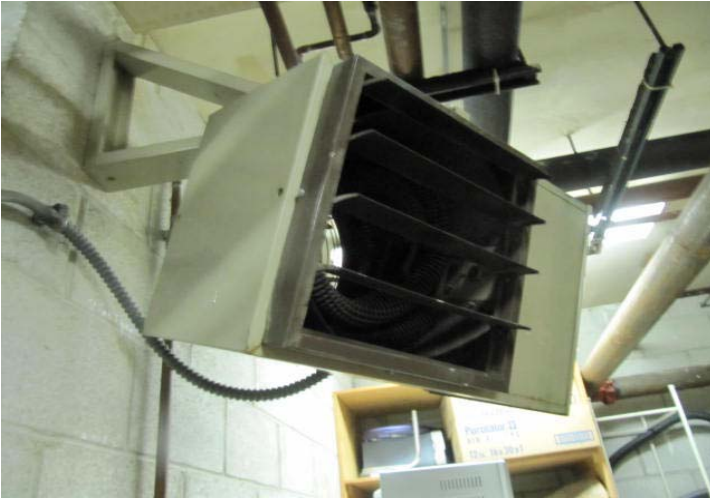
Electric unit heater at mechanical room.

Total quantity includes all electric unit heaters located at the underground parking garages and the (2) mechanical rooms at the lower levels. Unit heaters are 3-Phase, 460-Volt, electric high output heaters. Units range in age as they have been replaced as needed in past years. Continued phased replacement of the garage unit heaters is forecasted.

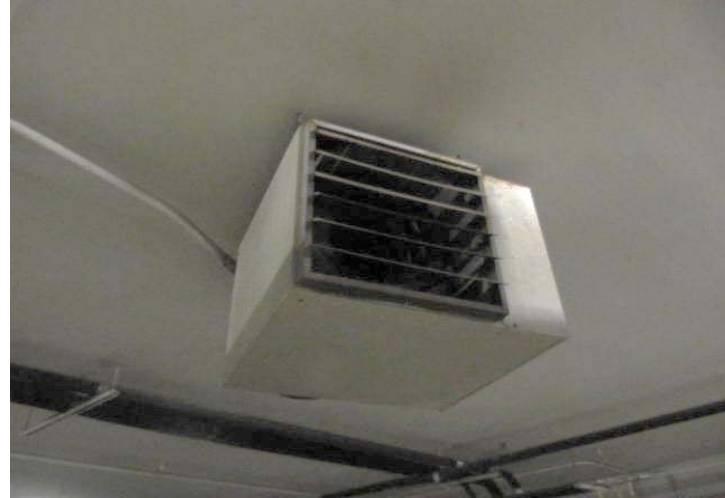
Electric unit heater at parking garage.

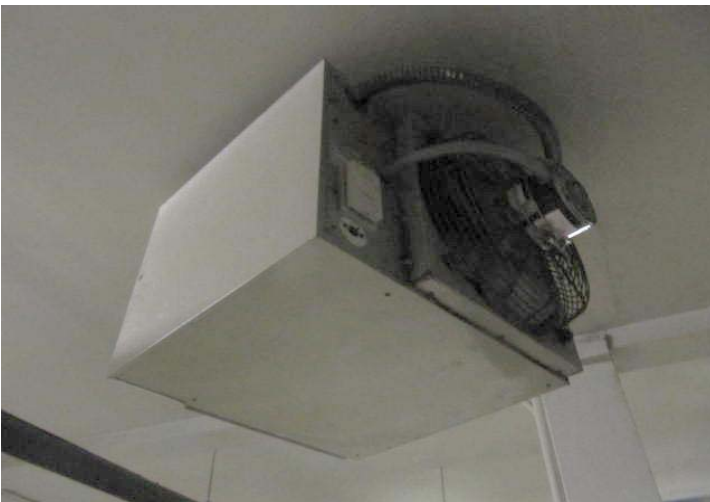
Electric unit heater at parking garage.
