# RESERVE STUDY

## Valley Lo Towers I Condominium Association

**Glenview, Illinois**

**June 12, 2019**

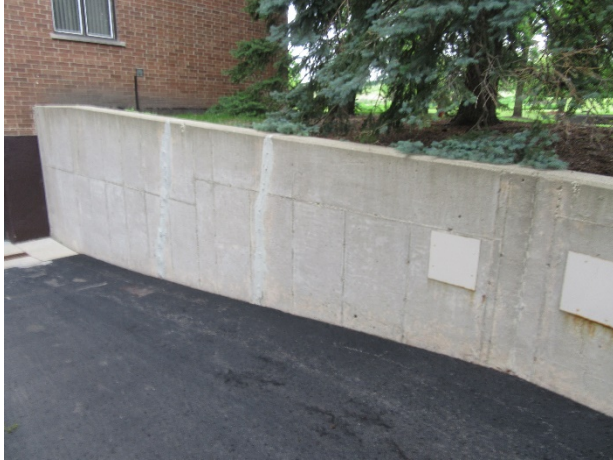
**Concrete retaining wall at east end of 2000 building**

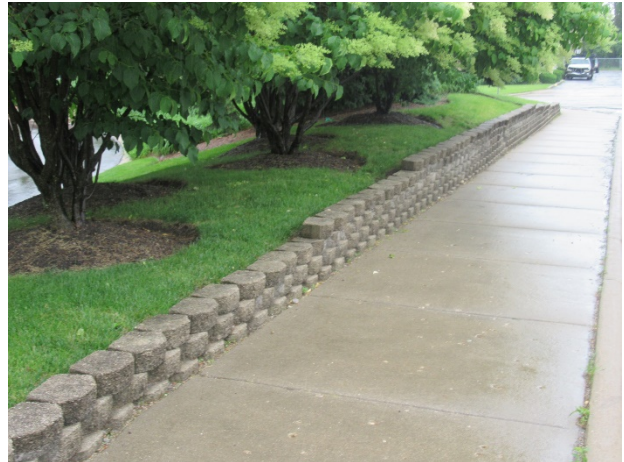
**Masonry retaining wall at west end of property**

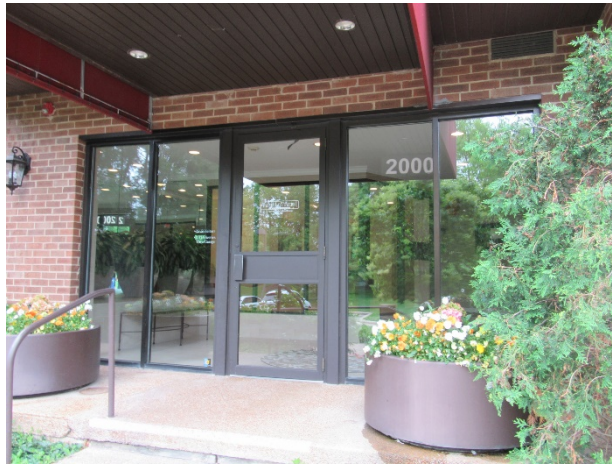
**Condition:** Good overall with no significant deterioration evident or reported operational issues

**Entrance door and windows**

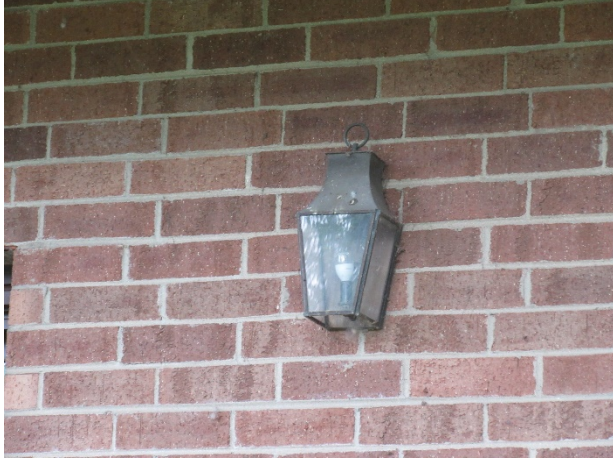
**Condition:** Satisfactory overall with isolated finish deterioration evident

**Typical light fixture**

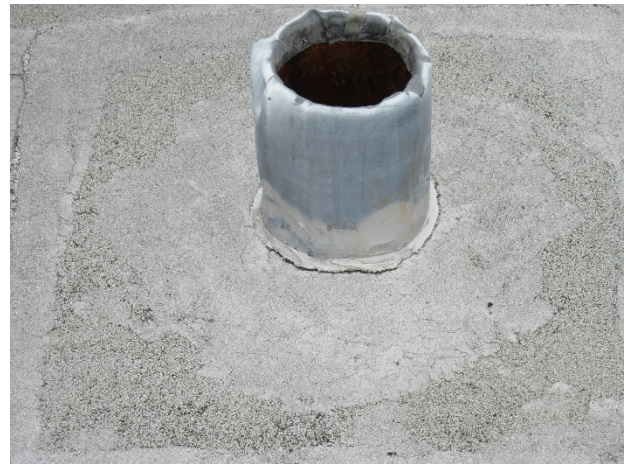
**Condition:** Good to fair overall with isolated membrane deflection, gaps at penetration sealant, water accumulation and granular loss at the roof access point evident. Management and the Board report proper drainage and a limited history of leaks. A recent leak was attributed to the supports for the air conditioning units.

**Gap at penetration sealant**

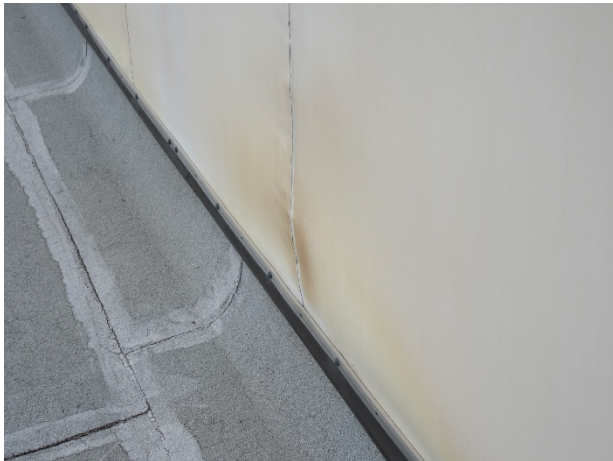
**Membrane deflection at parapet wall**

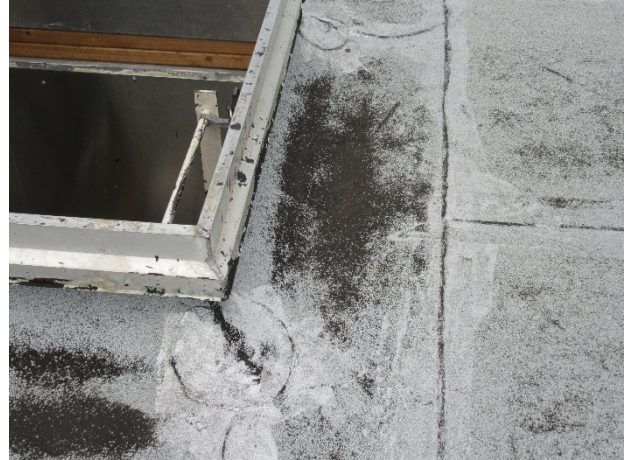
**Granular loss near roof access**

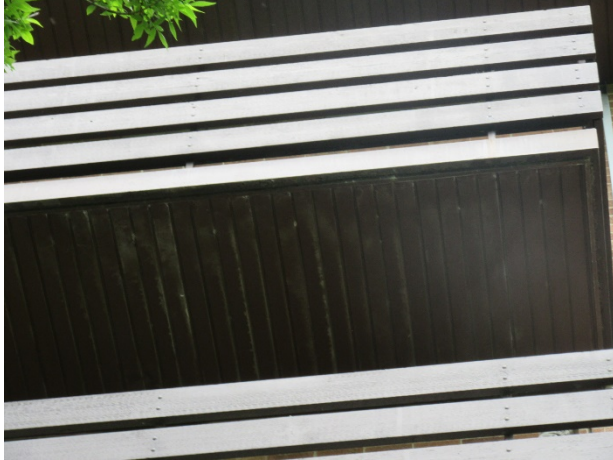
**Condition:** Vary in condition from good to poor. We note systematic evidence of water infiltration from the concrete balconies and discoloration and deterioration of the soffits.

**Evidence of water infiltration**

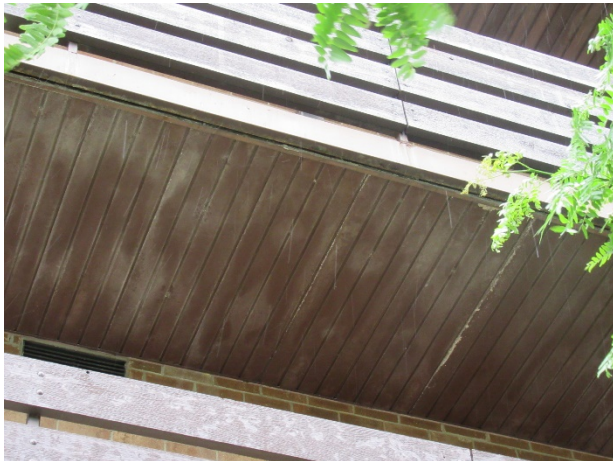
**Evidence of water infiltration**

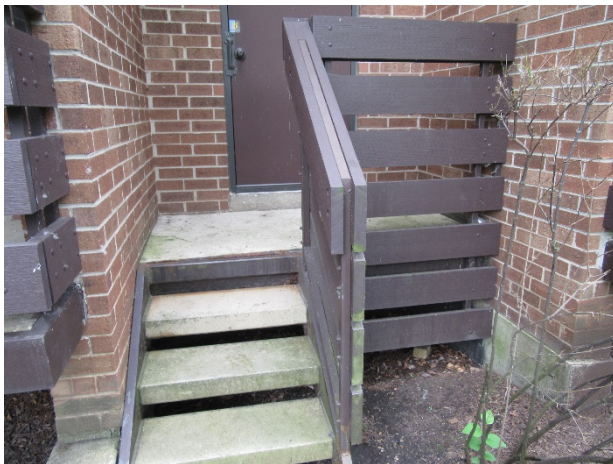
**Metal pan staircase and landing**

- Paint finish applications to the balcony railings and siding to limit deterioration and maintain a uniformly clean and consistent appearance of the buildings
- Partial sealant replacement in conjunction with paint finish applications to limit water infiltration
- Application of a waterproof coating at the balconies due to noted water infiltration
- Partial replacement of metal pan staircases due to noted deterioration

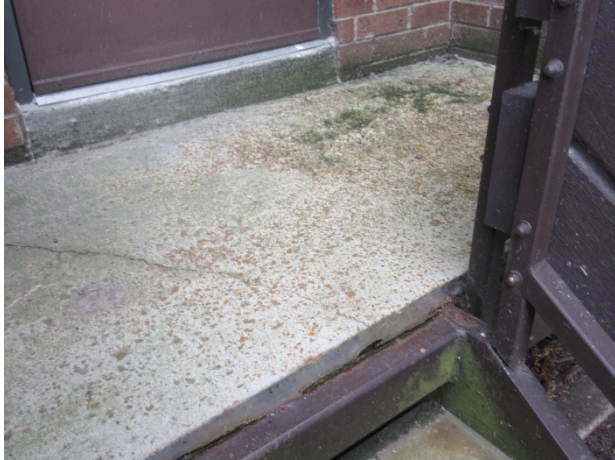
**Concrete crack and spall**

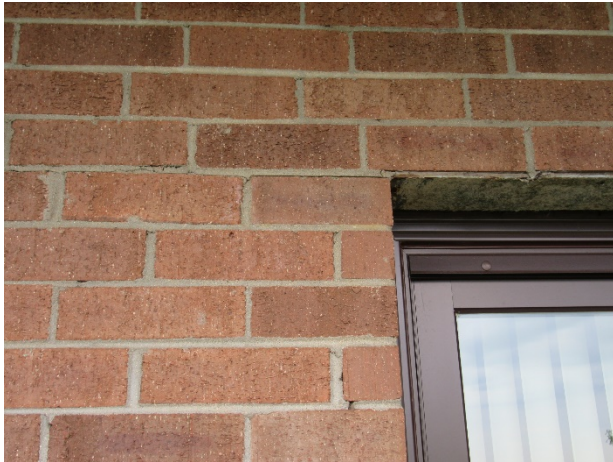
- Minimal previous repairs evident
- Efflorescence is visible but isolated to below balconies
- Lintel paint finish in good condition with isolated finish deterioration
- Isolated masonry cracks and delamination evident
- Mortar deterioration is isolated
- Mortar joints are tooled
- Weeps at lintels are visible

**Mortar crack at lintel**

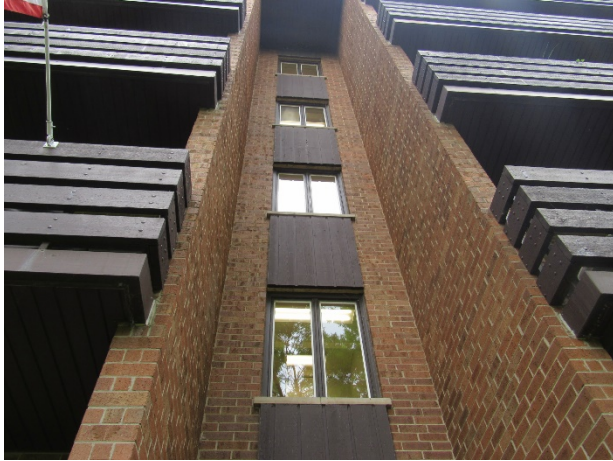
**Condition:** Fair overall with isolated frame deterioration evident

**Common windows at private stairwells**

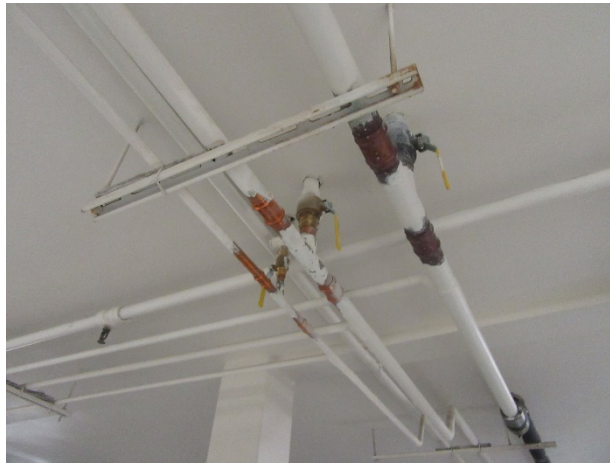
**Domestic water pipes**

- Domestic Water, Supply and Return – Original and reported in satisfactory condition

- Sanitary Waste Disposal and Vent – Original and reported in satisfactory condition with the exception of drainage pipes in the garage which were recently replaced with PVC

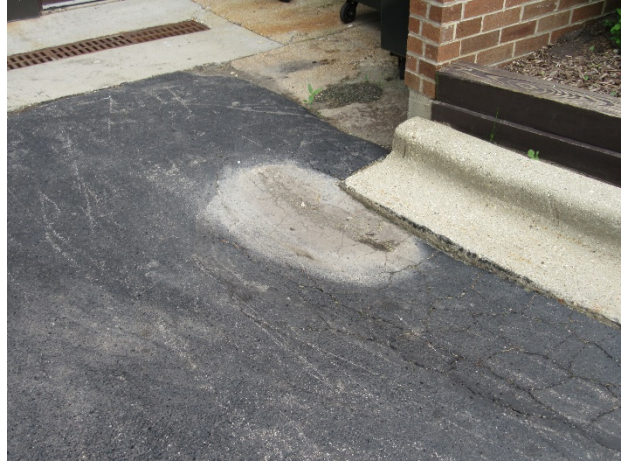
**Condition:** Good to fair overall with areas of alligator cracking, settlement and longitudinal cracks evident

**Settlement near west garage of the 2020 building**

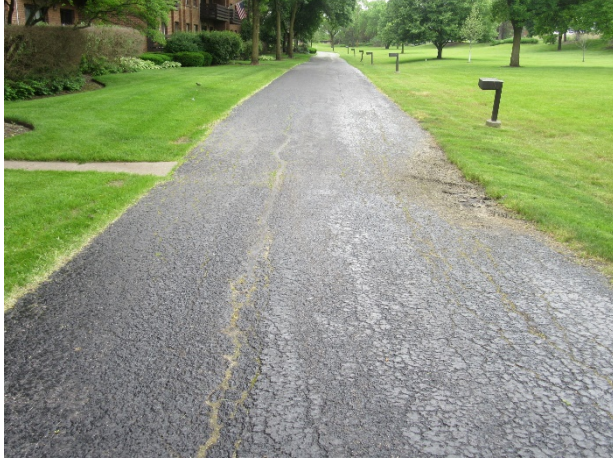
**Fire lane overview (note significant cracking)**

is overlaid atop the remaining base course of pavement. Total replacement includes the removal of all existing asphalt down to the base course of aggregate and native soil followed by the application of two or more new lifts of asphalt. We recommend mill and overlayment on asphalt pavement that exhibits normal deterioration and wear. We recommend total replacement of asphalt pavement that exhibits severe deterioration, inadequate drainage, pavement that has been overlaid multiple times in the past or where the configuration makes overlayment not possible. Based on the apparent visual condition and configuration of the asphalt pavement, we recommend the mill and overlay method for initial repaving of the access drive and parking areas and the total replacement method for fire lane repaving and subsequent access drive and parking area repaving at Valley Lo Towers I.

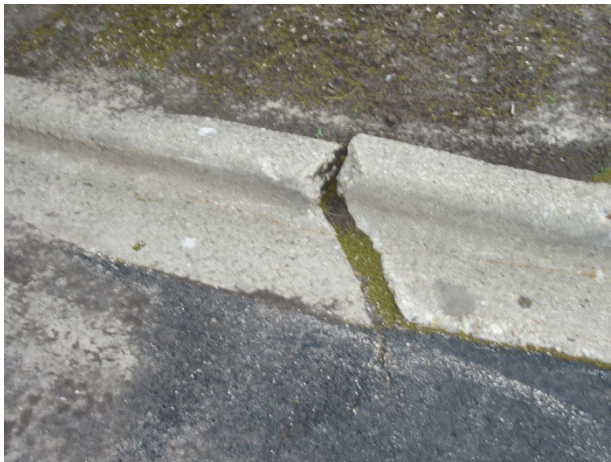
**Condition:** Good to fair overall with periodic cracks and settlement evident

**Curb crack and settlement**

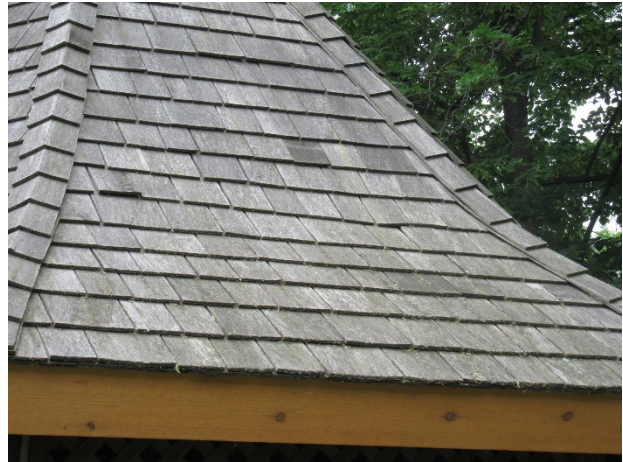
**Condition:** Fair overall with shingle lift and split, and deck board deterioration evident

**Shingle lift and split**

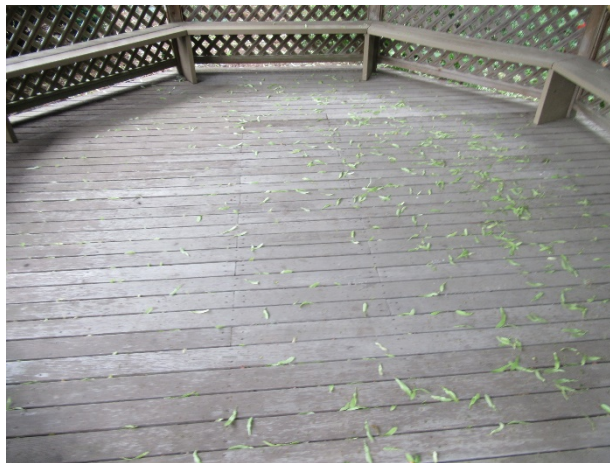
**Deck board overview**

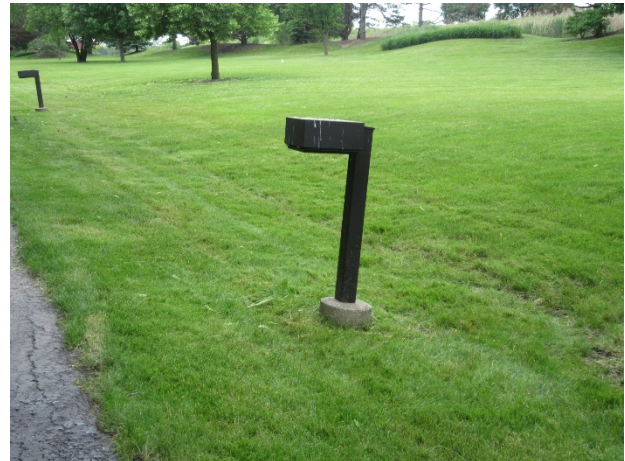
**Light pole lean**

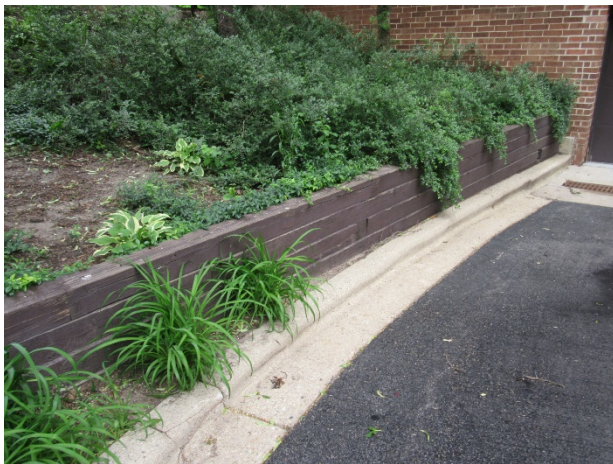
Retaining wall overview

**Condition:** Fair overall with wall lean, paint finish deterioration and wood deterioration evident

**Component Detail Notes:** We advise Valley Lo Towers I replace with a modular, interlocking dry-set masonry retaining wall system. The cost of dry-set masonry retaining walls is similar to the cost of timber walls. However, dry-set masonry retaining walls offer a longer useful life of up to 35 years and lower total maintenance costs. The following schematic depicts the typical components of a retaining wall system although it may not reflect the actual configuration at Valley Lo Towers I:

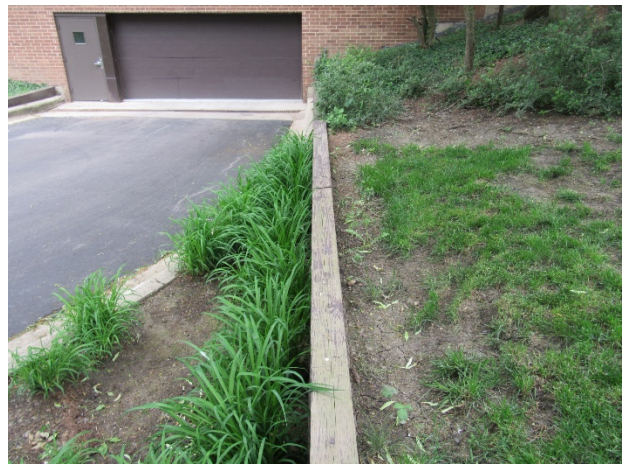
Slight wall lean

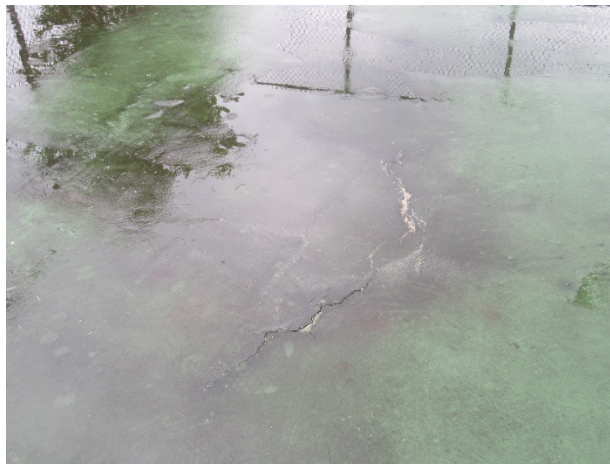
**Condition:** Fair to poor overall with discoloration and cracks evident

Discoloration and court crack

**Component Detail Notes:** Prior to the application of the color coat, the Association should require the contractor to rout and fill all cracks with hot emulsion. This deters water infiltration and further deterioration of the asphalt playing surface.

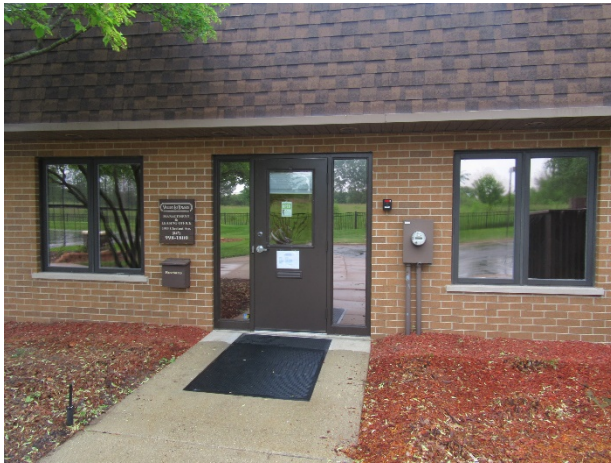
**Condition:** Fair overall condition with missing sealant and frame deterioration evident

**Windows and door**
