The Valley Lo Towers I Condominium Association

RESERVE STUDY
For
Valley Lo Towers I

Glenview, IL
Date of Inspection
January 10, 2014

BUILDING RESERVES, INC.

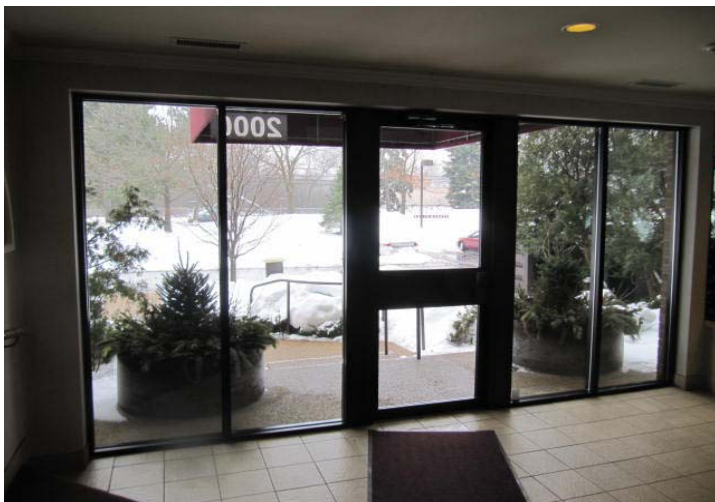
Swing style entry door with adjacent glazing.

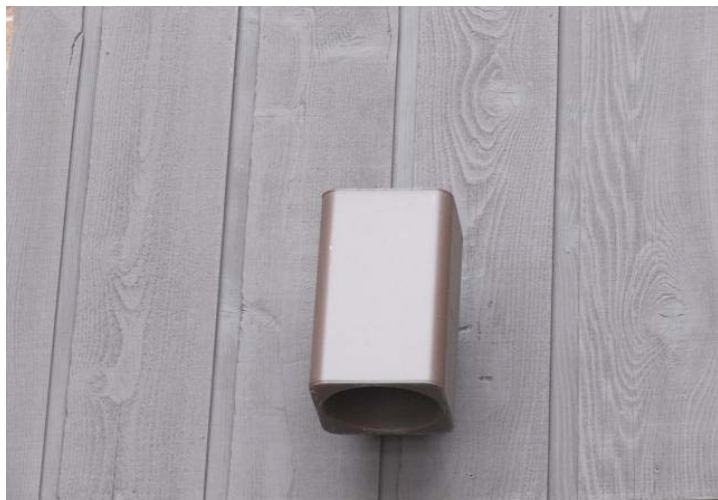
Exterior wall sconce above private stairwell door.

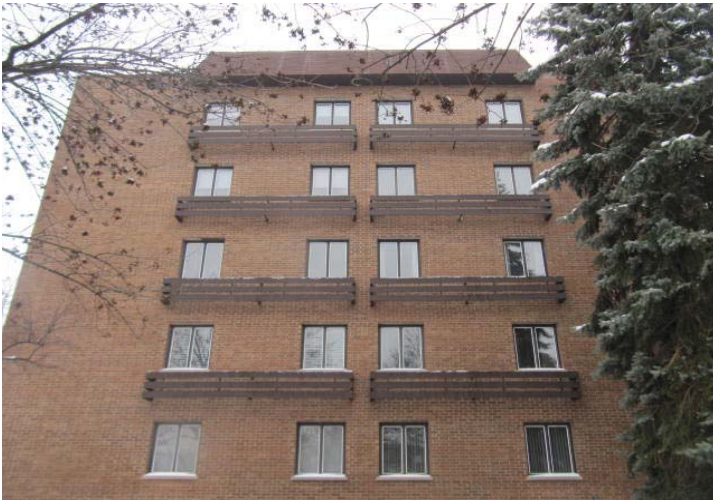
Common "railings" at end building façade.

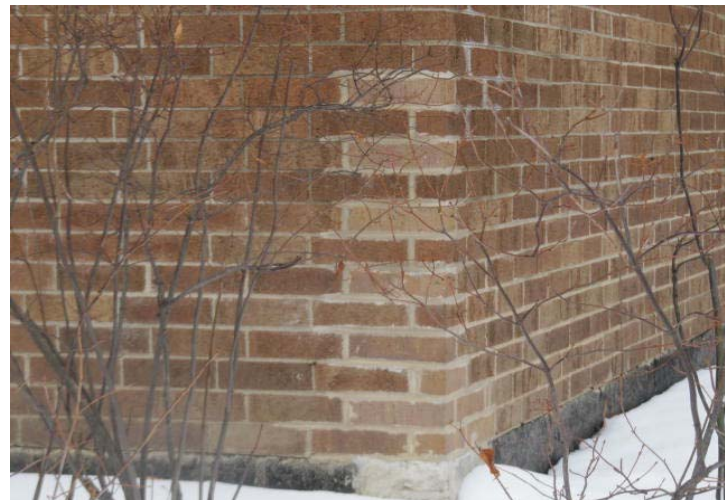
Evidence of past repointing at masonry mortar joints.

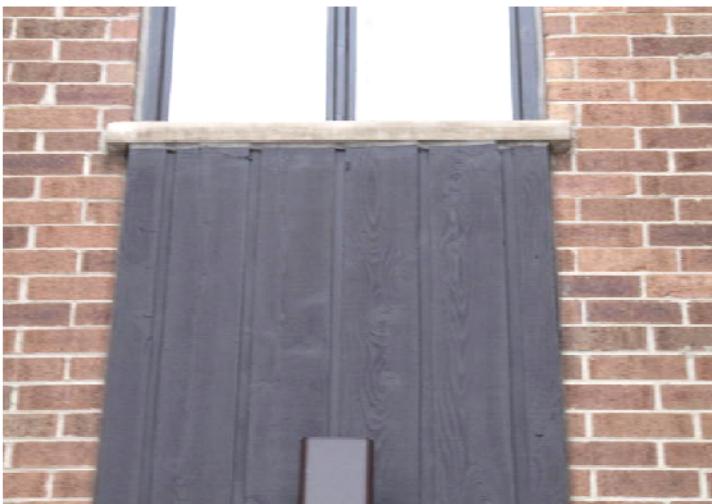
Wood siding with paint finishes.

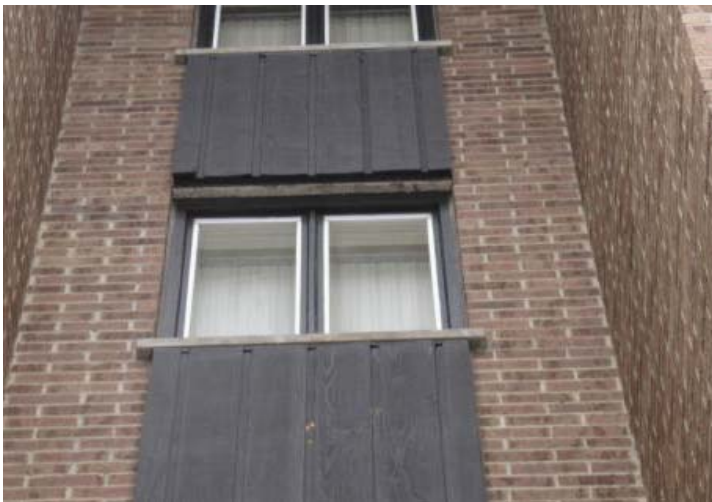
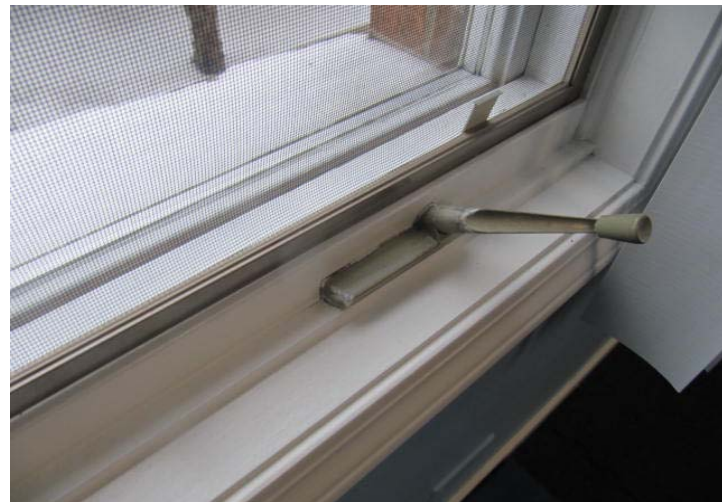
Interior view of window at exercise room.

Interior view of wood casing at common window.

Common window at private stairwell.

Casement window with turn-crank.

Special Conditions
Total quantity includes the following: windows at the exercise room, windows at the meeting room, and windows at interior private stairwells. Original wood clad windows are in fair overall condition at 30 years of age. Replacement of the common-area windows is forecasted for 2027 to coincide with the replacement of exterior sealants and masonry repairs. All windows and glass patio doors at homeowner units are the financial responsibility of individual homeowners.

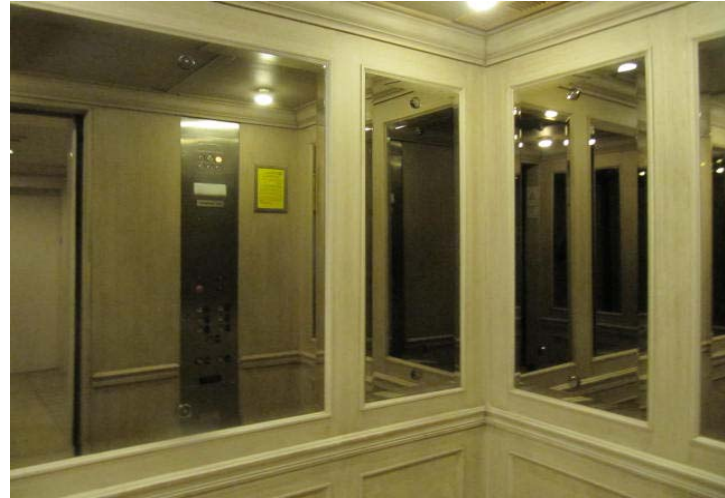
Overview of elevator cab interior.

Mirrored walls with wood trim.

Wood ceiling at elevator cab interior.

Tiled floor and wood wall panels at elevator cab interior.

Component includes renovations at the buildings' (4) elevator cabs. Existing finishes include wood wall panels with inset mirrors, wood ceiling panels with ceiling lighting, and ceramic tile at cab floors. The existing cab finishes are in fair overall condition, with worn wood finishes noted at several locations. Extensive renovations at existing cab finishes or replacement of cab finishes are forecasted within the next 10 to 15 years. Renovations in 2026 coincide with carpet and tile replacement, as well as interior paint finishes.

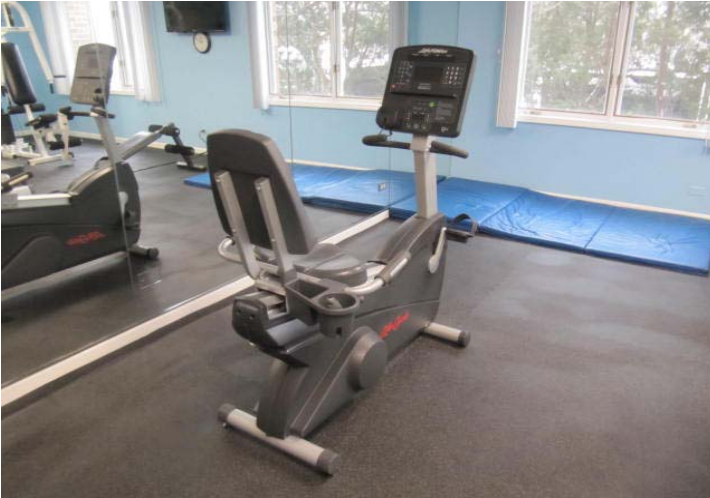
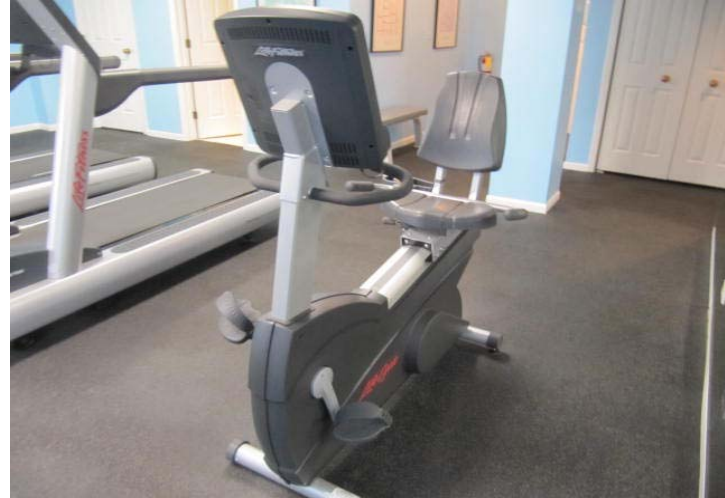
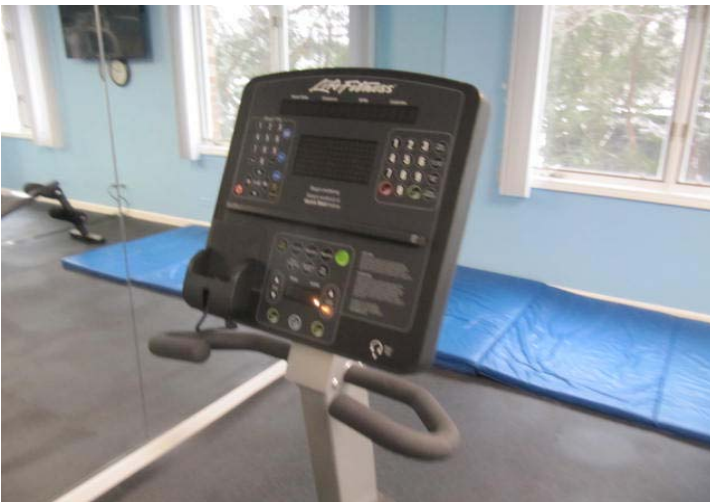
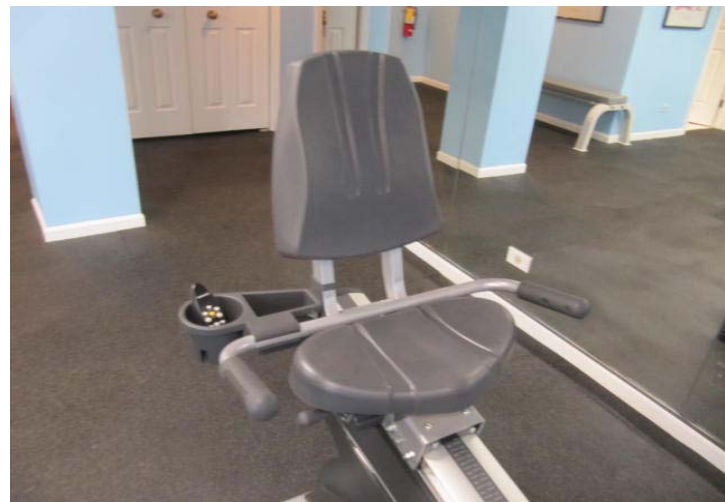
Overview of recumbent bike at exercise room.

Exercise bike, purchased in 2013.

Control panel at exercise bike.

Seat at exercise bike.

Special Conditions
Component includes the replacement of (1) recumbent exercise bike at the exercise room. The exercise equipment was purchased in 2013 and is currently in very good condition. Future equipment replacement is forecasted every 10 years, beginning in 2024. Replacement coincides with the replacement of the remainder of cardio exercise equipment.

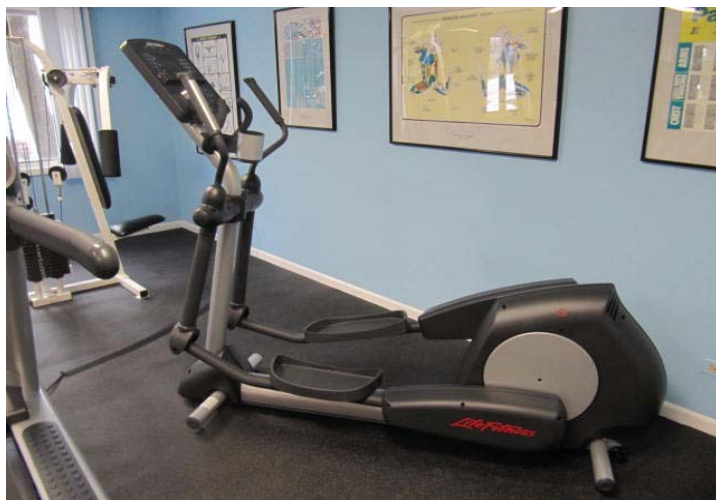
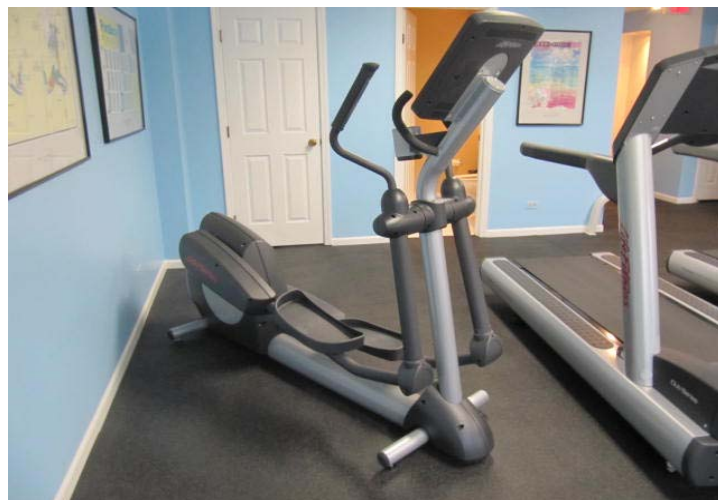
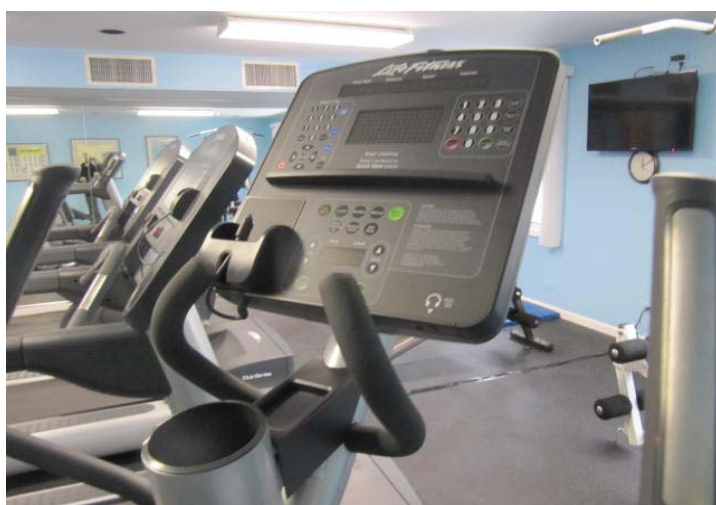
Overview of elliptical machine at exercise room.

Elliptical machines, purchased in 2013.

Control panel at elliptical machine.

Base of elliptical machine, at exercise room.

Special Conditions
Component includes the replacement of (1) elliptical machine at the exercise room. The exercise equipment was purchased in 2013 and is currently in very good condition. Future equipment replacement is forecasted every 10 years, beginning in 2024. Replacement coincides with the replacement of the remainder of cardio exercise equipment.

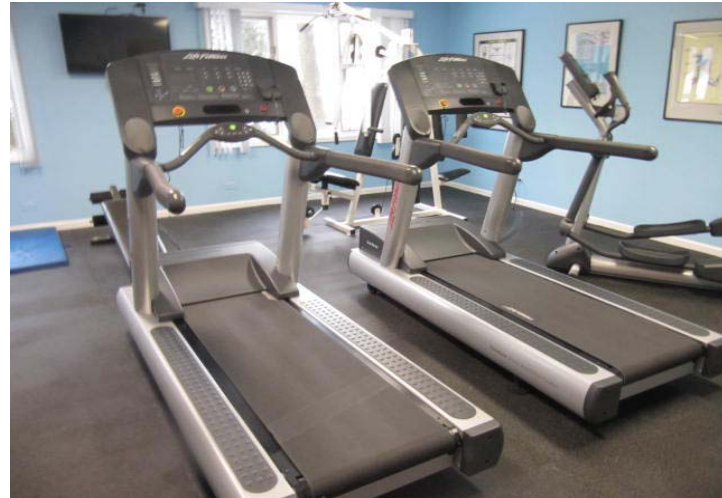
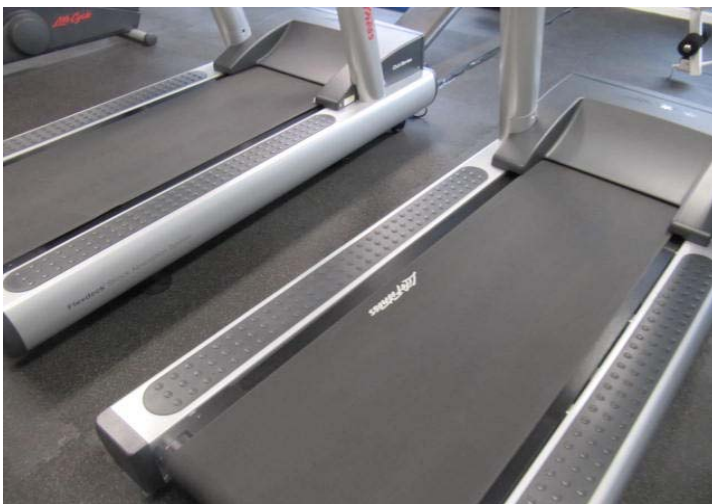
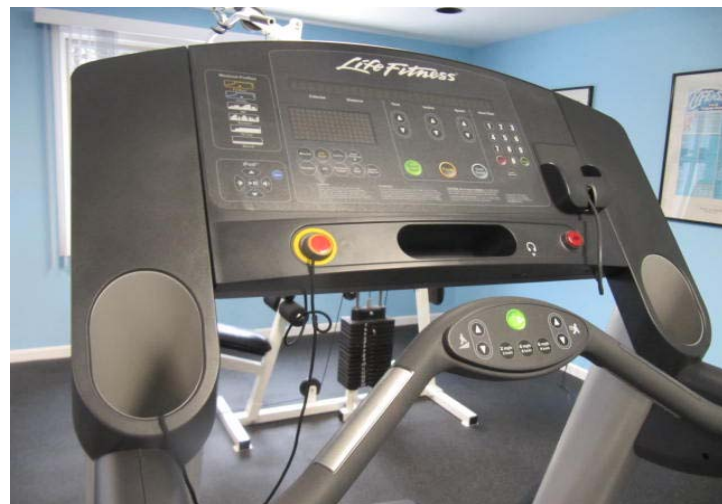
Overview of treadmills at exercise room.

Treadmills, purchased in 2013.

Running surface at treadmill.

Control panel at treadmill.

Special Conditions
Component includes the replacement of (2) treadmills at the exercise room. The exercise equipment was purchased in 2013 and is currently in very good condition. Future equipment replacement is forecasted every 10 years, beginning in 2024. Replacement coincides with the replacement of the remainder of cardio exercise equipment.

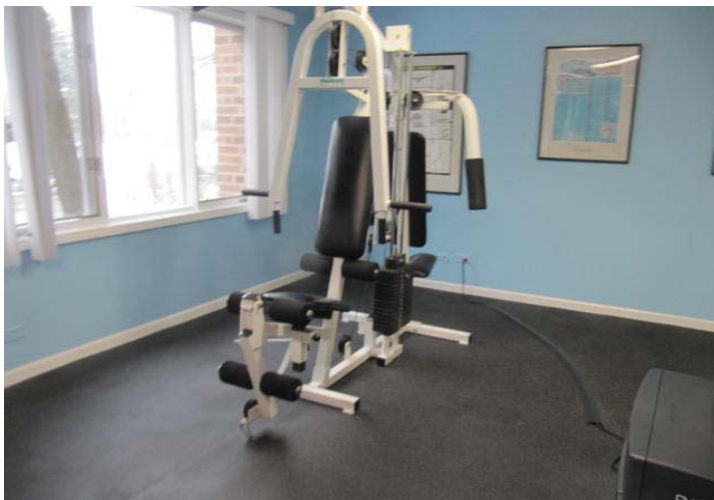
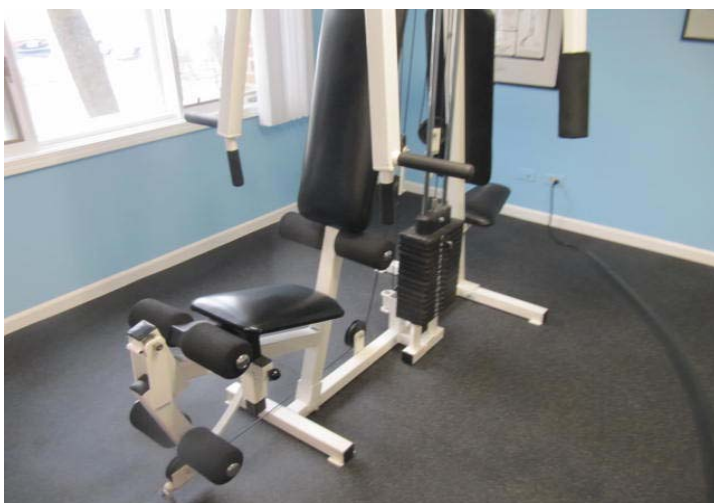
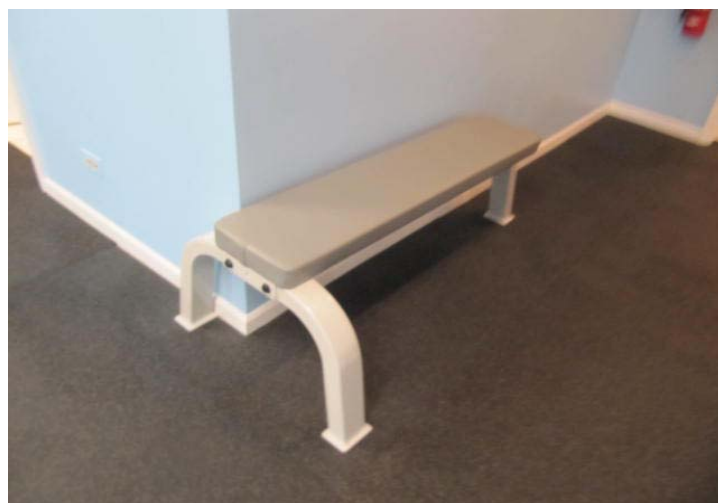
Overview of strength-training equipment

Hoists and pulleys at strength-training machine.

Upholstered seats at base of strength-training machine.

Upholstered weight bench.

Strength-training equipment allowance includes the following: (1) strength-training station and (2) upholstered weight benches. The exercise equipment was purchased in 2013 and is currently in very good condition. Future equipment replacement is forecasted every 12 years, beginning in 2026.

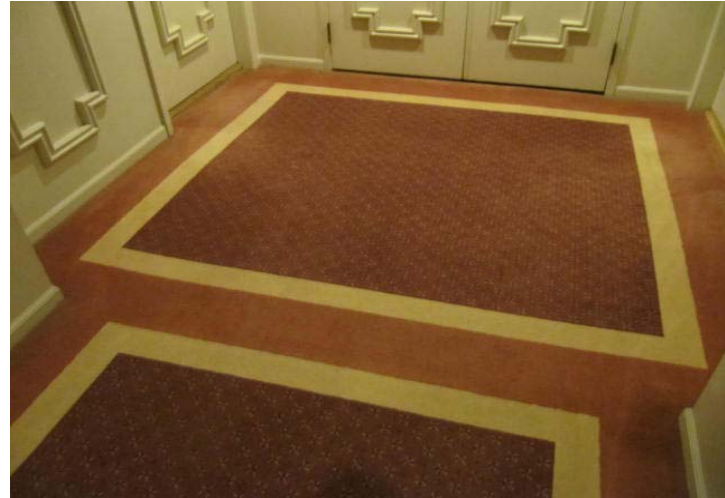
Overview of carpet flooring at hallway area.

Carpet flooring at end of hallway.

Total quantity includes all carpet flooring at the buildings' interior hallways, the meeting room, and the stairs at the entrance vestibules. Carpet flooring is approaching the end of its useful life. The carpet appears dated, many areas have matted surface textures, and there are stains present at isolated locations (near elevator doors). The association anticipates a near-term carpet replacement. Subsequent replacements are forecasted every 8 to 15 years thereafter to coincide with interior paint finishes.

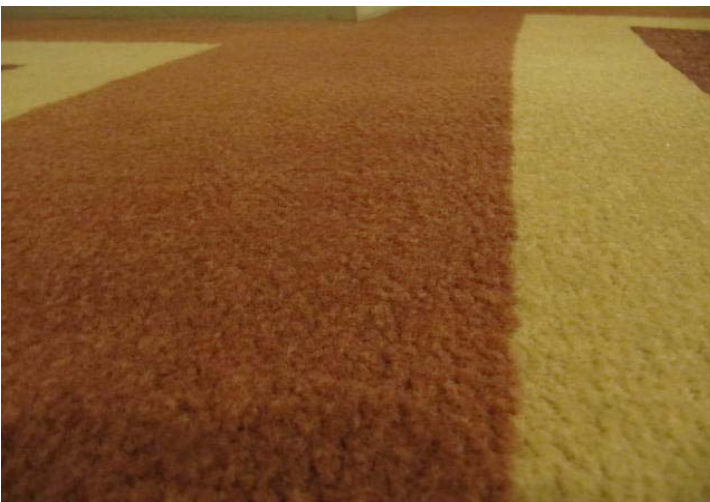
Matted carpet texture.

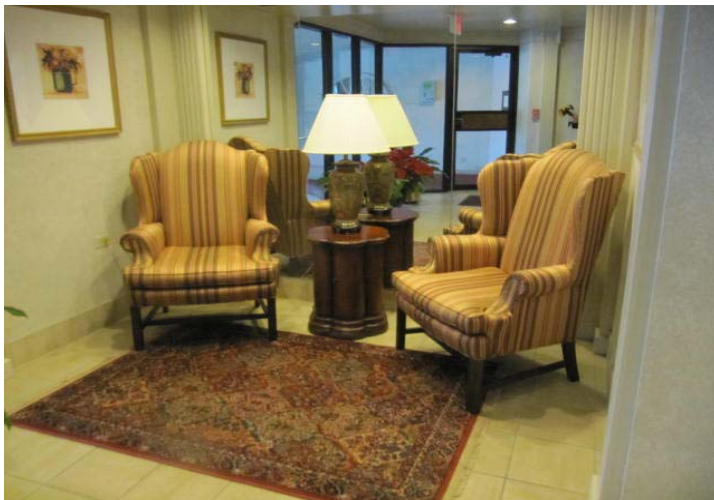
Furniture at entrance lobby.

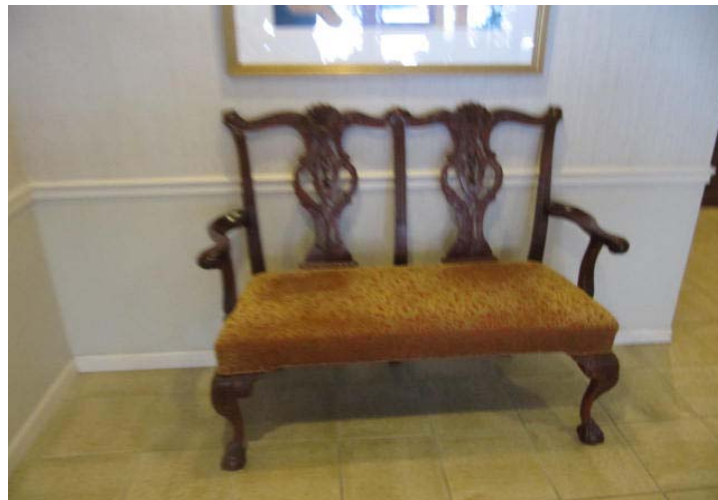
Settee at building entrance lobby.

Special Conditions
Total quantity includes the following furnishings located at the (2) building lobbies: (4) upholstered sitting chairs, (1) wood armchair, (1) settee, (2) end tables, (2) rugs, (2) wood cabinets. Lobby furnishings are in good overall condition. Future replacement is forecasted in 2027 to coincide with the replacement of floor tile, carpet, and interior paint finishes.

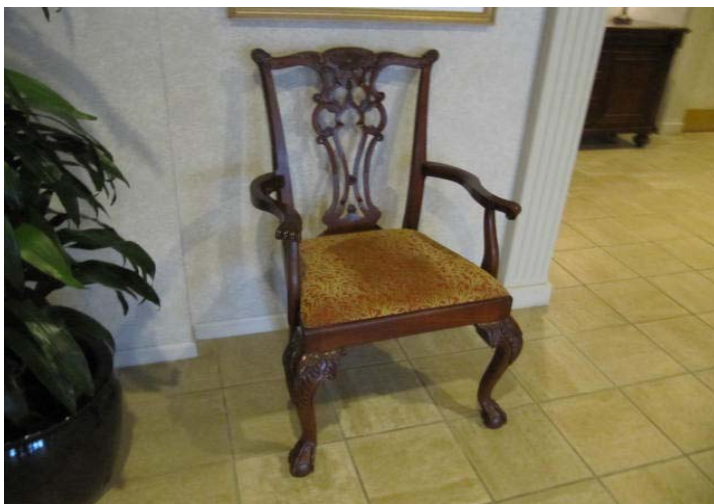
Settee at building entrance lobby.

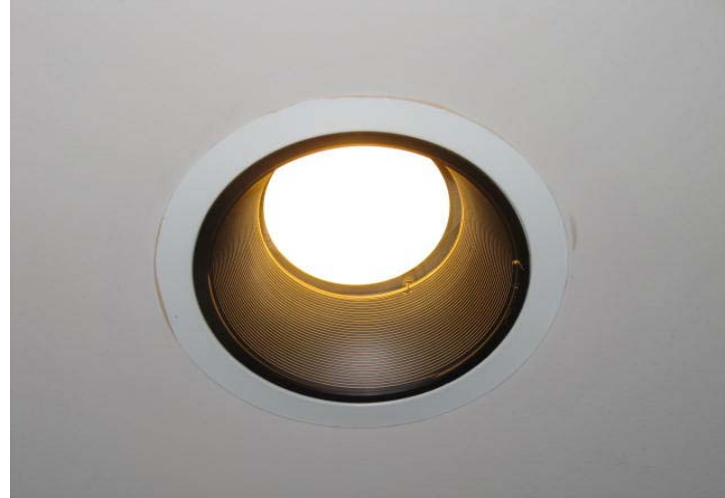
Typical recessed can light.

The majority of interior light fixtures at hallways, lobbies, entrance vestibules, the Exercise Room, Meeting Room, and lower level elevator lobbies are original and are 30 years of age. The association anticipates a near-term replacement. Replacement in 2015 coincides with the replacement of carpet flooring and interior paint finishes at hallways and common rooms. A subsequent replacement of all interior light fixtures is forecasted 25 to 30 years thereafter.

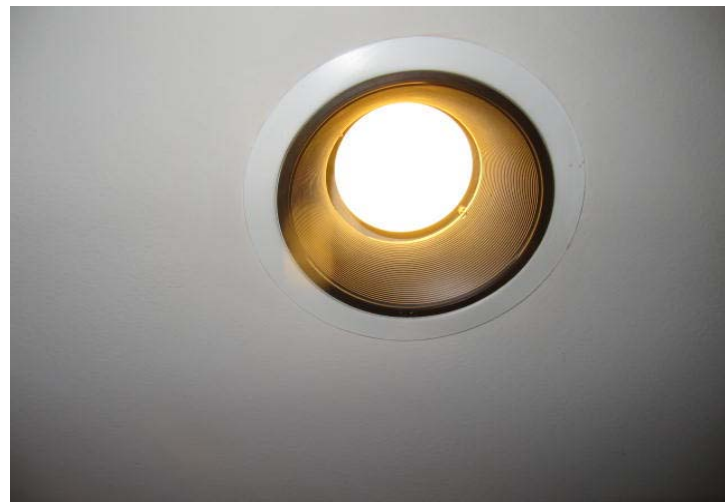
Typical recessed can light.

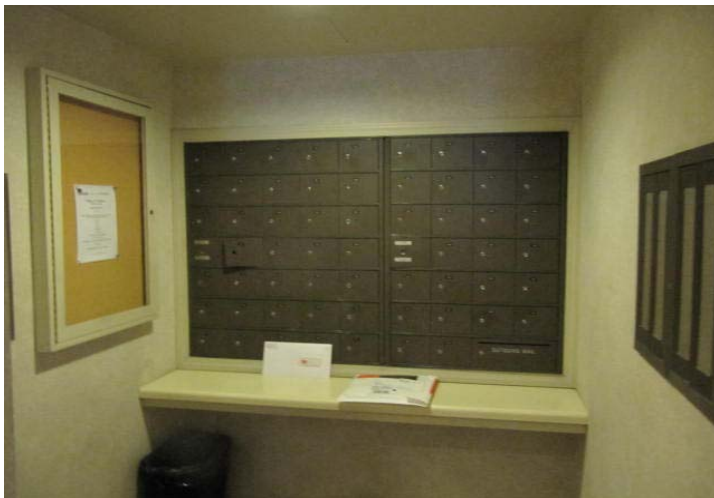
Overview of mailboxes.

Component includes the replacement of interior aluminum mailboxes and surrounding trim / millwork. The original mailboxes are 30 years of age and show deteriorating finishes. Additionally, wood trim at the mailbox surrounds has chipped edges and worn finishes. Replacement of the mailboxes in 2015 coincides with other interior renovations, such as carpet and interior light fixture replacement as well as interior paint finishes.

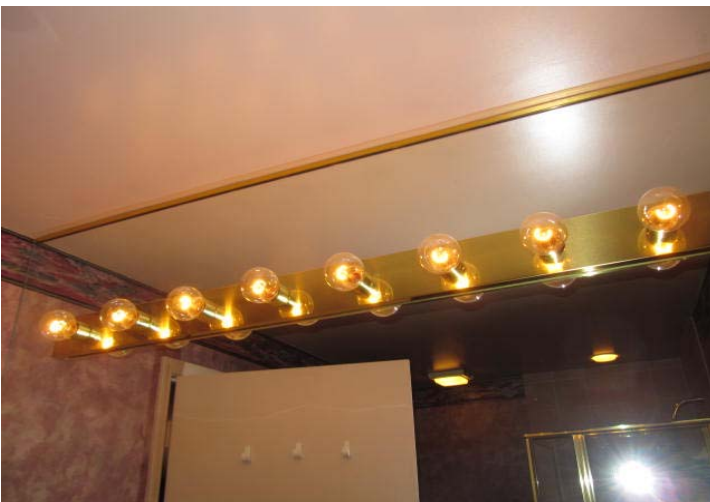
Vanity light fixture at mirror.

Special Conditions
Restroom allowance includes the renovation of the restroom at the Exercise Room and the restroom at the Meeting Room, including the following: (2) sinks, (2) faucets, (2) toilets, (1) set of shower controls/faucet, (1) shower stall with glass enclosure and door, grab bars, mirrors, countertops, floor and wall tile, and restroom accessories. Renovations coincide with carpet replacement, tile replacement at the lobbies, and lobby furniture replacement.

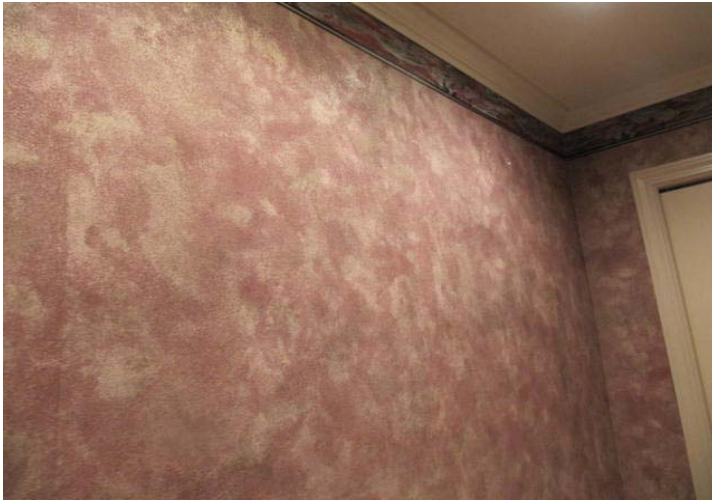
Wall coverings at meeting room.

Total quantity includes all wall coverings at the (2) building lobbies as well as the Meeting Room. The wall coverings are in fair overall condition with markings at various locations. A near-term replacement is anticipated by the association. Wall covering replacement coincides with the replacement of carpet flooring.

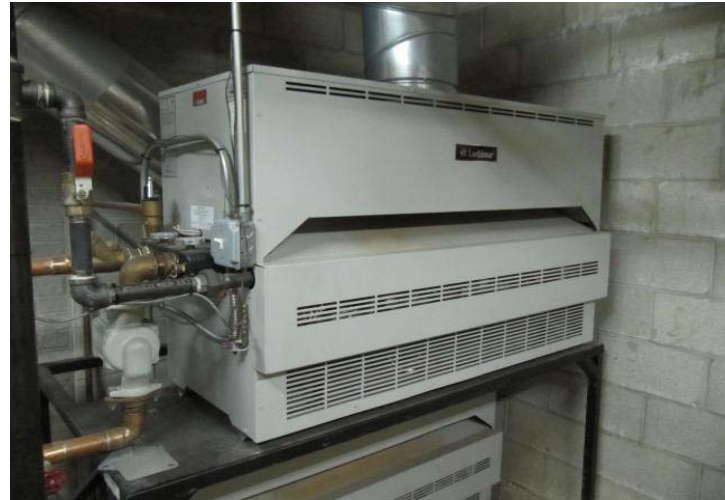
Domestic hot water boilers, at 9 years of age.

(4) domestic hot water boilers rated for 500-MBH input each are located in the lower level mechanical rooms. The boilers were replaced in 2004 and are currently in good functional condition. Future replacement of the boilers is forecasted for 2028, to coincide with the replacement of the hot water storage tanks.

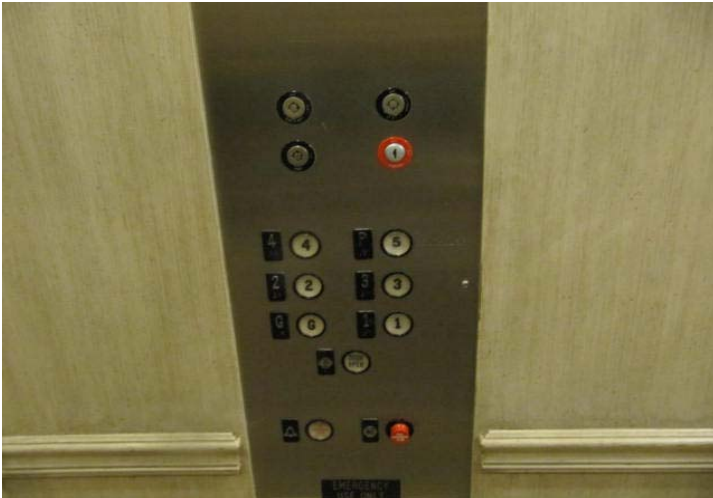
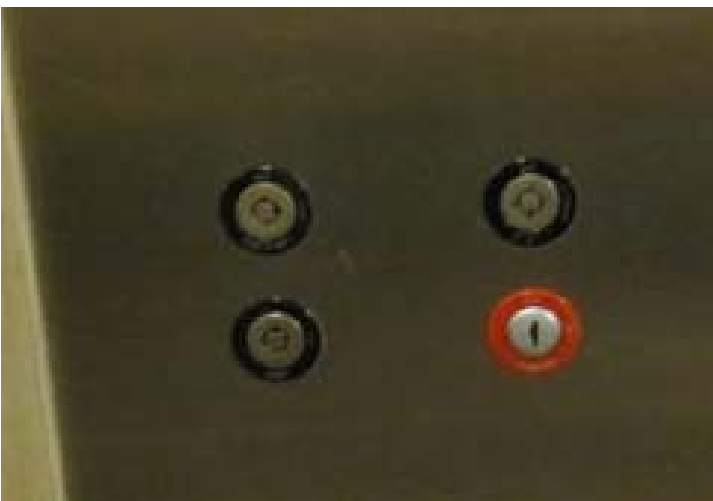
Fixtures at floor selector panel at cab interior.

Floor selector buttons at cab interior.

Component includes the replacement of the original elevator fixtures. Fixtures include buttons in elevator cabs, floor indicator panel/lights inside elevator cabs, floor push buttons at hallways, and up/down indicator lights. Original elevator fixtures are currently 30 years of age, and replacement is recommended within the next 5 years to coincide with the replacement of the elevator controllers.

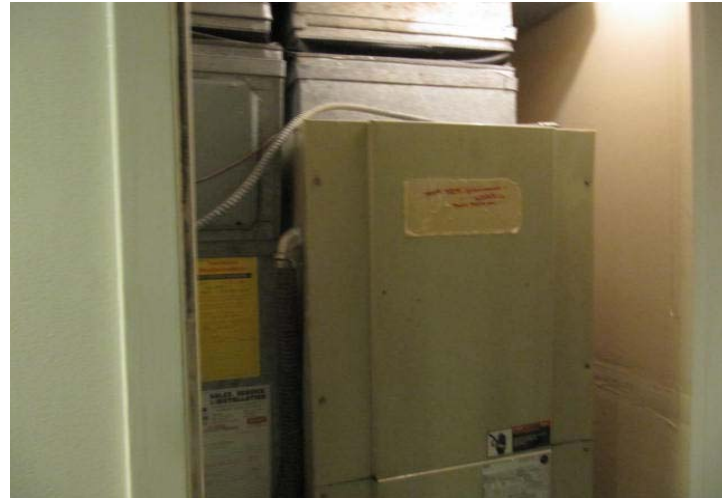
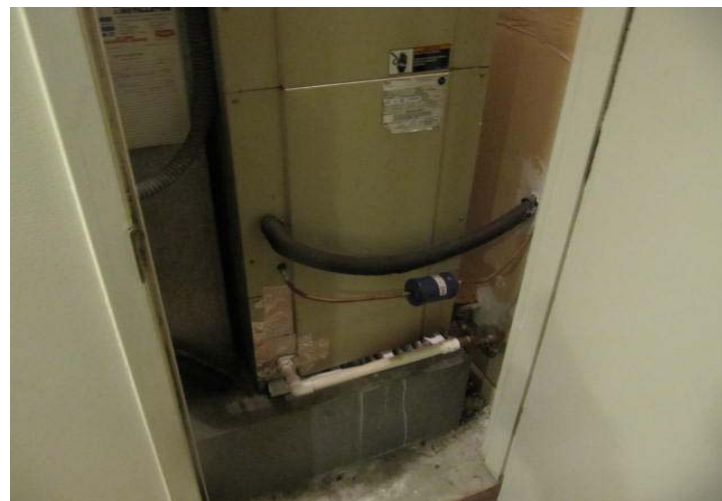
Overview of fan coil unit serving meeting room.

Meeting room fan coil unit, at unknown age.

Fan coil unit located at hallway closet near meeting room.

BDP Company brand fan coil unit.

The fan coil serving the Meeting Room is currently rated for 5.0-ton cooling. Replacement with a lower capacity unit is recommended. Replacement cost includes new fan coil unit (sized to match newer unit at Exercise Room). Replacement of the fan coil unit coincides with the replacement of the rooftop condensing unit serving the Meeting Room.

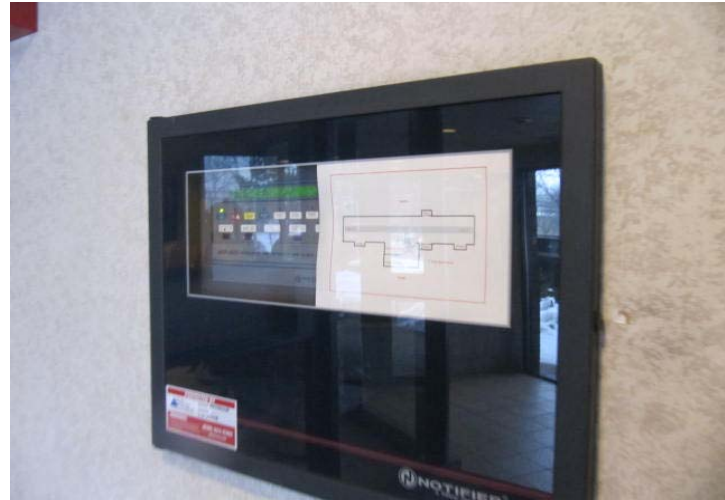
Overview of fire control panel at lobby.

NOTIFIER brand fire control panel.

Wireless transmitter for fire control panel.

Digital display at fire control panel.

The fire panels at the building's entrance vestibules are in good functional condition at an unknown age. Replacement cost includes addressable Notifier brand panel (or equivalent) and adjacent wireless transmitter. Replacement of the fire panel is recommended every 15 to 20 years due to changes in technology. Replacement coincides with the replacement of the emergency fire devices.

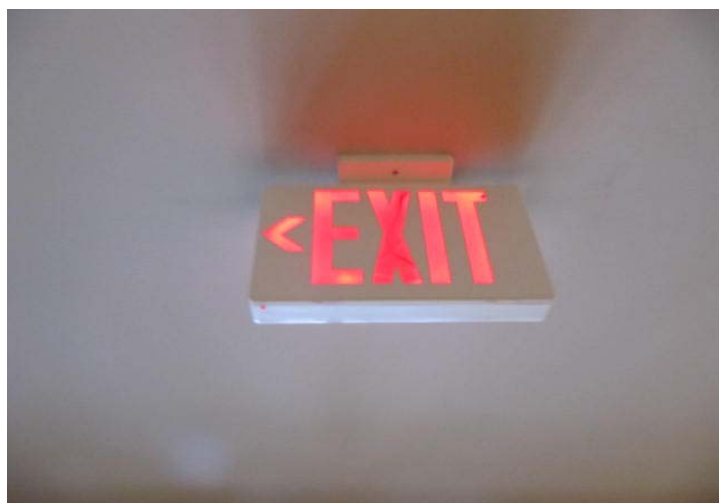
Wall mounted emergency exit sign.

Ceiling mounted double-sided emergency exit sign.

Emergency exit sign, at 9 years of age.

Special Conditions
Emergency exit signs were replaced in 2004 and 2005 and are currently in good overall condition. Replacement is forecasted for 2030, when the fixtures reach an age of 25 years. Replacement coincides with the replacement of the emergency twin beam light fixtures.

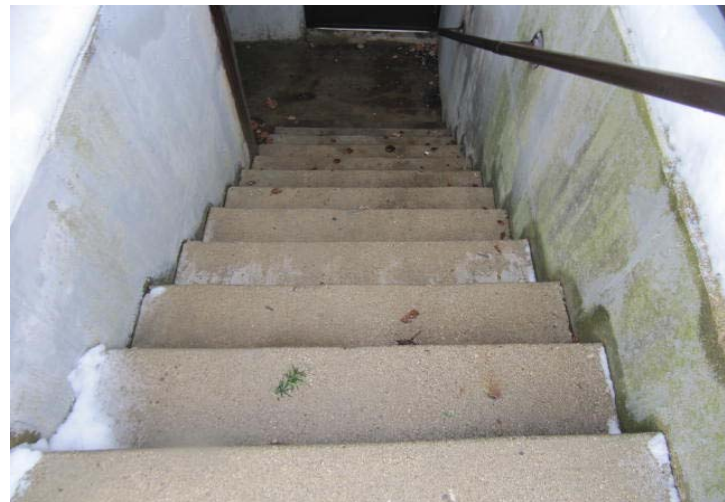
Overall Current Condition:	Fair
Useful Life in Glenview, IL	to 65 Years
Full or Partial Replacement:	Partial 40.0%

Overview of concrete stairs leading to lower level.

Concrete formed stairs, viewed from garage level.

Concrete stair treads leading to private stairwell.

Special Conditions
Total quantity includes all concrete stairs and concrete landings at the lower level stairwells leading from the garages and from the internal private stairwells leading directly from units. Unit cost is an average cost among all formed concrete stairs, concrete treads, and concrete landings. A 40% phased replacement is forecasted over the next 30 years. Replacements coincide with the replacement of concrete curbs, concrete gutters, and concrete sidewalks.

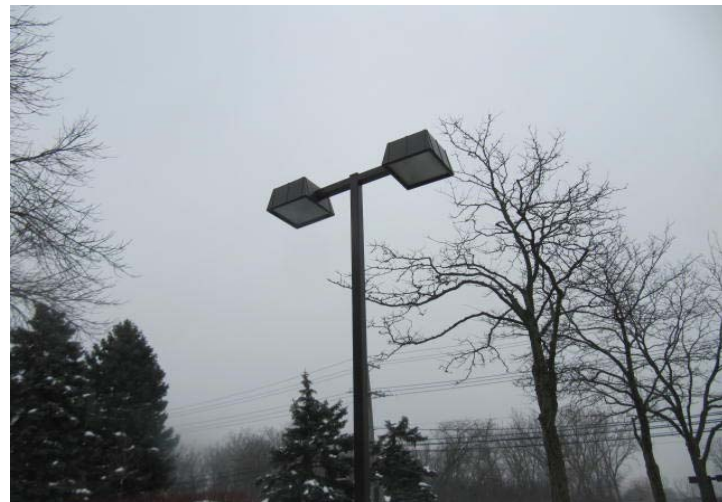
Overall Current Condition:	Fair	
Useful Life in Glenview, IL	30 to 40	Years
Full or Partial Replacement:	Full

Typical single-fixture light pole at parking lot.

Duplex fixture near property entrance.

Special Conditions
Total quantity includes (11) shorter light poles with single fixture, (1) shorter light pole with duplex fixture, (9) tall light poles with single fixture, and (1) tall light pole with duplex fixture. Unit cost is an average cost among all light poles and fixtures. The light poles and fixtures are 30 years of age and are in fair overall condition. Replacement of the light poles and fixtures is forecasted within the next 10 years and coincides with the replacement of the light poles and fixtures located at the front parking lots areas.

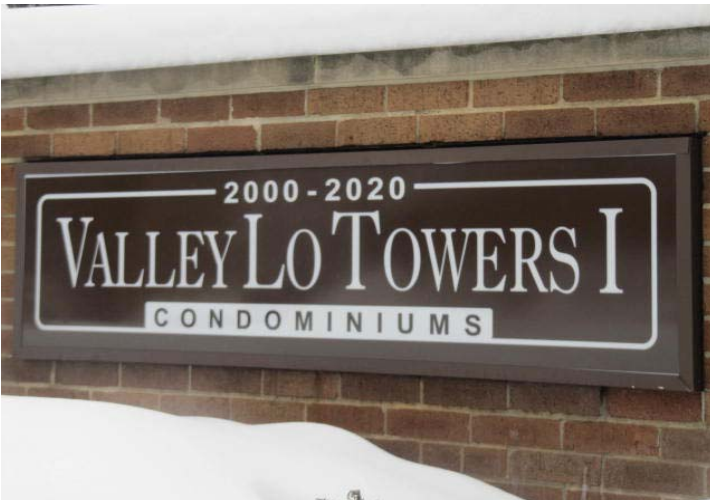
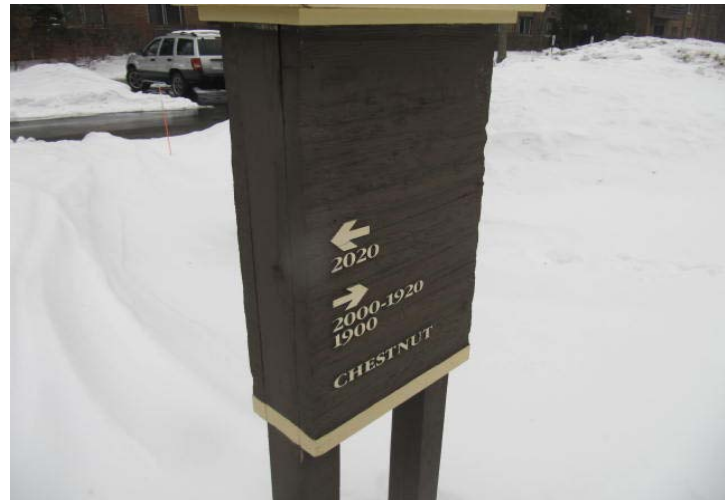
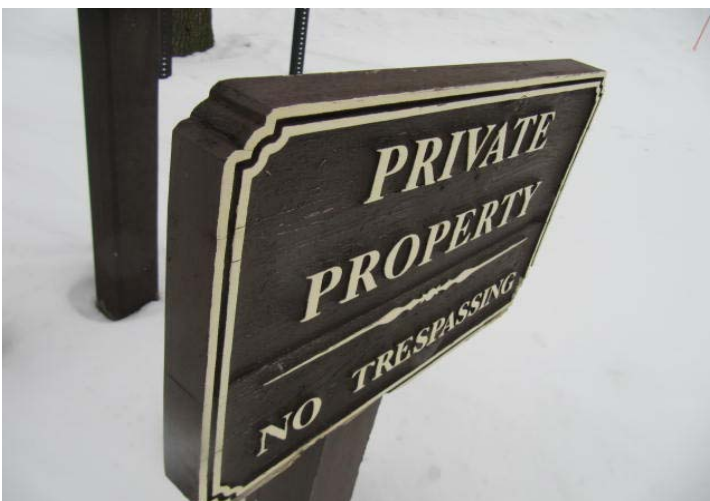
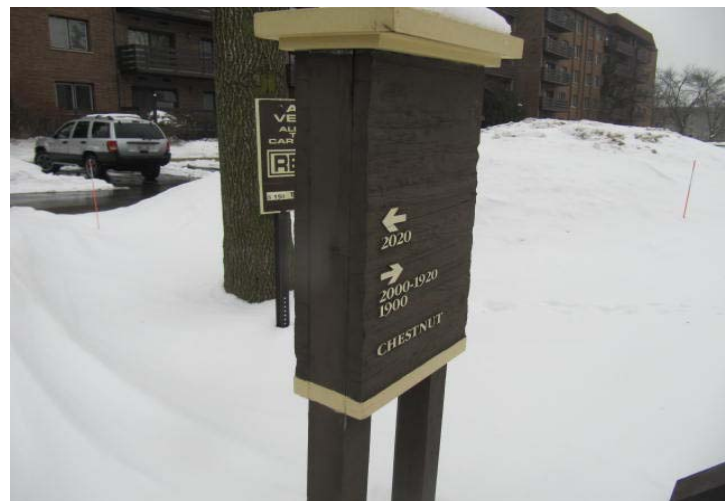
Overall Current Condition:	Fair
Useful Life in Glenview, IL	20 to 25 Years
Full or Partial Replacement:	Full

Sign box insert at monument entrance wall.

Directional wood signage, with paint finishes.

"Private Property" sign near property entrance.

Total quantity includes the following site signage: (1) small "Private Property" sign, (5) wood directional signs or traffic signs, and (1) signage insert box at the masonry monument walls at the property entrance. Signage is in good overall condition at an unknown age. Replacement is forecasted for 2023 and again 20 years thereafter. Prior to full replacement, touch-up painting as needed should be funded from the association's operating budget.

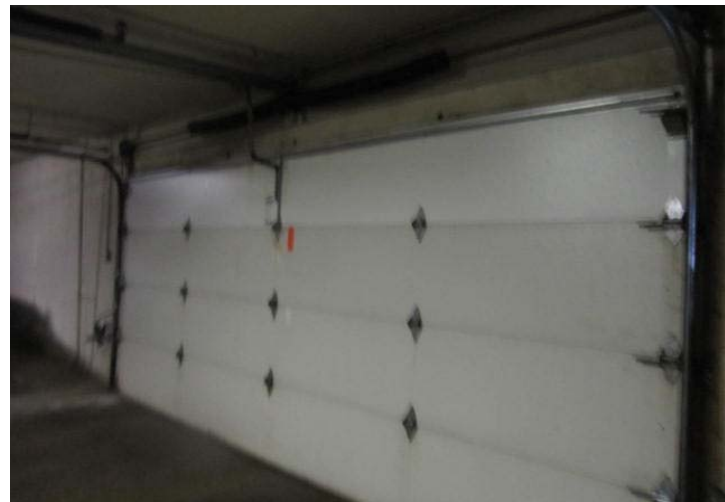
Overview of metal sectional garage door.

Interior view of garage door.

Exterior door finishes are in good condition.

Insulated, sectional door with springs, coils, and track.

Garage doors vary in age and condition, and a phased replacement is forecasted so that all garage doors are replaced within a 15-year period. Unit cost includes a metal sectional commercial-grade garage door with springs, tracks, and all hardware. Phased door replacement coincides with the phased replacement of the garage door operators. Phased replacement are anticipated, beginning in 2021.

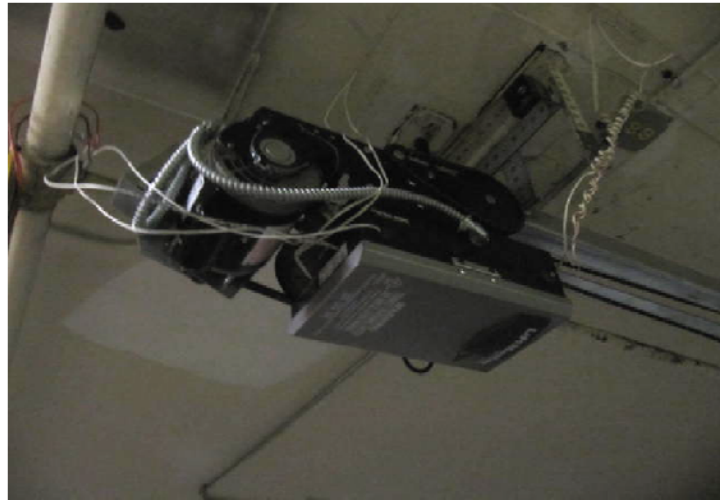
Garage door operator.

Lift Master garage door operator.

Garage door operator, with red/green lights.

Garage door operators vary in age and condition, and a phased replacement is forecasted so that all operators are replaced within a 15-year period. Unit cost includes a commercial-grade garage door operator with electric motor, rated for 0.5-0.75 Horsepower. Phased replacement are anticipated, beginning in 2021.

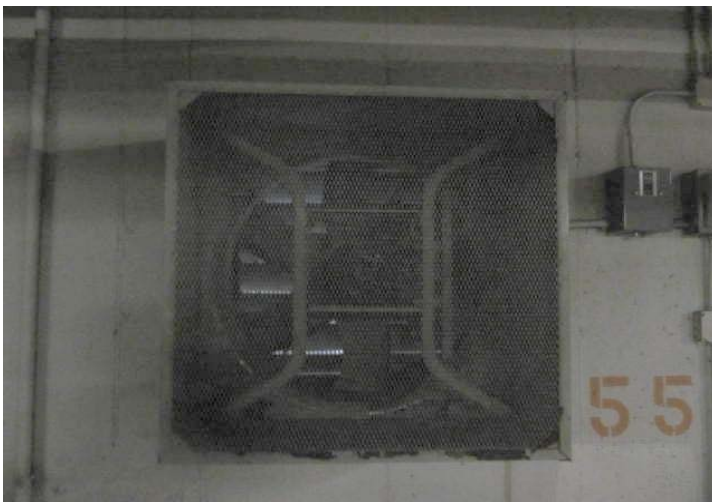
Original exhaust fan, at 30 years of age.

Special Conditions
<p>Component includes the replacement of the exhaust fans at the underground parking garages. Original garage exhaust fans are in functional condition at 30 years of age. Replacement of the exhaust fans is recommended within the next 10 years to maintain good air quality within the parking garages.</p>
