# RESERVE STUDY

## Valley Lo Towers I Condominium Association

**Glenview, Illinois**

**June 12, 2019**

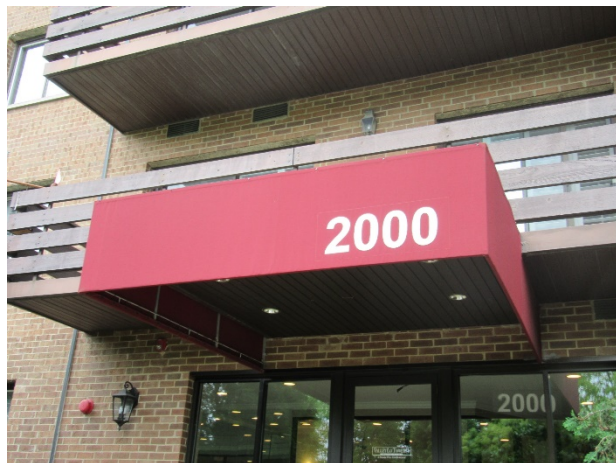
**Condition:** Good overall without significant deterioration evident

Awning

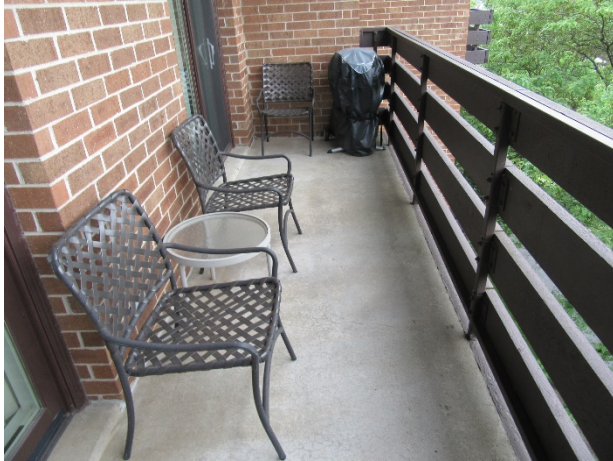
**Condition:** We note systematic evidence of water infiltration at the soffits at the undersides of the balconies and periodic evidence of water infiltration between the balcony and building intersection. Due to the non-invasive nature of our inspection, we are unable to determine the exact composition of the balconies. Based on our visual inspection, experience with similar construction and knowledge of replacement/capital

repair projects of this type, we surmise the balconies comprise a concrete surface atop a metal structure and soffit at the undersides.

**Balcony overview**

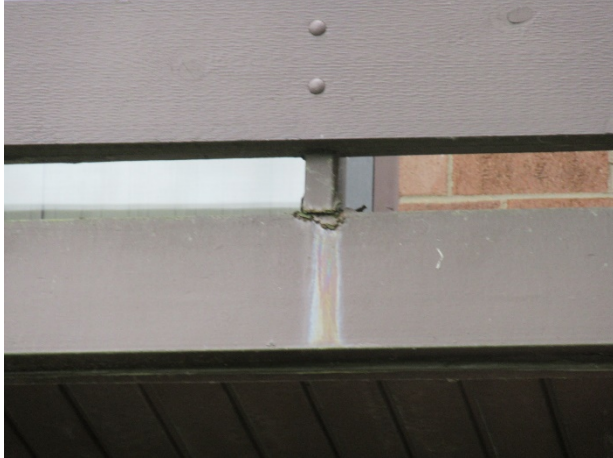
**Post rust**

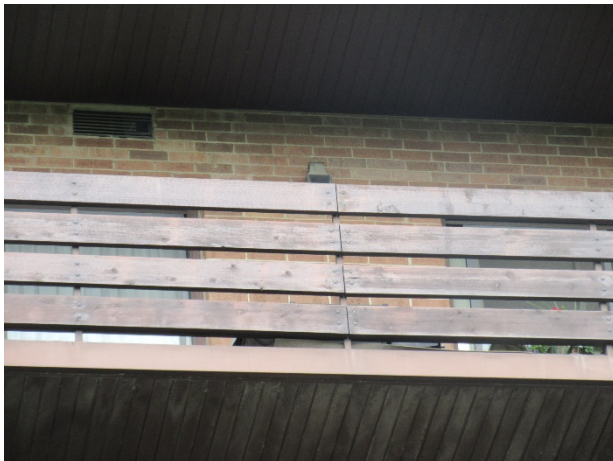
**Finish deterioration**

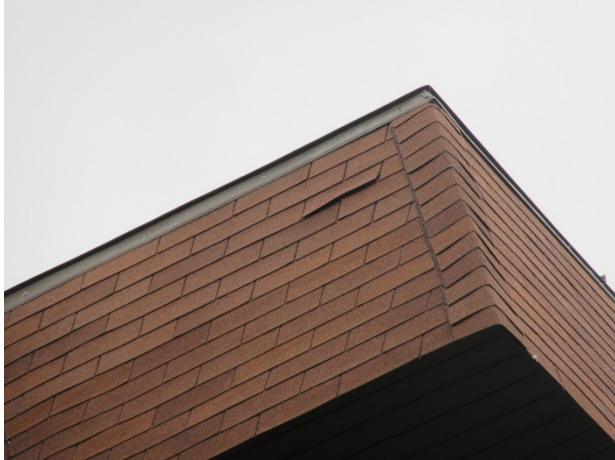
**Condition:** Fair to poor overall with loose, missing and lifted shingles evident from our visual inspection from the ground. Management and the Board do not report leaks associated with the mansard roofs.

**Shingle lift**

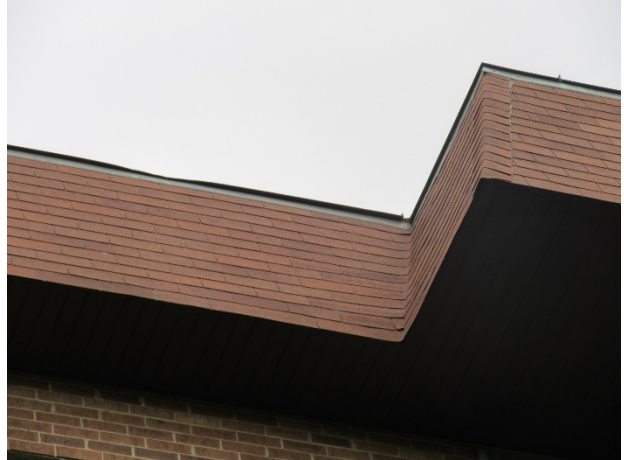
**Granular loss**

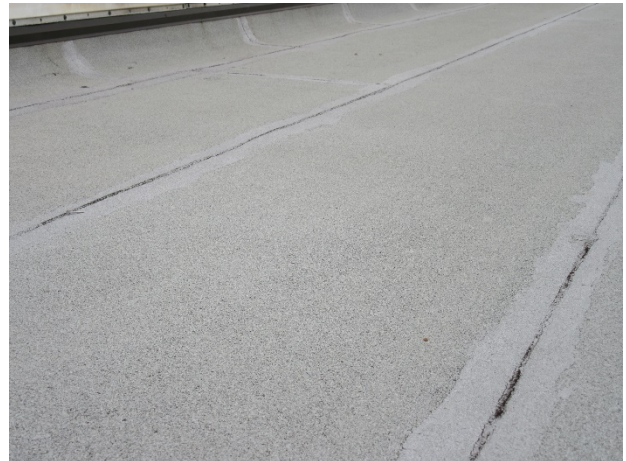
**Membrane deflection**

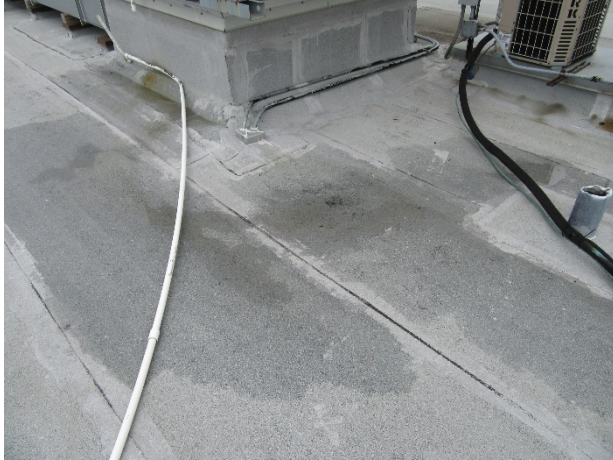
**Water accumulation**

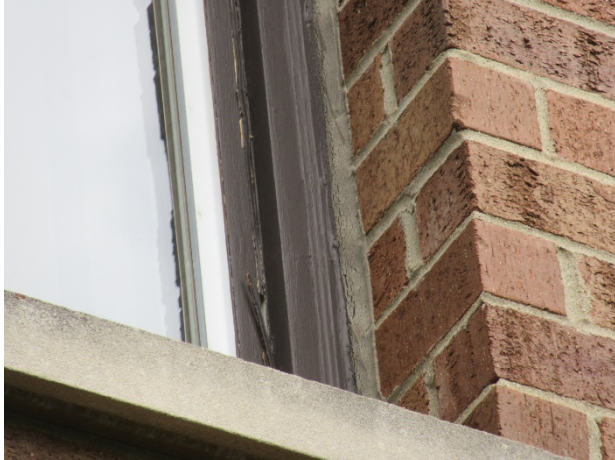
**Sealant deterioration**

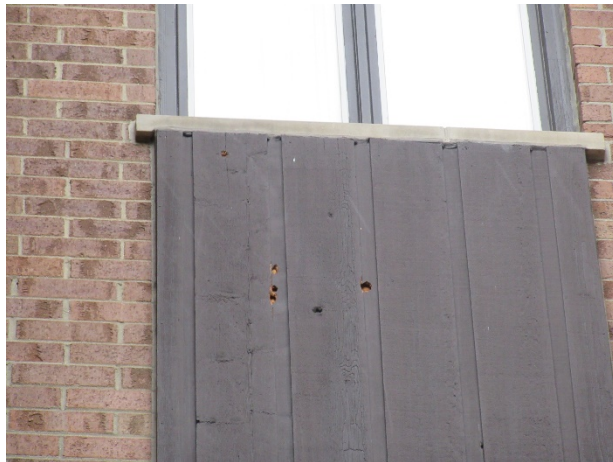
**Condition:** Fair overall with isolated damage evident

**Siding damage**

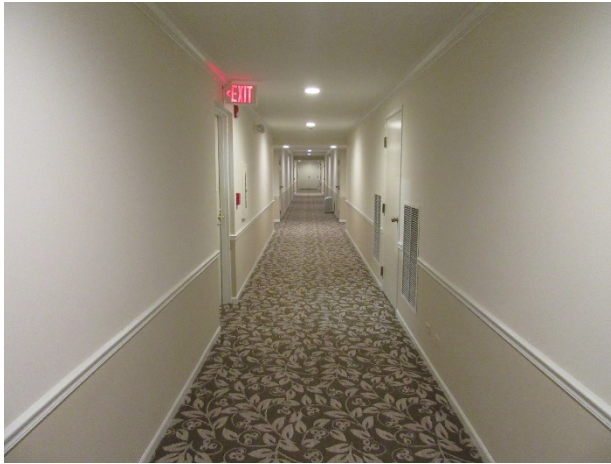
**Hallway overview**

**Condition:** Good overall with isolated fray and stains evident

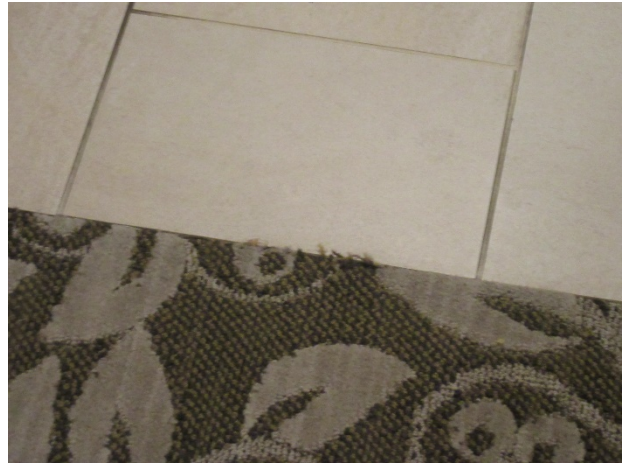
**Carpet fray**

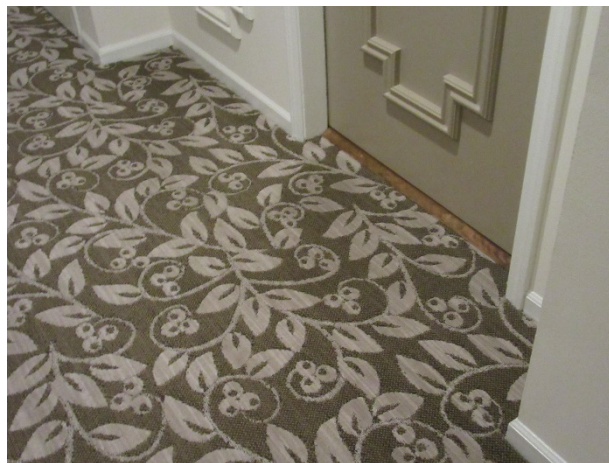
**Carpet stain**

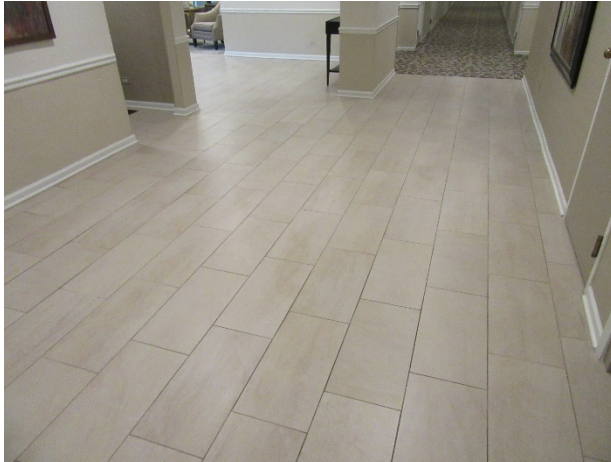
**Lobby tile**

**Condition:** Good overall with isolated grout discoloration

**Expenditure Detail Notes:** Expenditure timing and costs are depicted in the **Reserve Expenditures** table in Section 3. We include replacement in conjunction with subsequent replacement of the carpet. The Association should fund regrouting of the tiles through the operating budget if necessary.

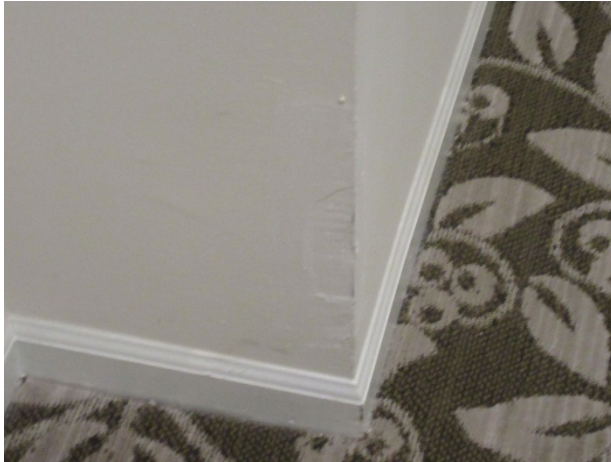
**Condition:** Good overall with isolated damage and scuffs evident, mainly at corners

**Corner damage**

**Expenditure Detail Notes:** Expenditure timing and costs are depicted in the **Reserve Expenditures** table in Section 3. We include paint finish applications in conjunction with replacement of the carpet.

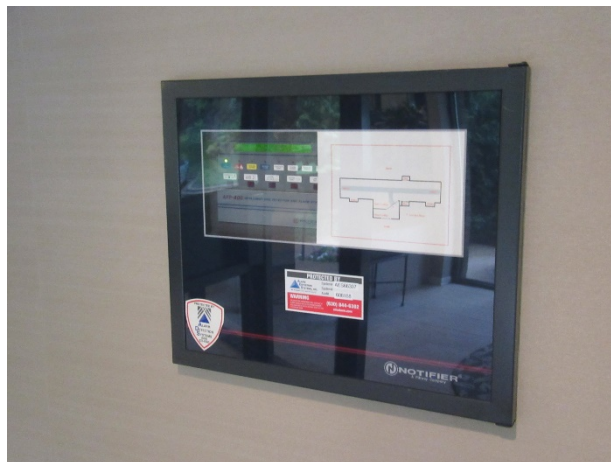
**Control panel**

**Conditions:** Reported satisfactory with a periodic false alarm originating in the garage

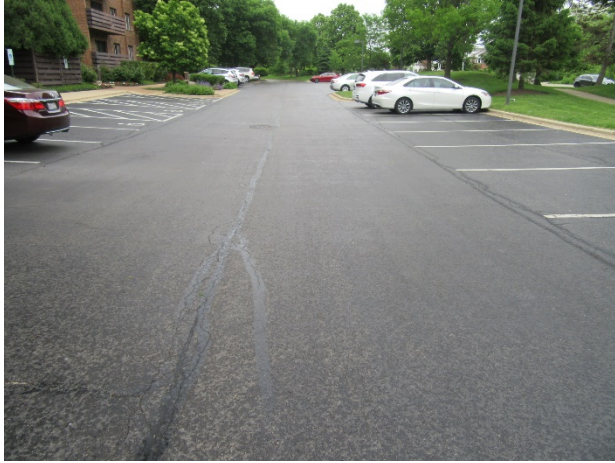
**Pavement overview**

**Condition:** Good to fair overall with areas of alligator cracking, settlement and longitudinal cracks evident

is overlaid atop the remaining base course of pavement. Total replacement includes the removal of all existing asphalt down to the base course of aggregate and native soil followed by the application of two or more new lifts of asphalt. We recommend mill and overlayment on asphalt pavement that exhibits normal deterioration and wear. We recommend total replacement of asphalt pavement that exhibits severe deterioration, inadequate drainage, pavement that has been overlaid multiple times in the past or where the configuration makes overlayment not possible. Based on the apparent visual condition and configuration of the asphalt pavement, we recommend the mill and overlay method for initial repaving of the access drive and parking areas and the total replacement method for fire lane repaving and subsequent access drive and parking area repaving at Valley Lo Towers I.

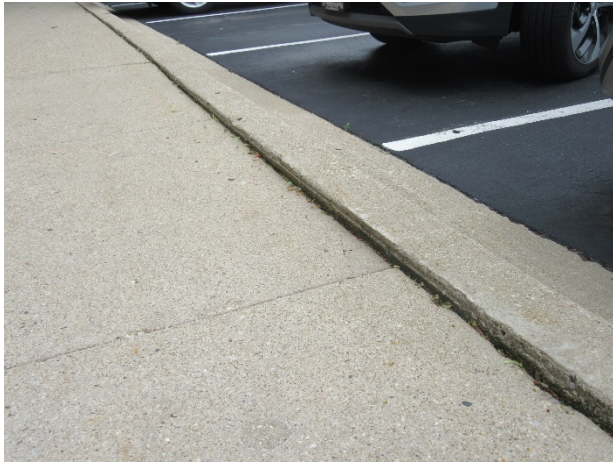
**Condition:** Fair overall with periodic cracks and settlement evident. We note continuous settlement at the curb and sidewalk intersection. The Association has a contract in place to mudjack these areas of settlement. Although likely to fix the settlement in the near term, mudjacking is likely only a temporary solution if the underlying base is insufficient or the base continues to settle.

**Sidewalk settlement**

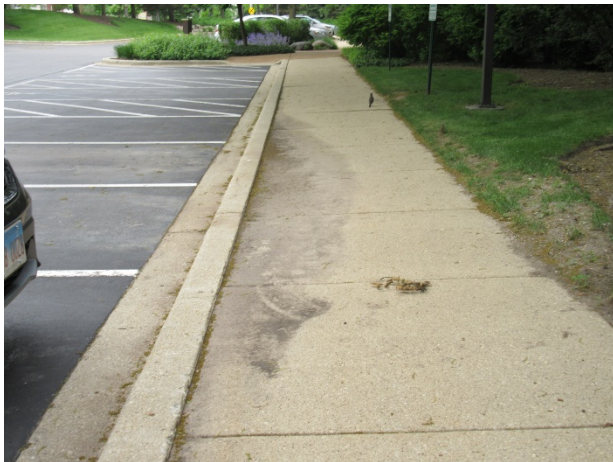
**Sidewalk settlement**

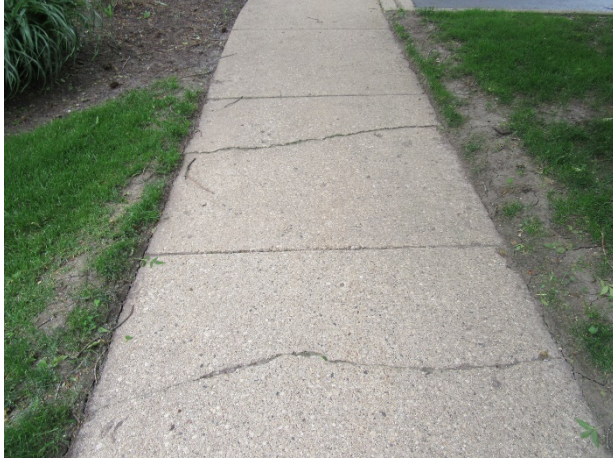
**Cracks**

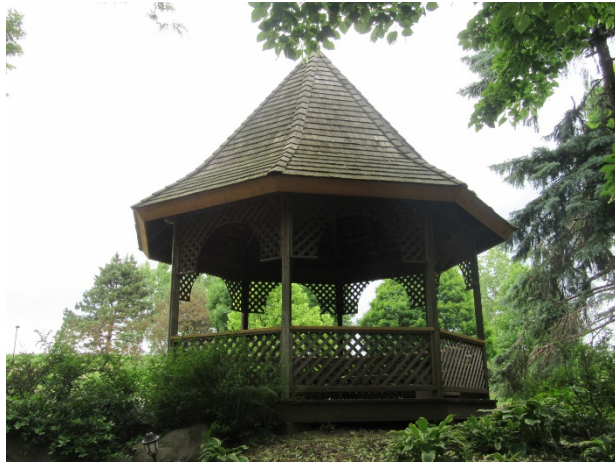
**Gazebo**

**Condition:** Fair overall with shingle lift and split, and deck board deterioration evident

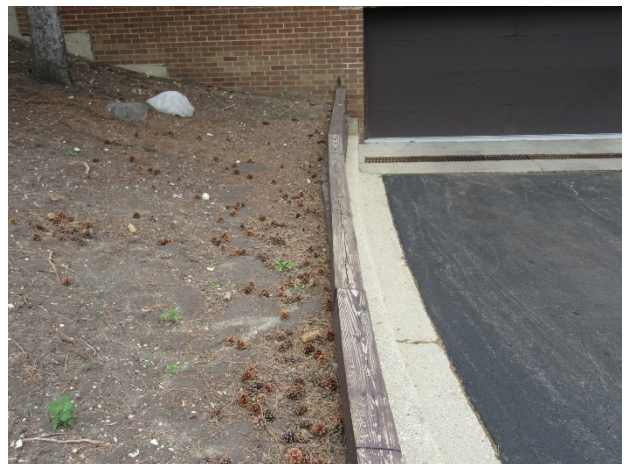
**Condition:** Fair overall with wall lean, paint finish deterioration and wood deterioration evident

Wall lean

**Component Detail Notes:** We advise Valley Lo Towers I replace with a modular, interlocking dry-set masonry retaining wall system. The cost of dry-set masonry retaining walls is similar to the cost of timber walls. However, dry-set masonry retaining walls offer a longer useful life of up to 35 years and lower total maintenance costs. The following schematic depicts the typical components of a retaining wall system although it may not reflect the actual configuration at Valley Lo Towers I:

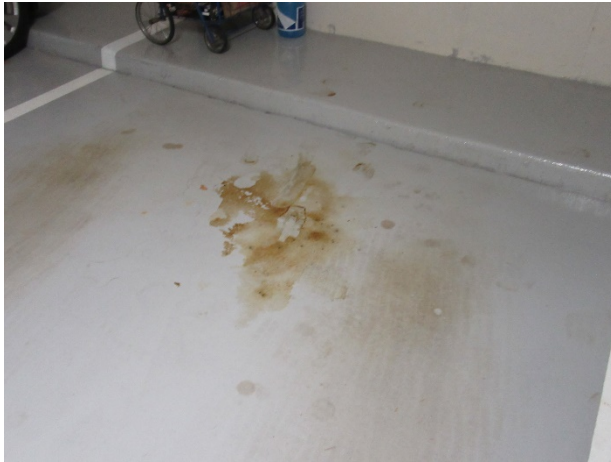
**Condition:** Good overall with no significant deterioration evident. However we note isolated finish deterioration, vehicle fluid stains and minimal use of aggregate resulting in a slipper surface if wet.

**Vehicle fluid stains**

- Complete inspection of the garage concrete and concrete repairs as described in the previous narrative “Concrete, On-grade”
- Removal of the existing coating and preparation of the concrete surface

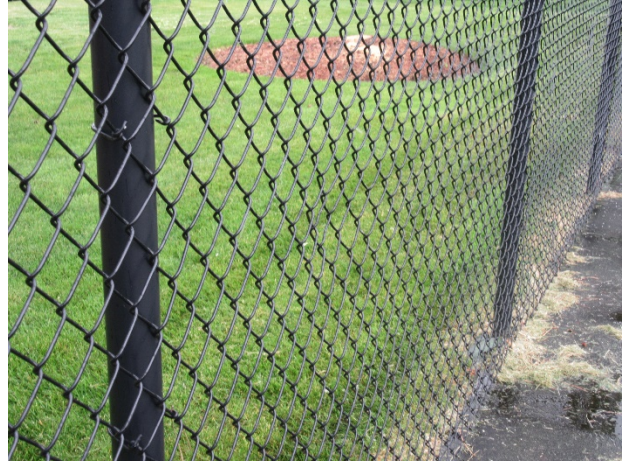
**Condition:** Good to fair overall with isolated chain link deflection evident

Chain link deflection

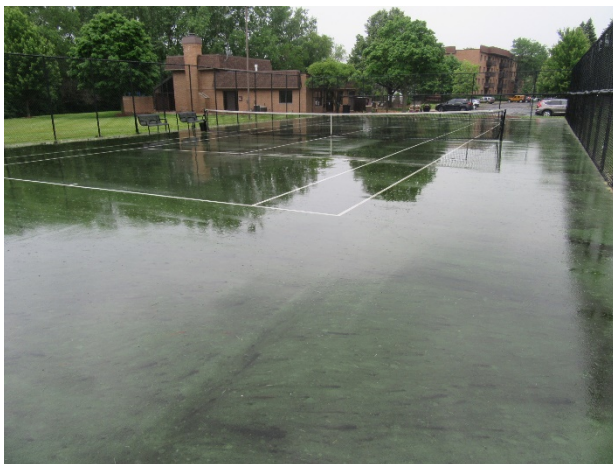
**Condition:** Fair overall with discoloration, court cracks and settlement evident

**Court overview**

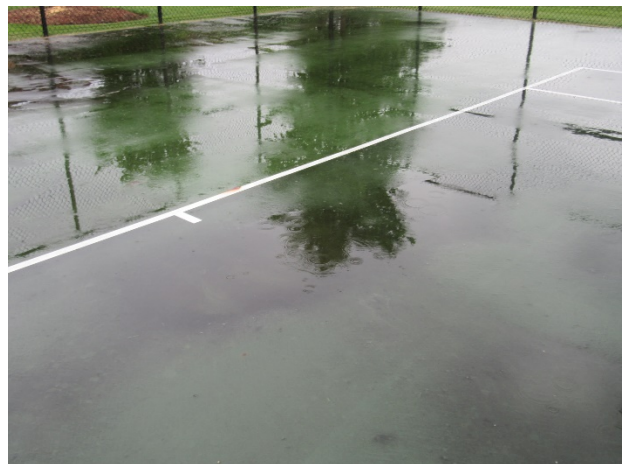
**Water accumulation**

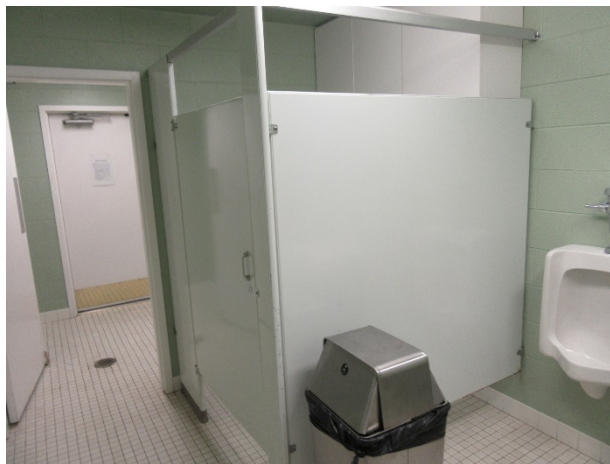
**Condition:** Fair overall and the finishes appear dated

**Rest room**

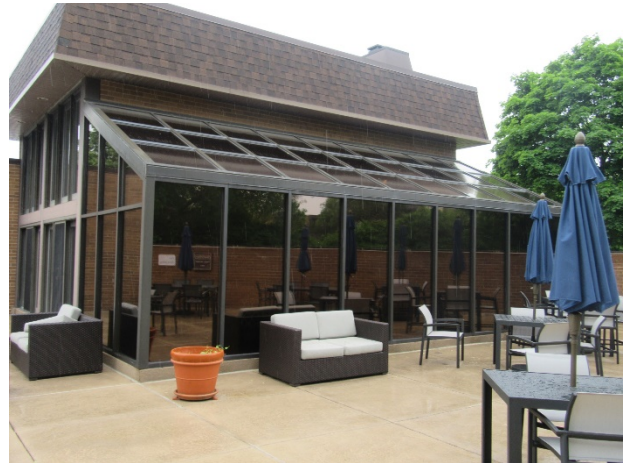
**Atrium windows**

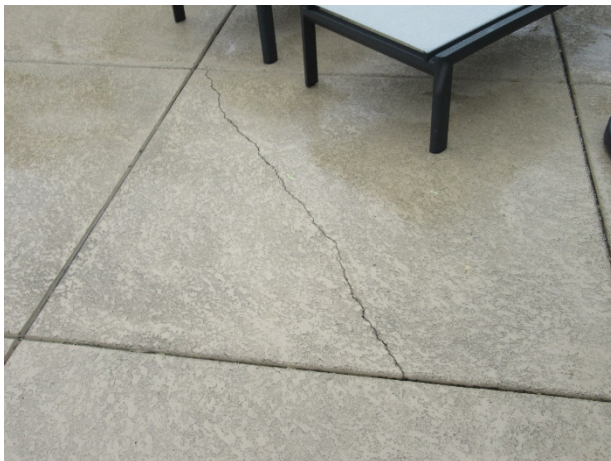
**Condition:** Good condition with isolated cracks, settlement and coating deterioration evident

Deck crack

- Selective cut out and replacements of up to ten percent (10%) of concrete
- Crack repairs as needed
- Mortar joint repairs
- Caulk replacement
- Coating replacement

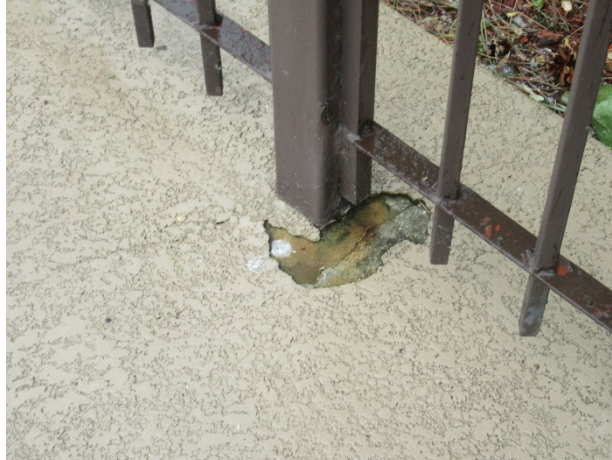
**Coating deterioration**

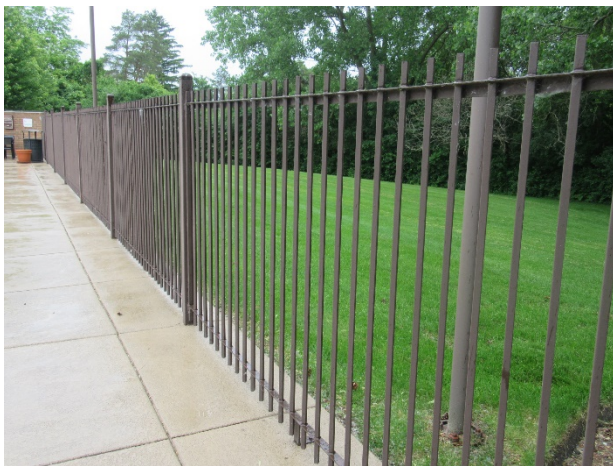
**Condition:** Fair overall condition with finish deterioration and picket deflection evident

**Fence overview**
